NextDay Inspect
46179 Westlake Dr, Suite 200 B
Sterling, VA 20165

21 Sample St, Sample VA, 10000

Inspection Date: 01/04/2020

Termite Inspector Findings

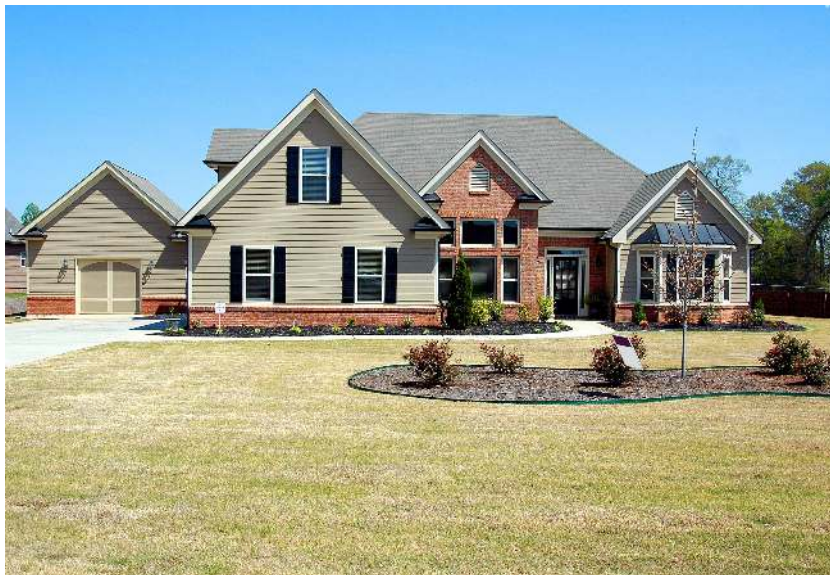
Findings: I found evidence of termites
Recommendations: Subterranean Termite Treatment

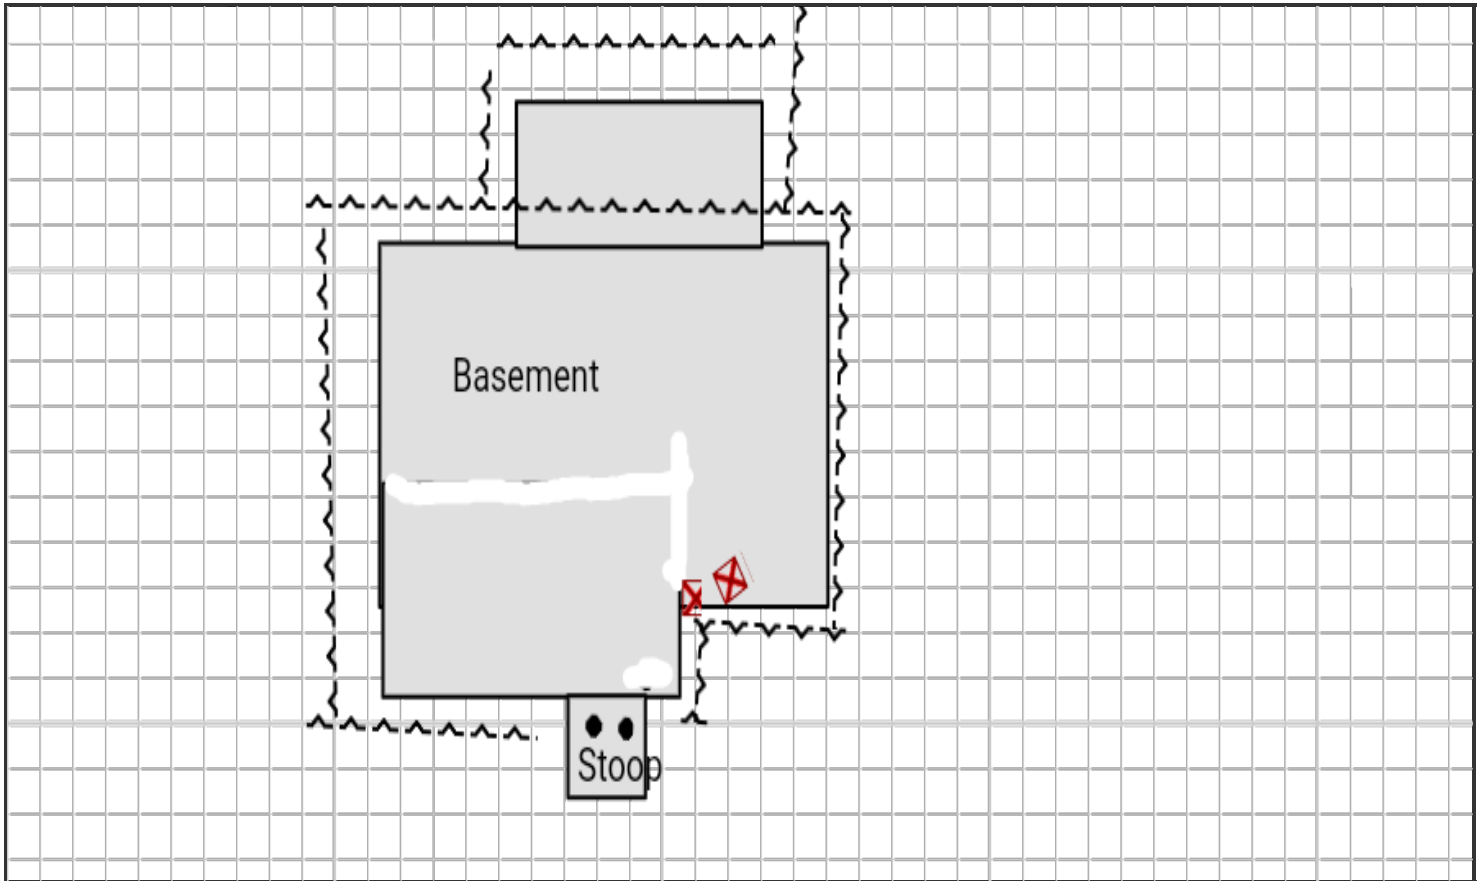
Property Graph

Visibility: Visible dead insects: TERMITE SHELTER TUBING ON FLOOR JOISTS AND SUBFLOORING IN BASEMENT UNFINISHED AREA; Visible damage: TERMITE DAMAGE TO SUBFLOORING IN BASEMENT UNFINISHED AREA

Recommendations: Recommend treatment: SUBTERRANEAN TERMITES
