INSPECTION REPORT

111 SAMPLE AVE, SAMPLE, VA 00001

Date of Inspection: 6/28/2025 Time: 9:00 AM

Year Built: 1985 Size (Sqft): 1628

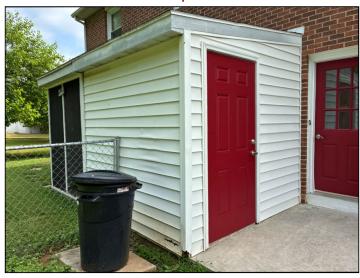
- Door did not latch. Adjust or repair as needed.
- Moisture damage noted on interior wall sheathing. Recommend repair or replace as needed.

Did not latch

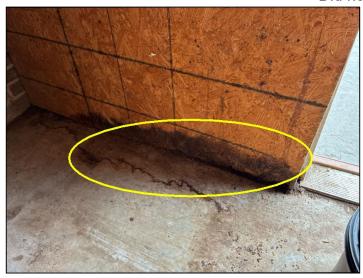
Moisture damage

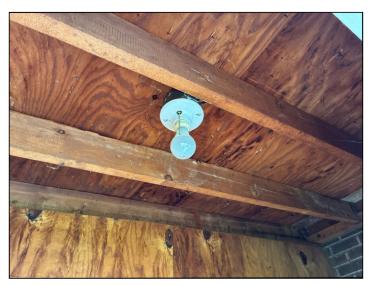
• Light did not work. Replace bulb and check for operation. Repair or replace fixture as needed.

Did not work

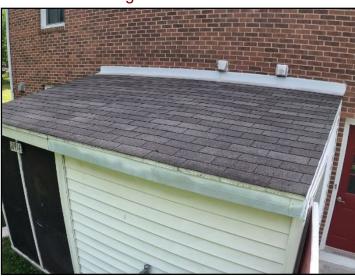
• Gutters and downspouts were not installed. Recommend installing to prevent water damage to structure.

Gutter and downspout missing

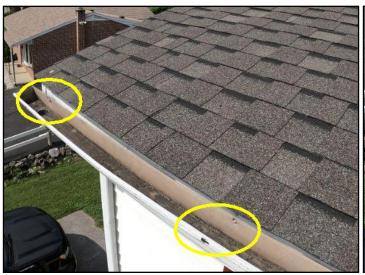
- Missing gutter fasteners observed. Gutter at the front of the house was detached. Recommend repair or replace as needed.
- Standing water noted in the gutter at the back of the house. Recommend confirm proper sloping of the gutter system. Repair or replace as needed.
- Downspout extender at the back of the house was detached. Recommend repair or replace as needed.

Fasteners missing

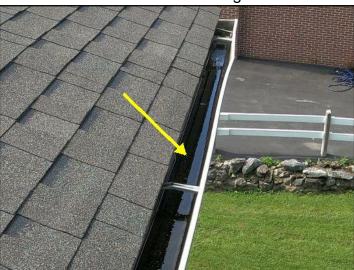
Standing water

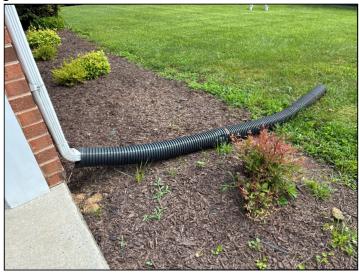
Detached

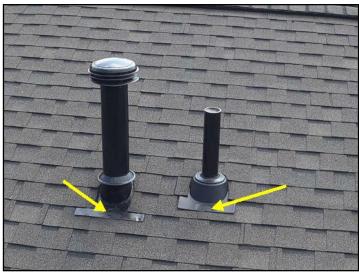
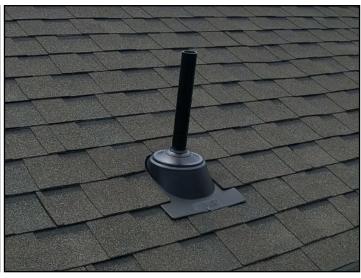
• Exposed nails observed at flashing aprons. Recommend sealing all fastener heads.

Unsealed fasteners

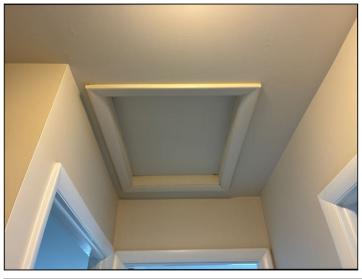
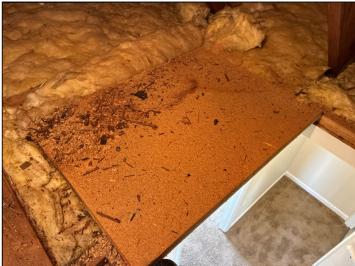
- Access at hallway ceiling.
- Access cover was not insulated. Recommend insulating the access cover to minimize energy loss.

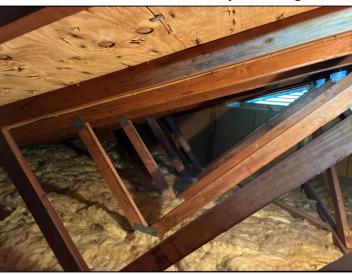
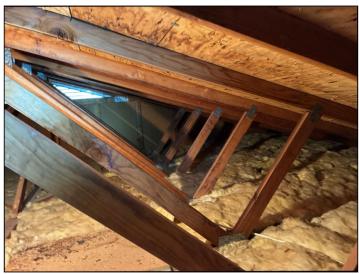
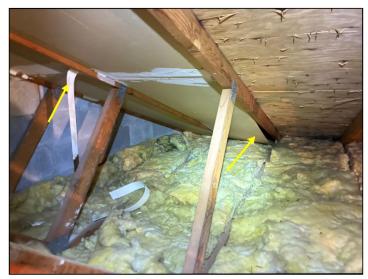
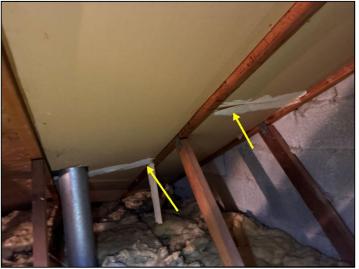
- Loose and peeling drywall tape noted on gypsum boards. Loose or sagging panel noted. Recommend repair by a qualified contractor.
- Roof sheathing appeared loose. Recommend further review and repair as needed by a roofing contractor.

Peeling drywall tape / loose panel

Peeling drywall tape

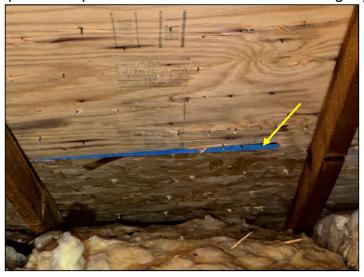
Loose sheathing

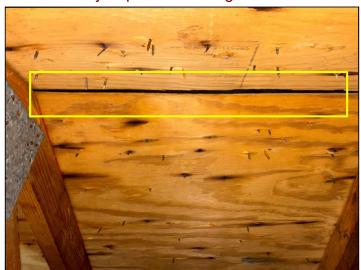
- Observations:
 Soffit and ridge vent.
- Gable louver vents.
- Soffit vents were blocked with insulation. Recommend installing baffles to keep insulation from blocking the soffit vents.
- Ridge vent air slots were between 1/2" and 2" wide. May not be adequate for proper air flow. Recommend review by a qualified roofing contractor.

Small air slot

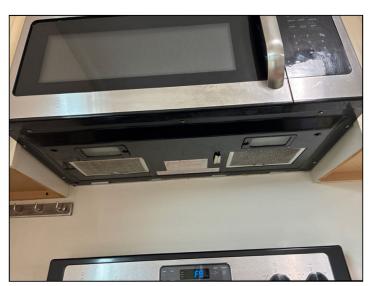
- Tested exhaust fan was operational at the time of inspection.
- Light bulb was not working or missing. Replace bulb and check for operation. Repair or replace unit as needed.

Lights did not work

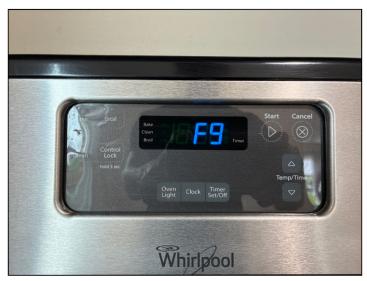
- Electric burner
- Error code noted on oven panel. Unable to operate oven. Recommend review and repair as needed.

Error message

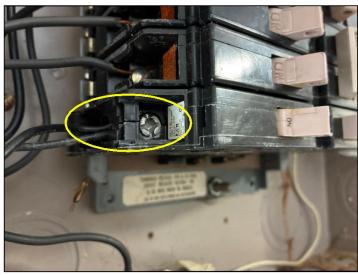
- White wires connected to hot breaker switches observed. White wires are designated to neutral bus connection. Replace or label as needed.
- Double tapped breaker observed inside panel box (more than one electrical conductor attached). This is not standard practice, and may cause overheating or an electrical fire. Recommend evaluation and repair by a licensed electrician.

Double tapped

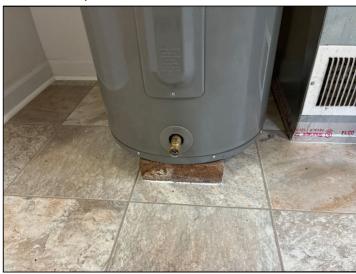
- No overflow pan and drain line noted. Installation of an overflow pan with a drain line beneath the water heater tank is recommended, especially if the water heater is inside the home or basement. A leak could cause lots of water damage. Installing an overflow pan and a drain eliminate this possibility.
- No overflow pan and drain line noted. Recommend installing.

Missing overflow pan and drain

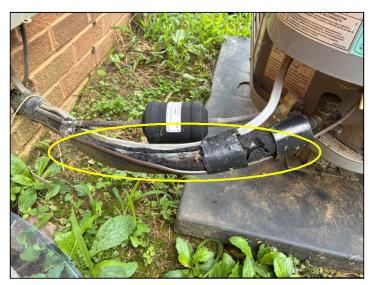
• Deteriorated insulation on the exterior refrigerant lines noted. Repair or replace as needed.

Deteriorated insulation

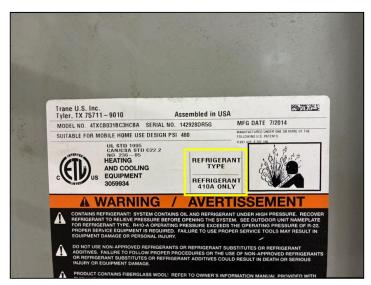
- Manufacture date: 2014. Life expectancy around 20 years.
- Unit appeared to operate properly using normal operating controls at the time of inspection.
- HVAC system service date was over 12 months ago or unable to be determined. Recommend servicing by a licensed HVAC specialist.
- R22 A/C system noted on the exterior unit. Indoor unit specified 410A refrigerant. Recommend review by a HVAC specialist.

410A refrigerant

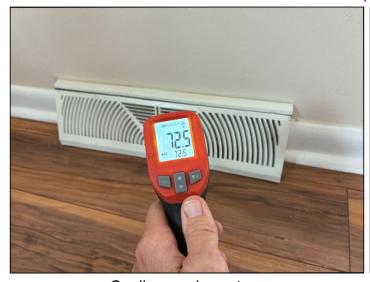
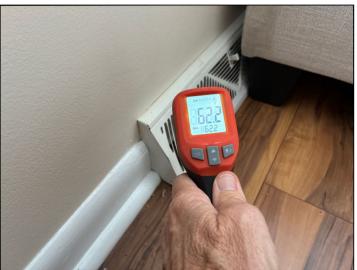
- Average temperature differential between supply and return air is 12-15 degrees F. On high efficiency units, expect 16-22 degrees F difference.
- The AC unit did not appear to be operating as efficiently as it should. Recommend review and repair as needed by a licensed HVAC specialist.

Cooling mode - supply
