# INSPECTION REPORT

10000 Sample Street, Sample MD 10000  
Inspection prepared for: Sample Client  
Real Estate Agent: Sample Agent

Date of Inspection: 12/20/2021 Time: 9:00 AM  
Year Built: 2021 Size (sqft): 2800  
Weather: Clear 25 to 30 degrees F  
Order ID: 9086

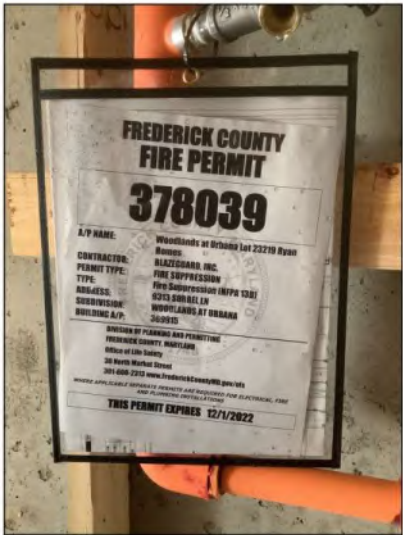
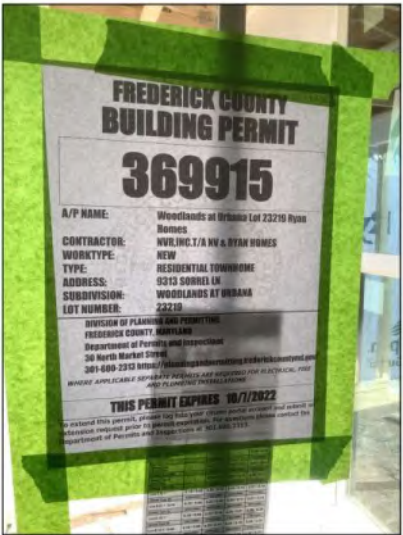
## 1. New Structure Condition

Observations:  
• Permits are displayed on site an accessible for viewing.

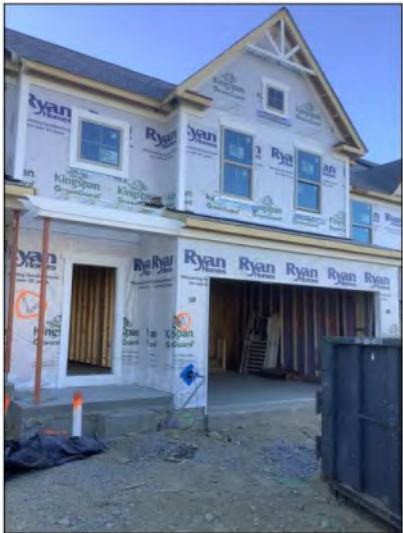
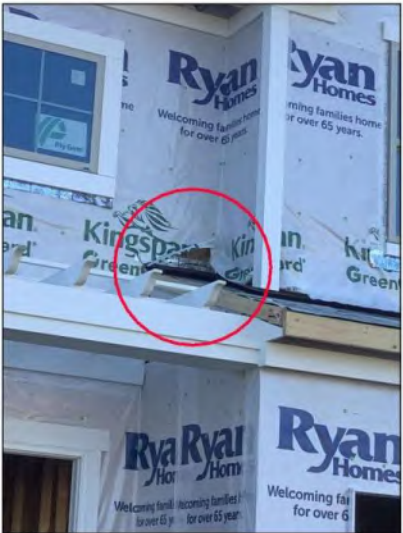
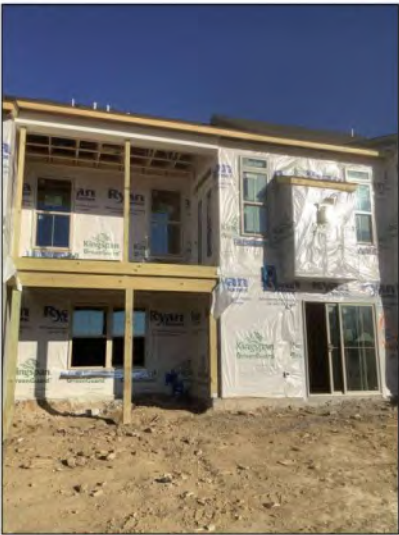
1. House Wrap Condition

- House wrap missing tape noted in the front of the structure, repair as needed.

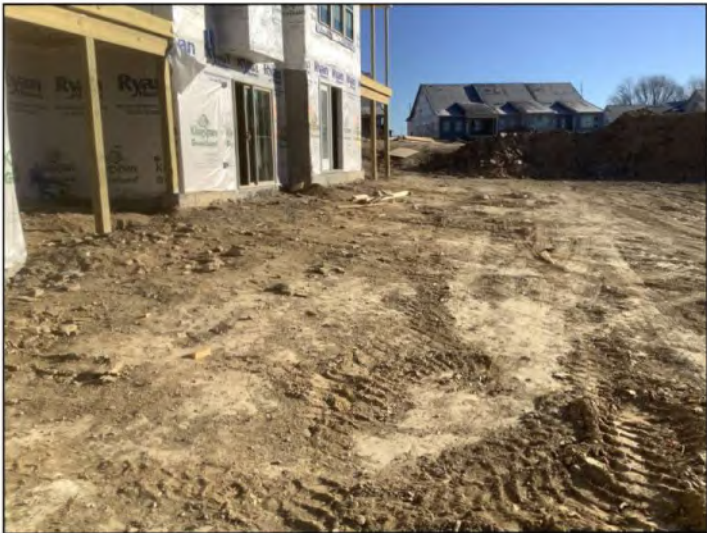
2. Grading

- New Construction - Some, if not many components have not been built/installed or completed/finished yet.
- Lot grading and drainage have a significant impact on the building, simply because of the direct and indirect damage that moisture can have on the foundation. It is very important that surface runoff water be adequately diverted away from the home. Lot grading should slope away and fall a minimum of six (6) inches within the first ten (10) feet around the perimeter of the building.

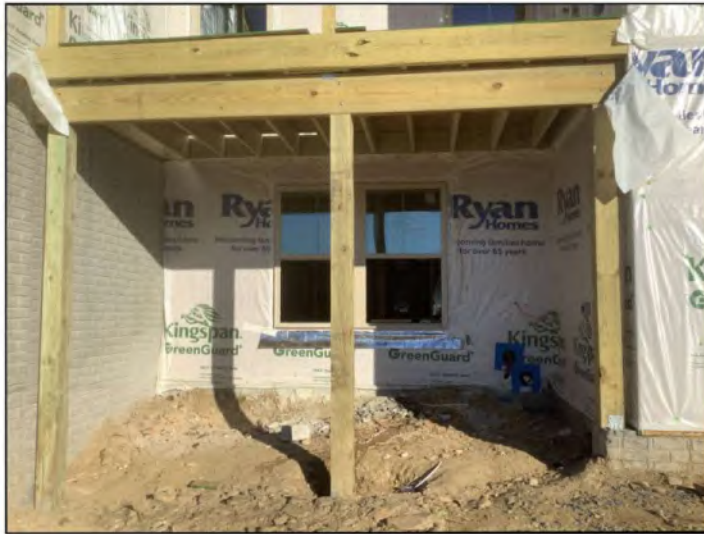
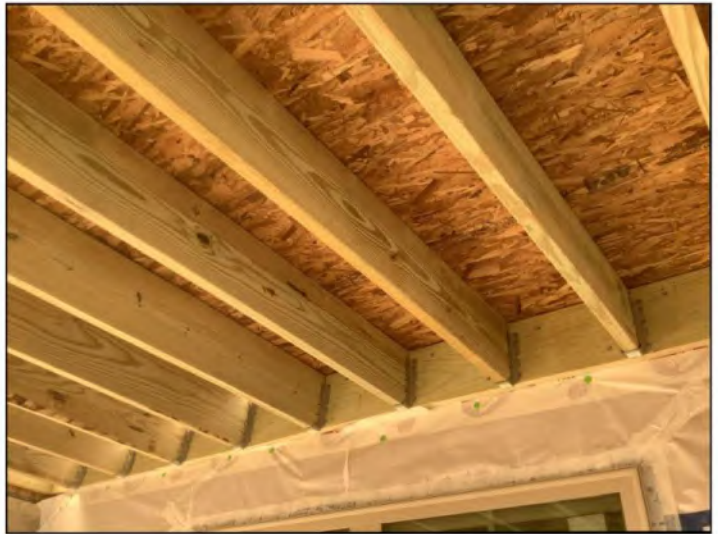
**3. Deck**

- No deficiencies noted.

• **MAINTENANCE:** Whether treated or not, it is important to keep a wood deck surface free of all forms of fungal growth and debris that retains moisture and will cause the deck to eventually rot. Recommend cleaning and resealing the deck annually. Cleaning can be accomplished by scrubbing the deck with a sodium-hypochlorite (bleach) and Tri-Sodium-Phosphate (TSP) deck wash and then rinsing with a pressure washer. Finally, a wood deck should be re coated with a high quality deck sealant.

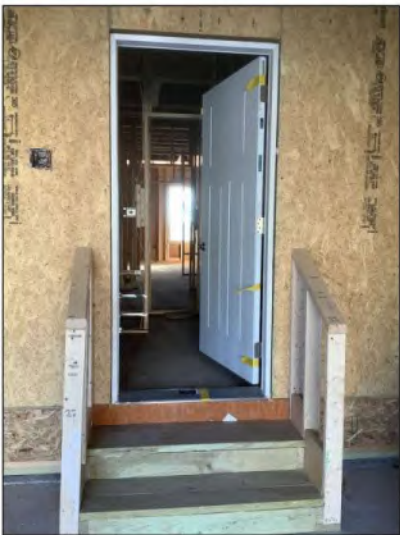
5. Fire Door

- No auto closure present. Recommend installing an auto closure for safety.

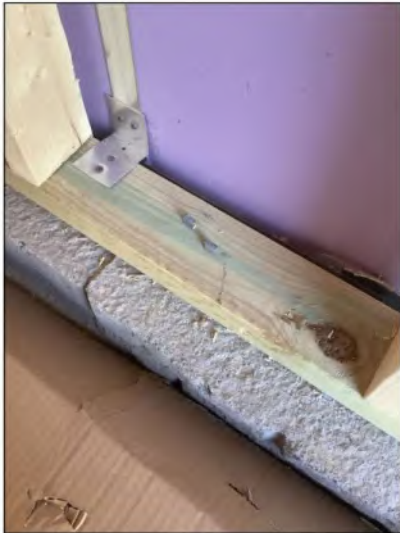
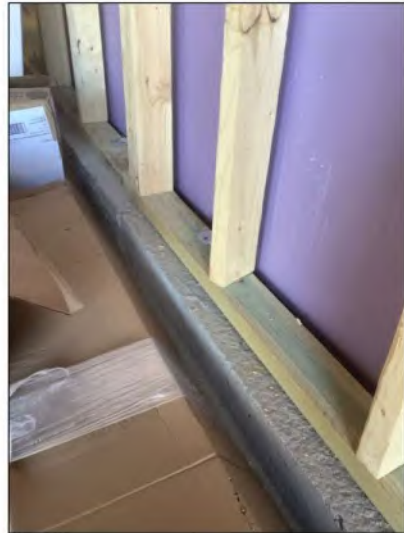
7. Anchor Bolts

- The builder used masonry or "cut" nails to attach the bottom plates to the foundation wall. We recommend adding retrofit style anchor bolts as necessary.

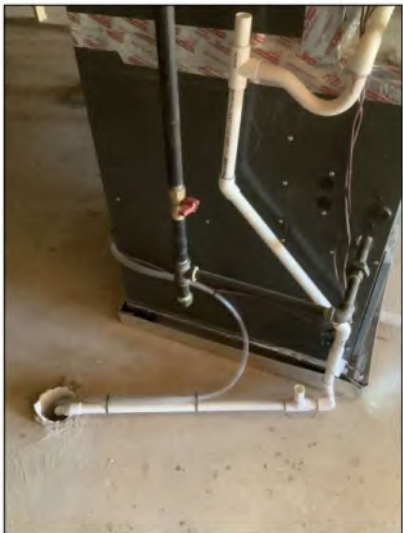
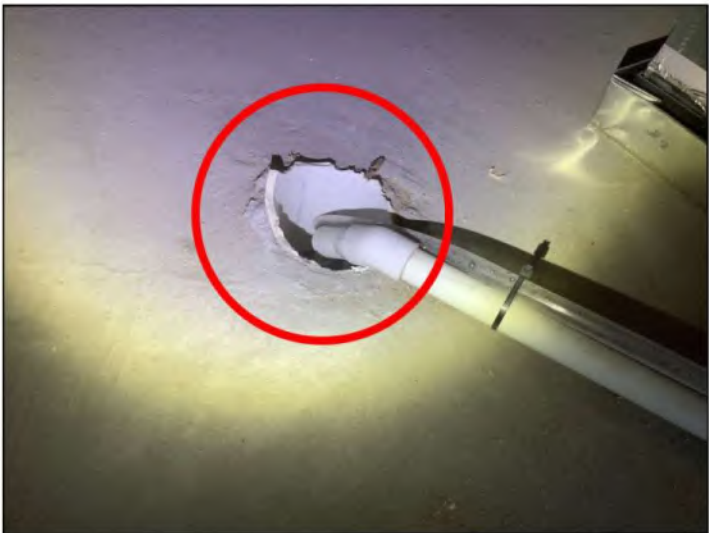
6. Plumbing

- Floor drain not properly cut, sharpened/pointed edges noted, possible trip hazard, repair as needed.

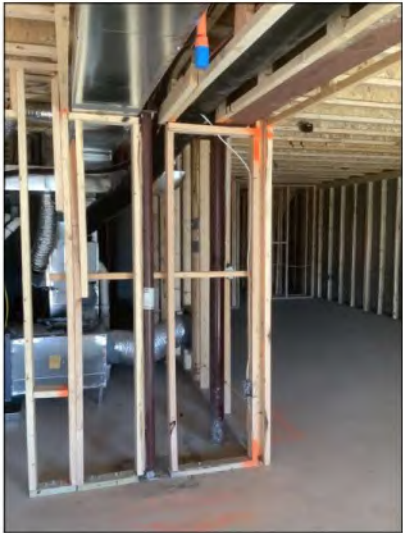
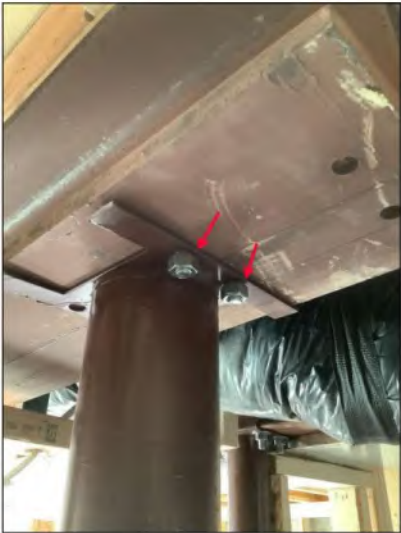
## 1. Columns

- Steel column top flanges are not properly bolted to the steel beams. Recommend tightened/installed bolts as needed.

Loose bolts

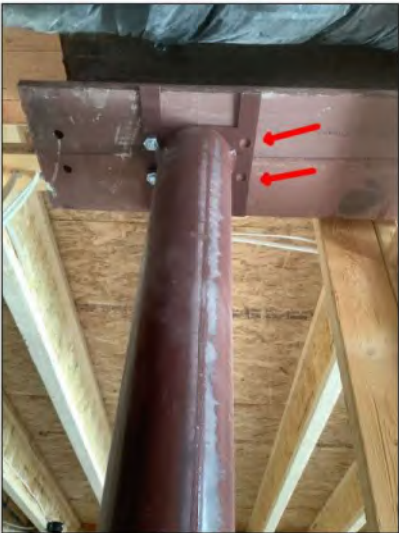
Missing bolts

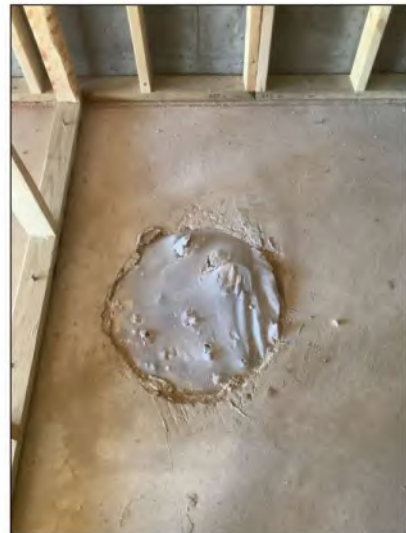
Sump pump discharge pipe
