Next Day Inspect Commercial Inspection Report

111 SAMPLE AVE, SAMPLE, MD 00001 Inspection prepared for: SAMPLE SAMPLE Date of Inspection: 2/5/2025 Time: 9:30 AM Year Built: 1994 Size (Sqft): 3240 Weather: Cloudy 47 degrees F

Inspector: Paulo Narduche 707 Godfrey Court SE, Leesburg, VA 20175

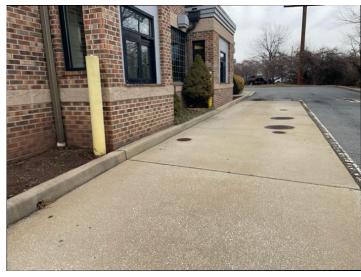
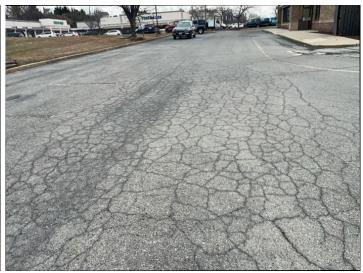
- Concrete and asphalt driveway and parking noted.
- Some asphalt alligatoring noted in the parking lot. Monitor for worsening condition. Repair as needed.

Alligatoring

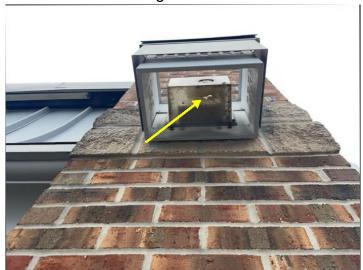
- Pole sign was not operational at the time of inspection. Recommend further review and repair as needed by a licensed electrician.
- Drive-thru pole light made a buzzing noise at the time of inspection. Power was not on. Recommend further review and repair as needed.
- Loose electrical box noted on the drive-thru side of building. Recommend repair by a licensed electrician.
- Covers were missing or broken on one or more exterior lights. Recommend repair.
- Open or disconnected **PVO** conduit noted at the drive-thru and at the roof top lights. Recommend repair.

Buzzing sound heard

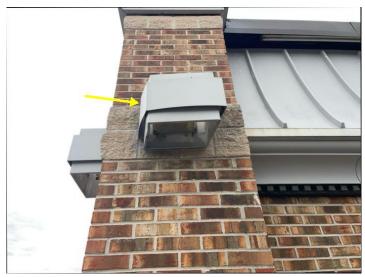
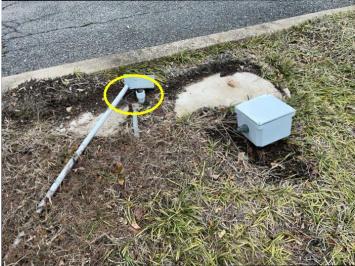
Bent housing

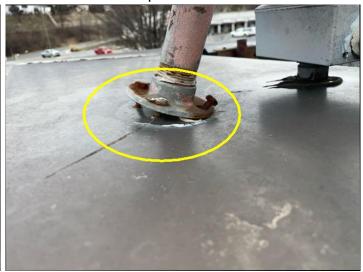
Loose

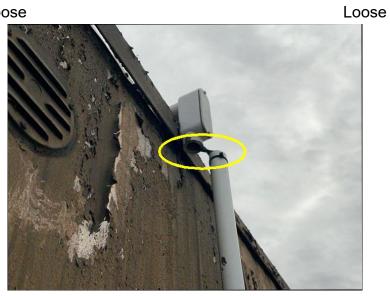
Detached conduit

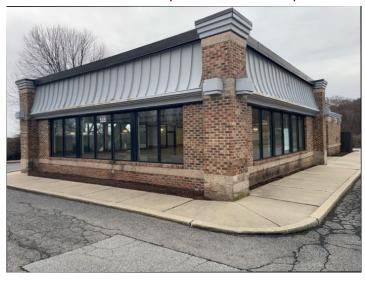
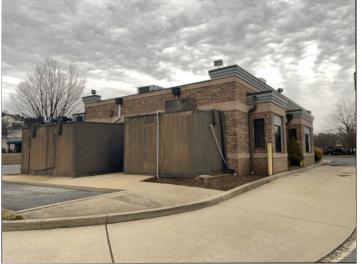
• Cracked mortar and bricks noted in several locations. Recommend repair to prevent moisture penetration.

Broken tiles

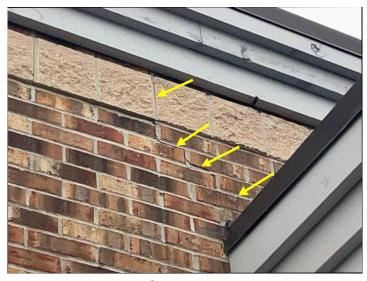
Step crack

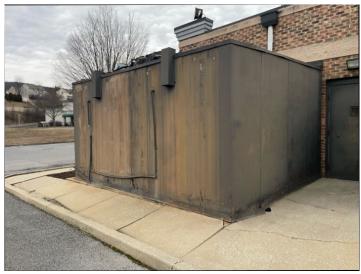
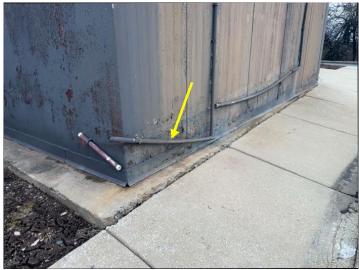
Left cooler

- Right cooler was locked at the time of inspection. Unable to inspect interior.
- The condensation plumbing on the left cooler was disconnected. Recommend repair.

Disconnected drain

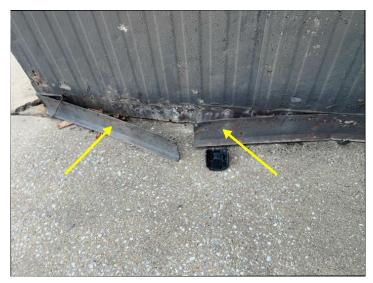
- Loose trim noted at the base of the left cooler exterior walls. Recommend repair.
- Deteriorated sheathing noted on the electrical conduits. Recommend repair.

Loose trim

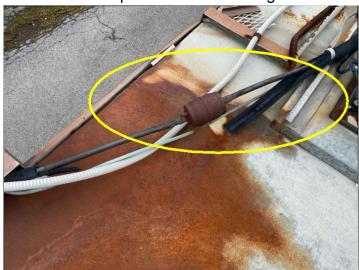
- Deteriorated insulation noted on refrigerant lines. Corrosion noted on roof beneath lines. Recommend repair.
- The cover was missing on the compressor units on the left cooler. Corrosion noted on motor and tubing. Recommend review and repair as needed by a qualified contractor.

Deteriorated insulation

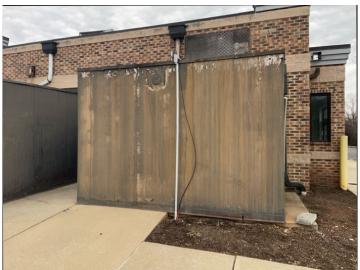
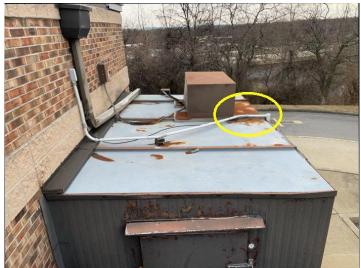
Corrosion

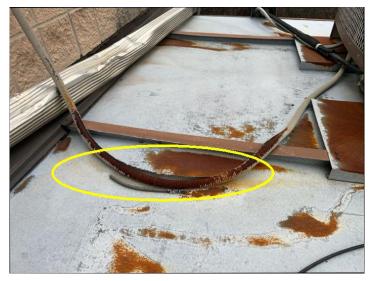
Deteriorated sheathing

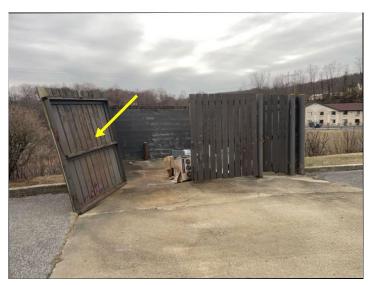
• Loose gate noted at dumpster corral. Recommend repair.

Loose

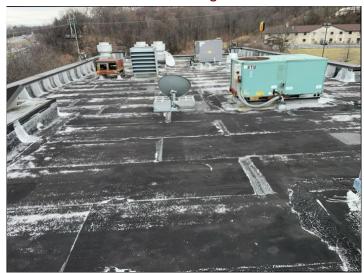
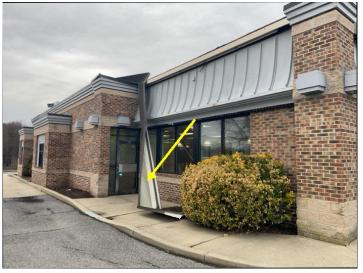
- The parapet coping / flashing on the drive-thru side was detached exposing the parapet wall sheathing. Wood deterioration and holes noted. Recommend repair.
- Gap noted between the parapet wall and roofing material where the parapet flashing was missing. Recommend repair.
- Bubbled areas noted near the missing parapet flashing and exposed seam. Potential water intrusion. Recommend repair.
- Pooling noted in several areas of the roof. This is normally caused by improper pitch or slope of the roofing materials or the roof deck. Recommend contacting a licensed roofing contractor to review repair options.
- Detached top for the make-up air fan was detached. Recommend repair.
- Loose satellite dish noted on roof. Remove or repair as needed to prevent damage to roof.

Loose parapet flashing

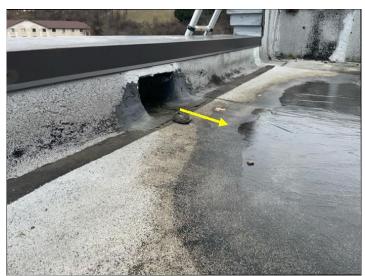
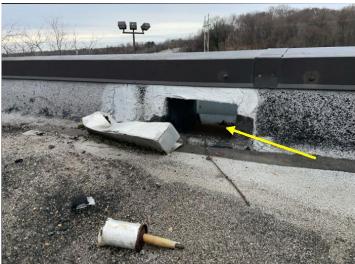
- Roof was improperly sloped at the roof drain. Recommend review and repair as needed.
- The roof scupper at the drive-thru window was missing. Recommend repair.
- Clogged underground drainage noted. Recommend cleaning and routine maintenance to ensure proper drainage.
- Disconnected downspout noted at the back of the building. Recommend repair by a roofing contractor.

Negative slope

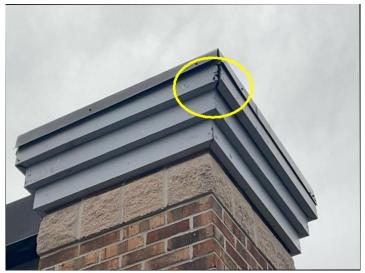
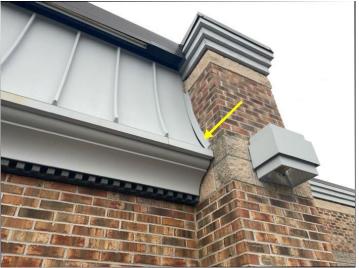
• Gaps and minor wood deterioration noted at soffit area. Recommend review and repair as needed.

Gaps Loose flashing

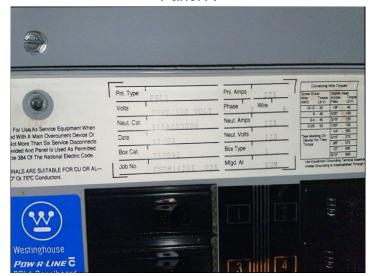
Panel A

- Tripped breaker noted in Panel A.
- Open breaker slot noted in Panel B. Recommend repair by a licensed electrician.

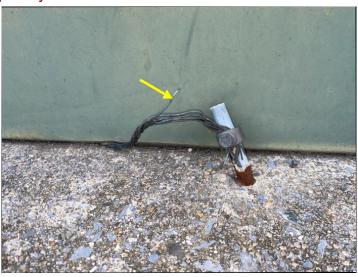
- Concrete encased rod at transformer noted.
- Ground wire was not completely clamped to grounding rod. Recommend repair by a licensed electrician.

Loose wire

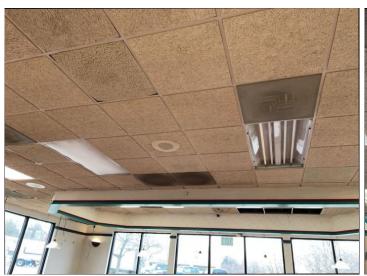
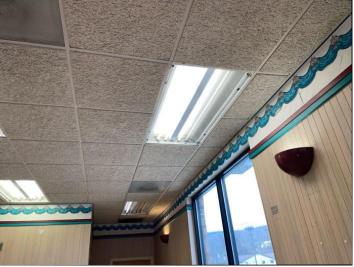
- Several florescent bulbs were not working. Recommend replacing.
- Florescent light covers were missing at several fixtures. Recommend replacing.
- Light switches did not stay in the up position. Recommend repair.

Bulbs did not work

Cover missing

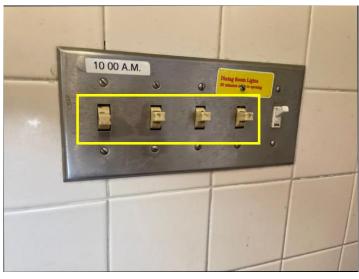
Loose switches

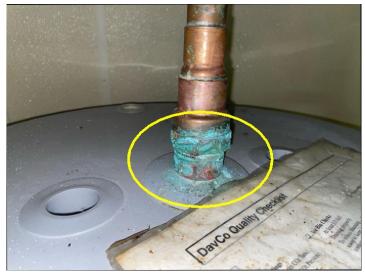
- The water shut off valve was in the off position at the time of inspection.
- Corrosion noted on the copper plumbing. Unable to determine if an active leak was present due to the water being off. Recommend review by a licensed plumber.

Corrosion

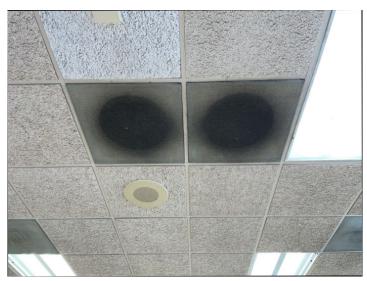
• Several register grills were dirty at the time of the inspection. This affects the air quality in the building. Recommend cleaning.

Stained grids

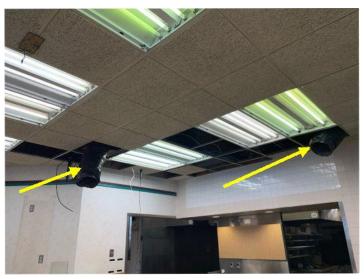
Good	Fair	Poor	N/A	None	Observations:
					Observations.
	✓				• Registers and return grills were missing. Recommend installation.

Register vents missing

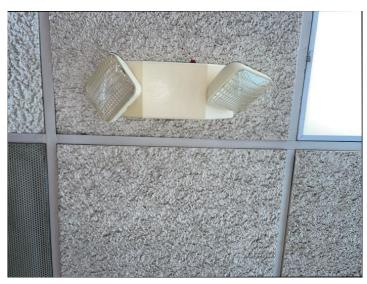
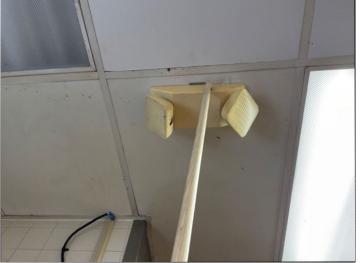
• Emergency lights were broken or inoperable. Recommend repair.

Did not work

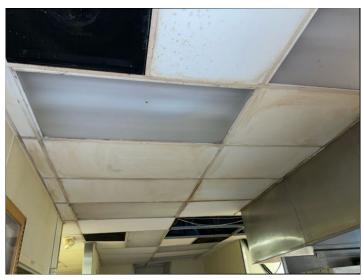
• Missing and stained ceiling tiles observed. Paint or replace as needed.

Stained and missing tiles

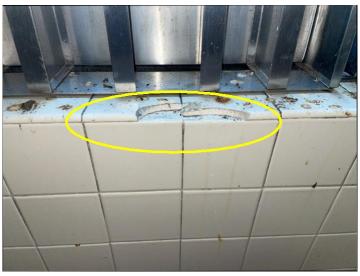
- Ceramic tiles noted.
- Cracked tiles noted at the drive-thru window. Recommend repair.

Broken tile

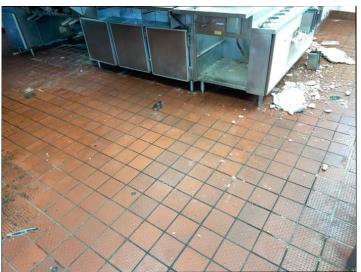
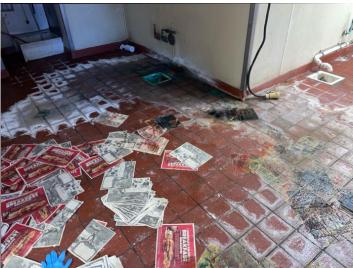
Kitchen

• Water and stains noted on the kitchen floor. Recommend repair plumbing leak and clean or replace tiles as needed.

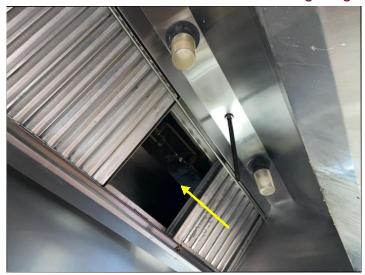
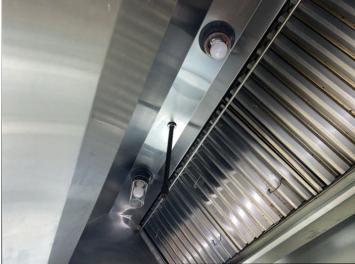
- Exhaust vent panel was not installed. Recommend repair.
 Globe was missing at light fixture over cooktop. Recommend repair.

Grill missing

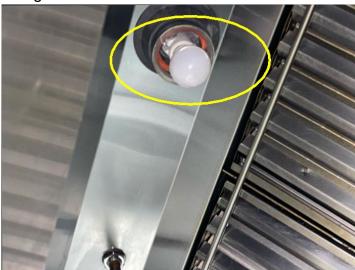
Globe missing

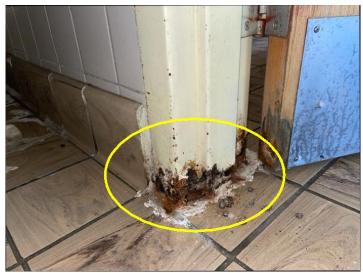
- Corrosion noted on metal door frames. Recommend repair.
- Closer on men's bathroom door stuck when opening. Recommend lubricate or repair as needed.

Corrosion

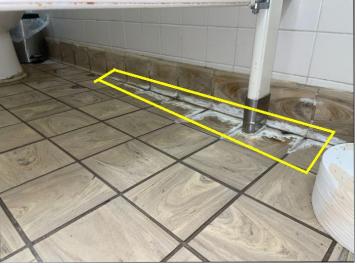
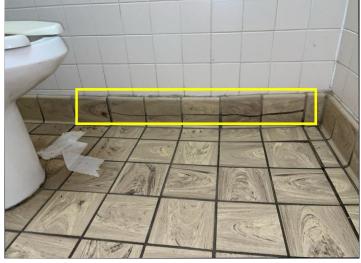
• Cracked or loose tiles observed. Repair or replace as needed.

Water stain Cracked tile

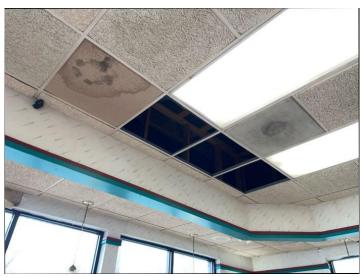
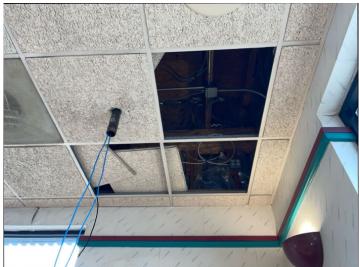
- Several ceiling tiles were stained. Evidence of previous leak or accumulation of moisture. These tiles were dry with no active leaks noted at the time of the inspection.
- Several ceiling tiles were missing or stained. Repair replace ceiling tiles as needed.

Stained and missing tile

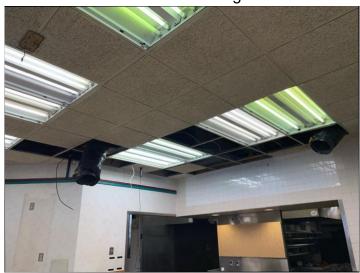
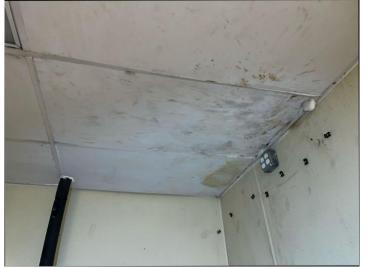
Tiles missing

Stained tiles

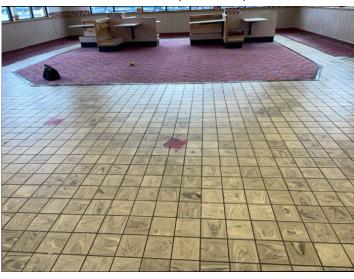
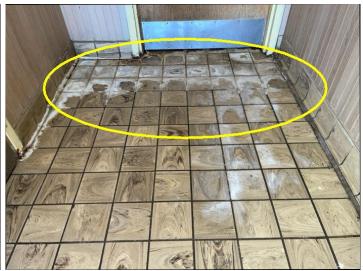
• Water stains and loose tiles noted near the bathroom doors. Recommend repair or replace as needed.

Dining Water stains
