# Next Day Inspect Commercial Inspection Report

111 SAMPLE AVE, SAMPLE, VA 00001 Inspection prepared for: SAMPLE SAMPLE Date of Inspection: 2/3/2025 Time: 1:00 PM Year Built: 1988 Size (Sqft): 1000 Weather: Cloudy 44 degrees F

Inspector: Paulo Narduche 707 Godfrey Court SE, Leesburg, VA 20175

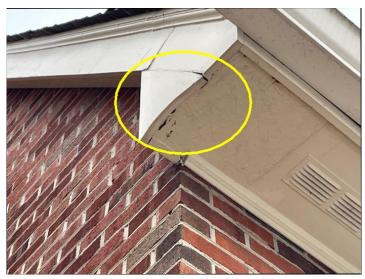
• Gaps and minor wood deterioration noted at soffit area. Recommend contacting the property manager to review and repair as needed.

Gaps and deterioration

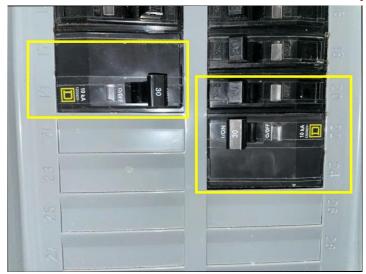
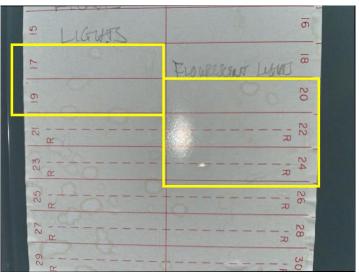
• Three breakers were not labeled. Recommend contacting an electrician to label the breakers for safety.

Not labeled Blank

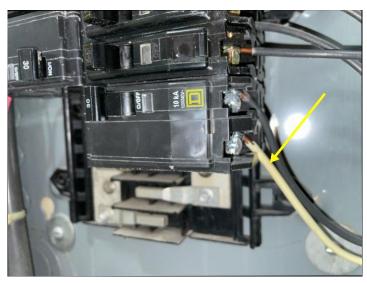
• Neutral wire noted being used as a hot wire. Recommend labeling the wire by a licensed electrician.

Neutral as hot

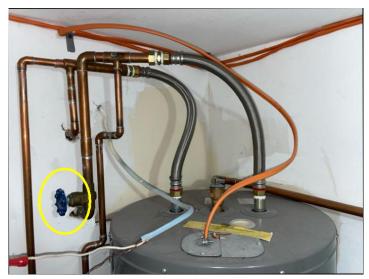
• Expansion tank was not installed. An expansion tank is required on closed water systems. Recommend repair by a licensed plumber.

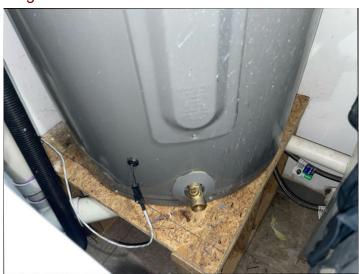
• Overflow pan and drain were missing. Recommend installing to prevent damage to finished areas.

Overflow pan and drain missing

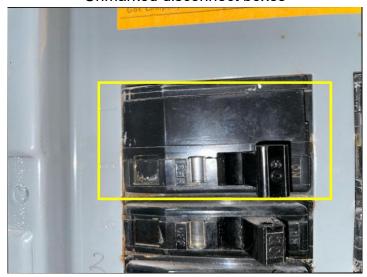
- Date of manufacture was 2022. Life expectancy around 20 years.
- The condenser was at the back of the building.
- Unit was not operated due to the exterior temperature below 64 degrees F.
- The AC disconnect boxes were not labeled. Recommend asking property manager or HVAC technician to label boxes.
- The unit was connected to a 60 amp breaker. The manufacturer specified that the unit be connected to a 45 amp breaker for proper overcurrent protection. Recommend repair.

60 amp breaker

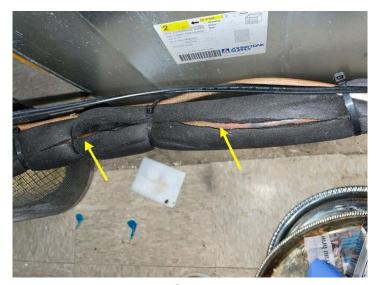
• Torn insulation noted on the interior and exterior refrigerant lines. Recommend repair by a licensed HVAC technician.

Torn insulation

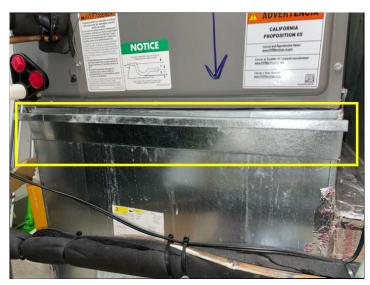
• The filter was dirty. Recommend replacing and inspecting monthly.

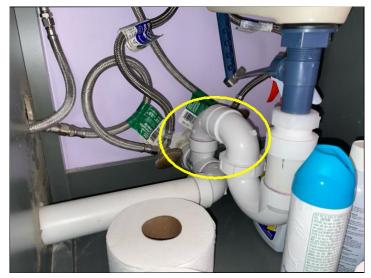
• Improper "S" trap noted below sink. This trap configuration may cause the trap to siphon dry, allowing sewer gas and odor to enter the dwelling. Recommend repair.

Improper connection

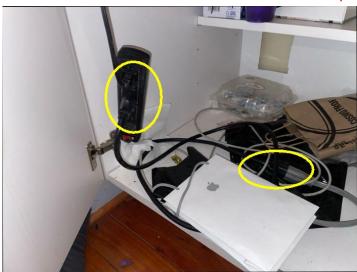
- Several extension cords and power strips in use at front of room. Recommend installing more outlets to meet current and future needs.
- No GFCI present at outlet under sink. GFCI outlets are required near water sources. Recommend repair.

Power strip / extension cord

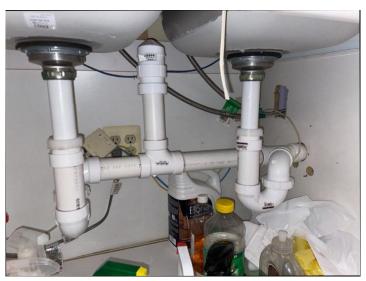
- One P trap is allowed for two or three like fixtures (sinks) as long as they're in the same room. In this configuration, two P traps are present which required the addition of an air admittance valve (in between the drains). This is an unprofessional installation.
- This drain connects with the bathroom drain in the adjacent room. Raising this drain may have eliminated the improper S trap plumbing noted in the bathroom.
- Unprofessional drain installation noted. Recommend review and repair as needed by a licensed plumber.

Unprofessional installation

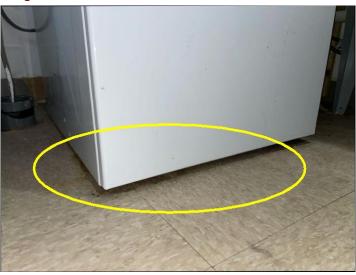
- Vinyl tiles noted.
- Overflow pan was missing at the washer. Recommend installing to prevent damage to floor.

Overflow pan missing

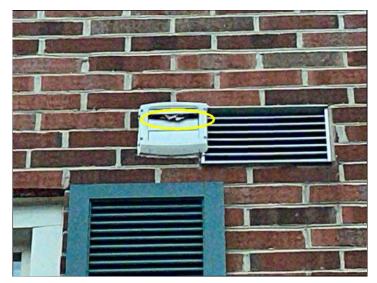
- Flexible dryer vent observed. Flexible vent should not exceed a 6' run or penetrate walls. Recommend replacing at least a portion of the flexible vent with a smooth duct vent for safety.
- Lint noted at the exterior portion of the vent. Recommend cleaning.

Lint
