INSPECTION REPORT

222 W Lafayette Ave, Baltimore, MD 21217

Date of Inspection: 5/7/2022 Time: 11:00 AM

Roof

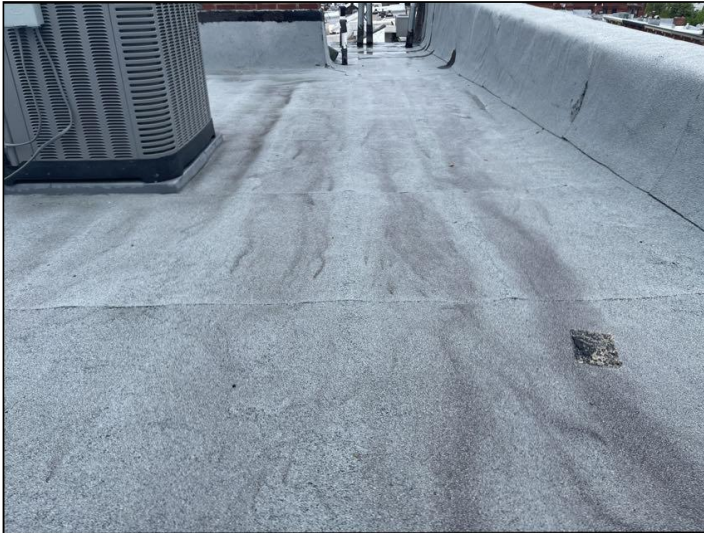
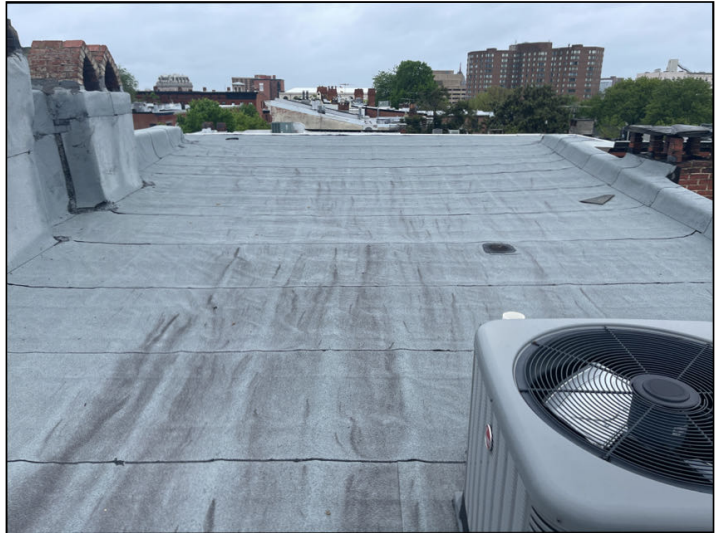
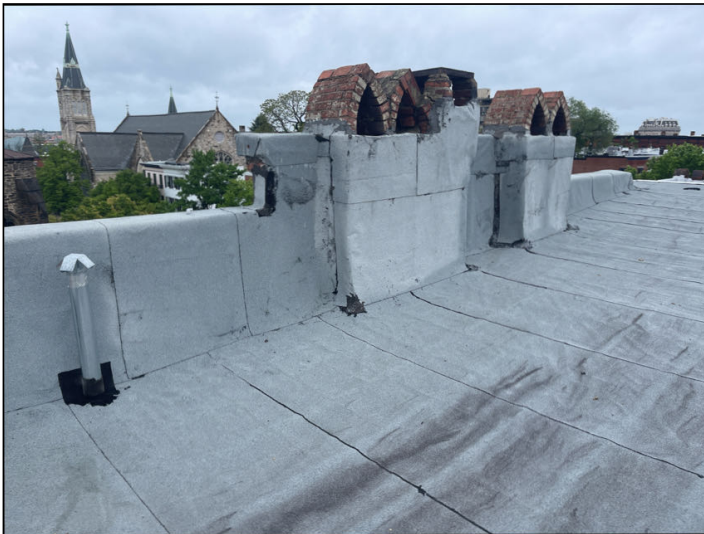
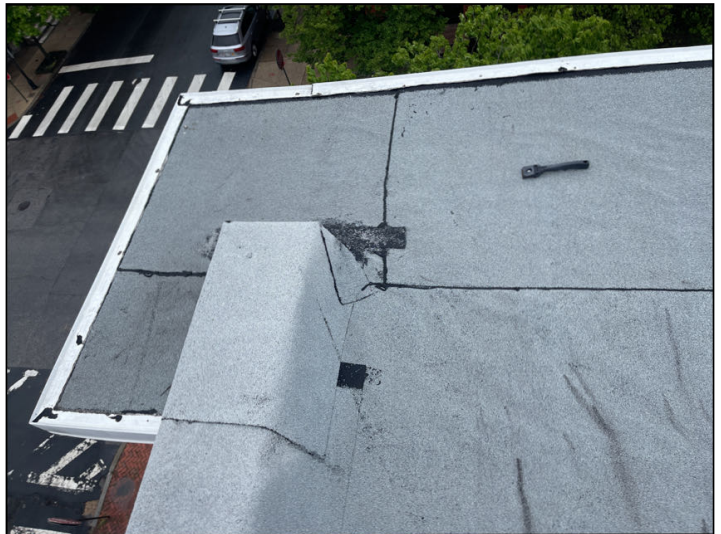
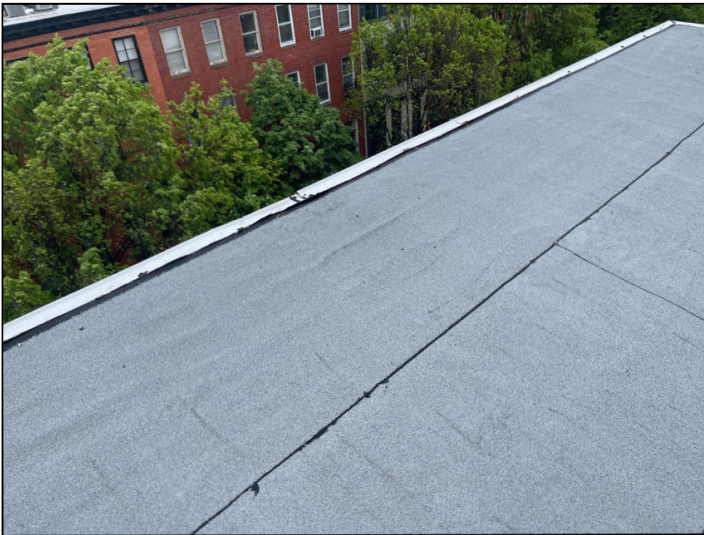
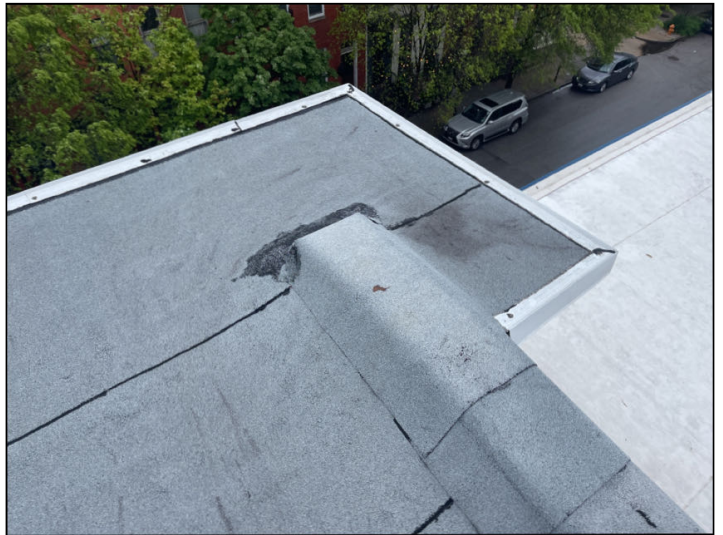
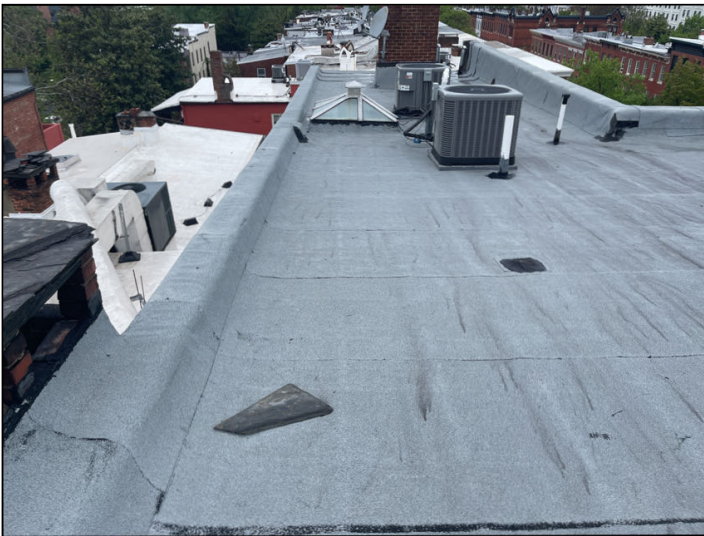
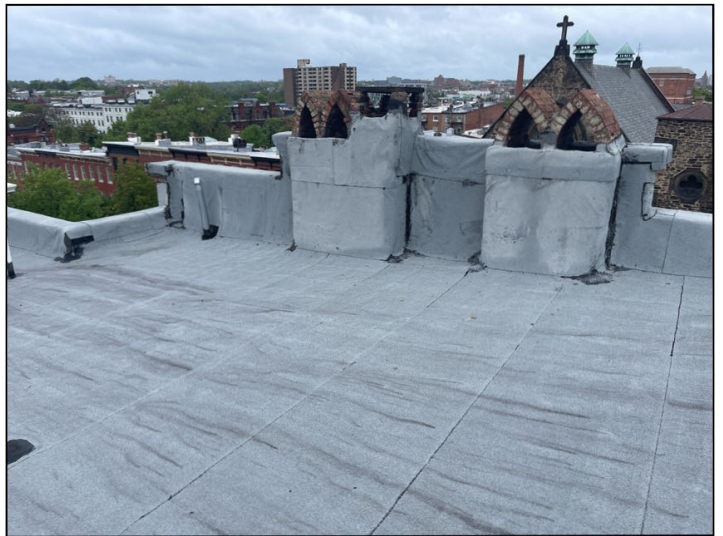
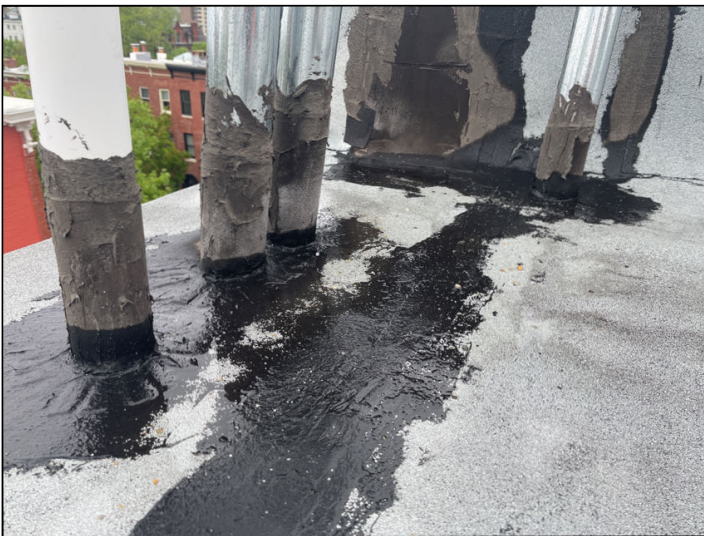
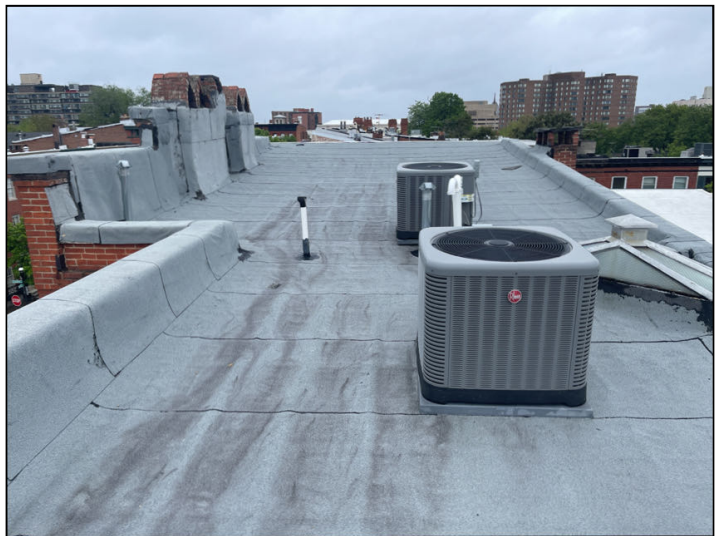
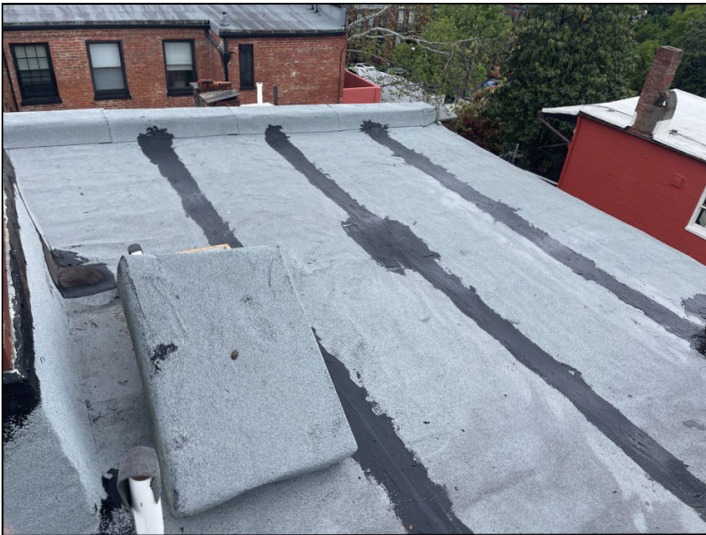
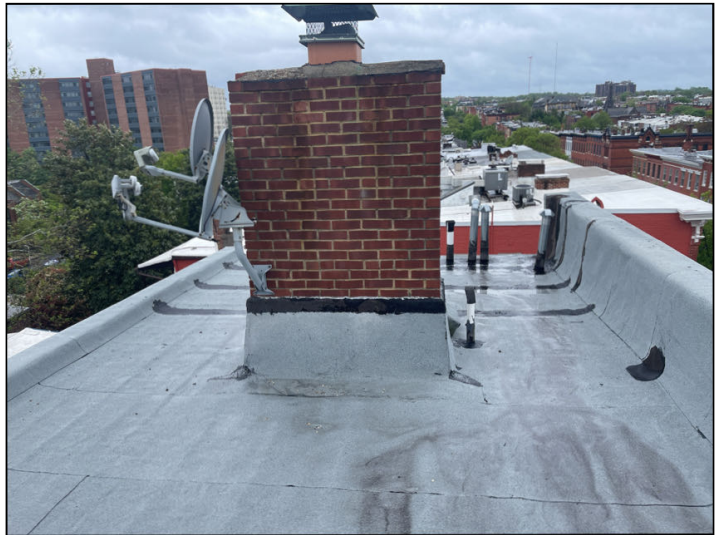
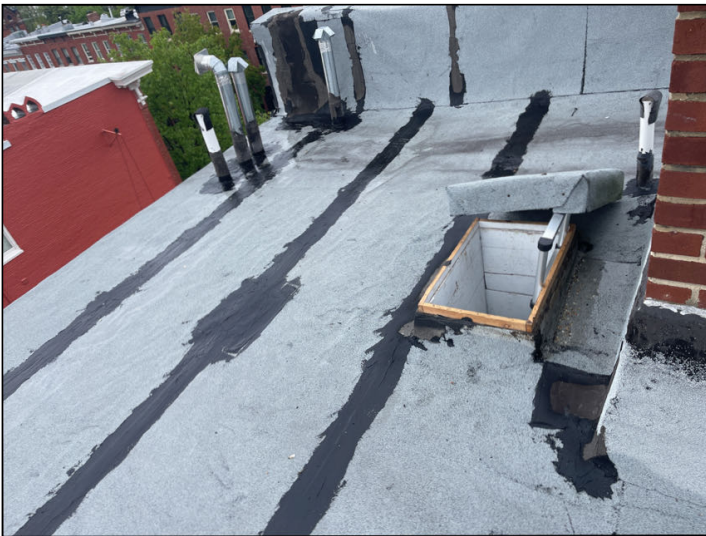
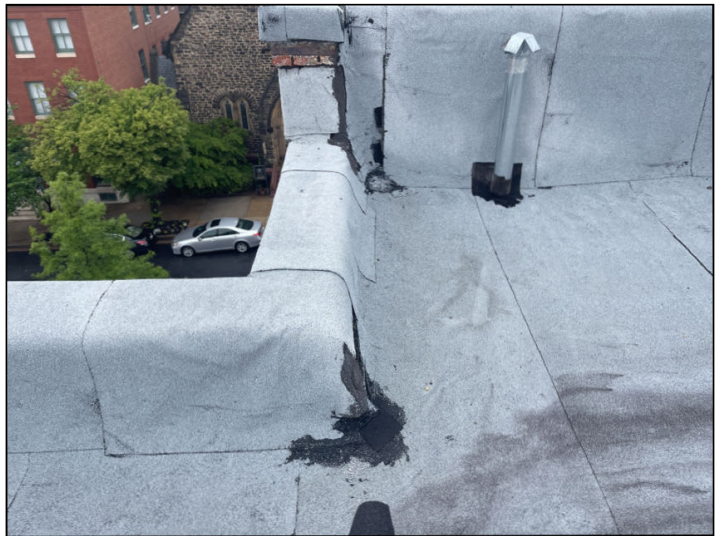
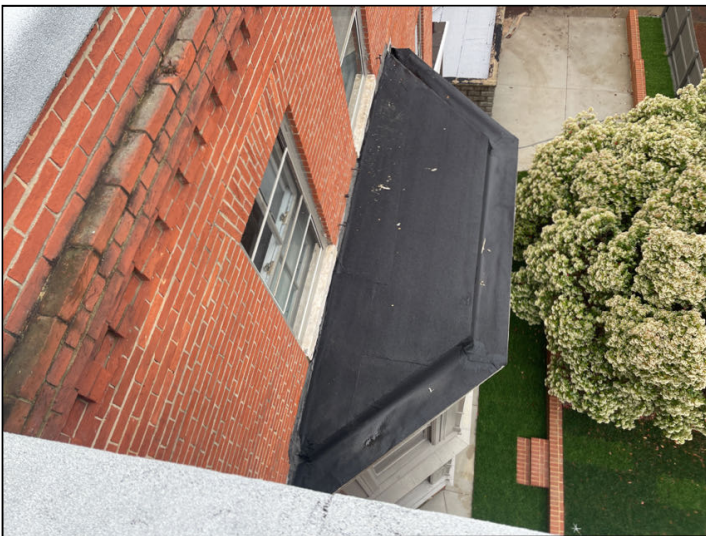
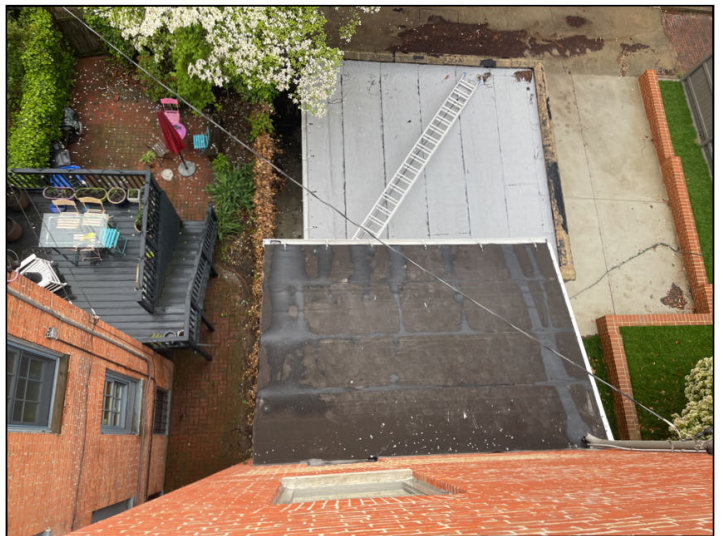
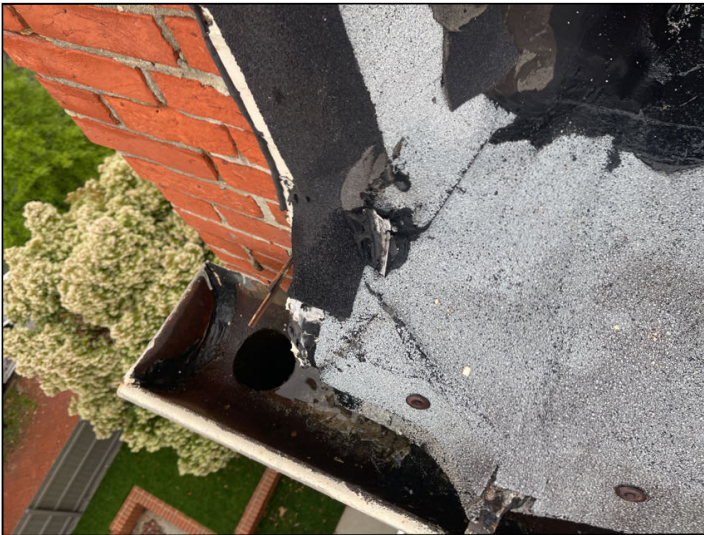
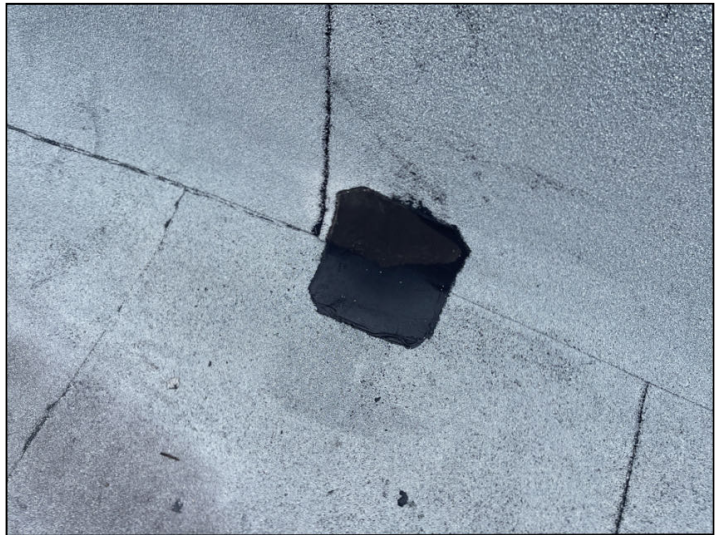
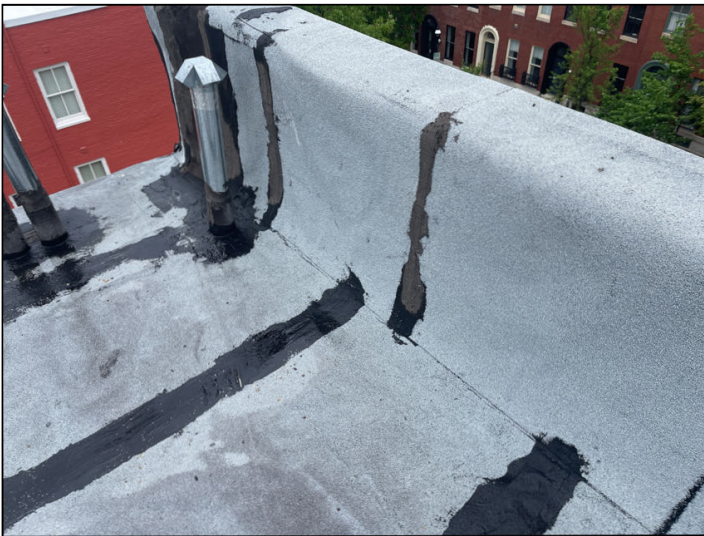
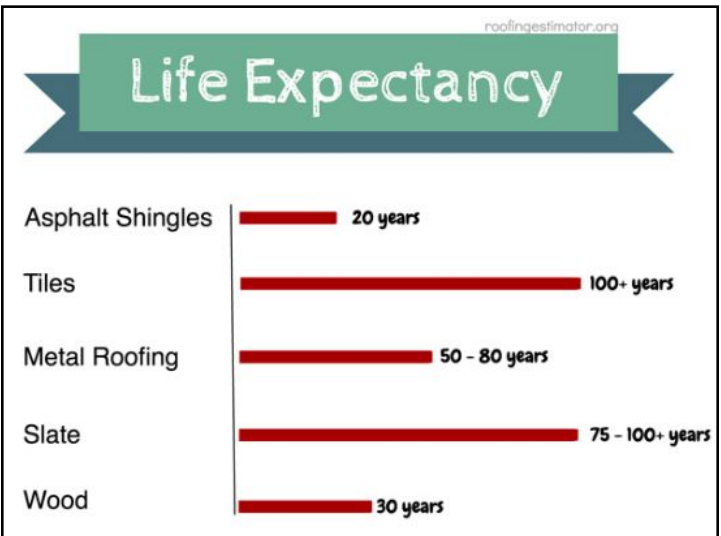
1. Roof Condition

Page 5 Item: 1	Roof Condition	• Pooling water noted in some areas. Rolled areas in roofing material noted. Recommend repair as needed.
Page 11 Item: 6	Sky Lights	• Cracks and gaps noted in the skylight glass sealant. Repair as needed.

- Previous repair noted. Roof appeared to have a few patches and sealant applied.
 - Pooling water noted in some areas. Rolled areas in roofing material noted.
- Recommend repair as needed.

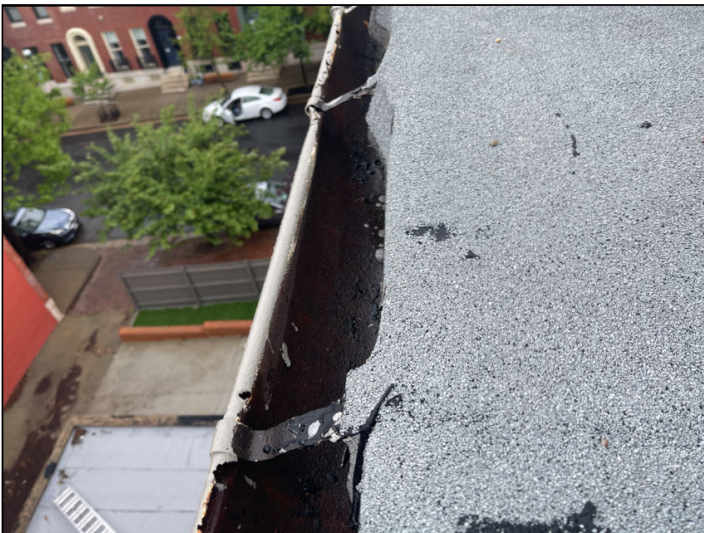
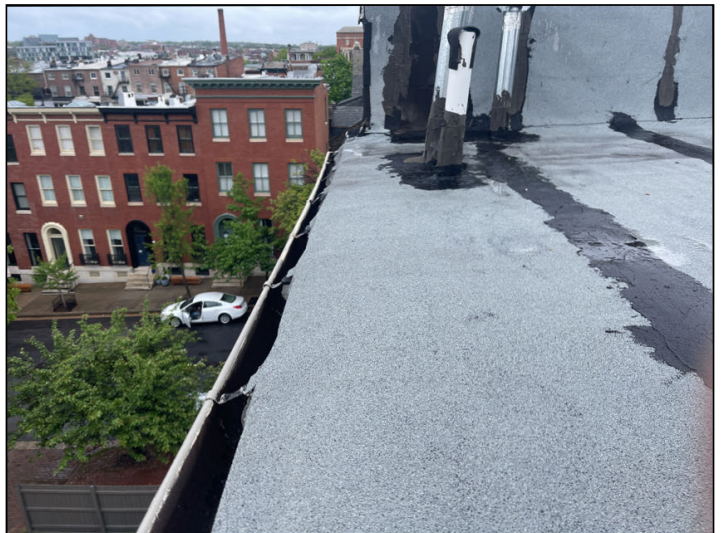
2. Gutter

- No major system safety or function concerns noted at time of inspection.

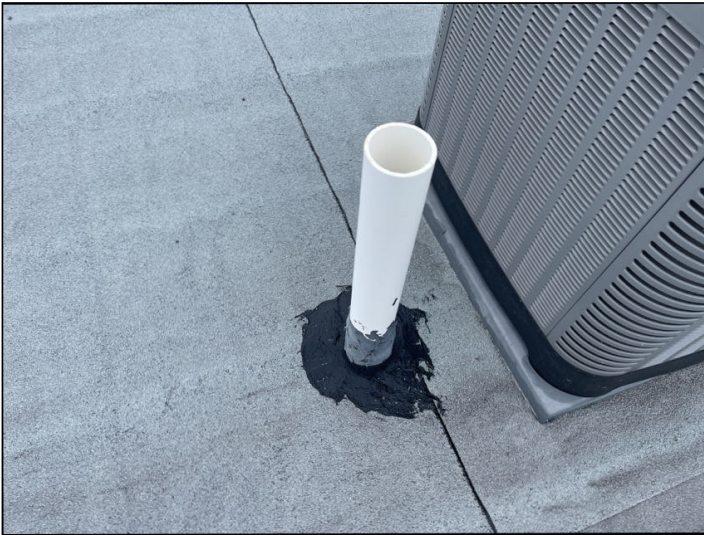
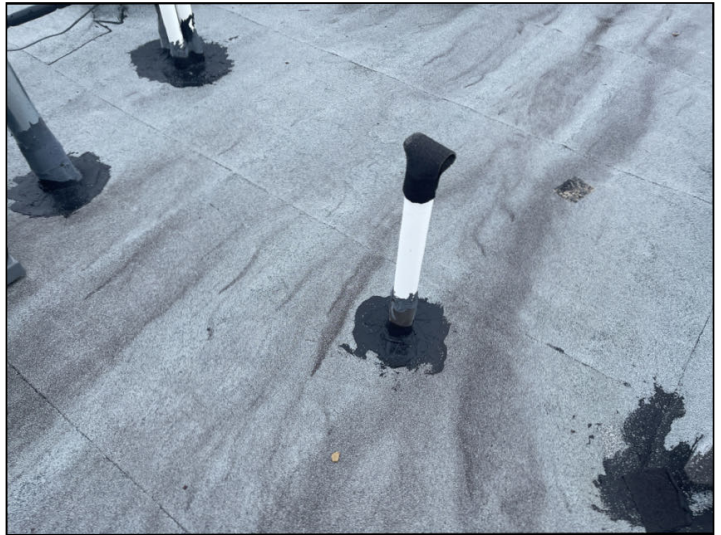
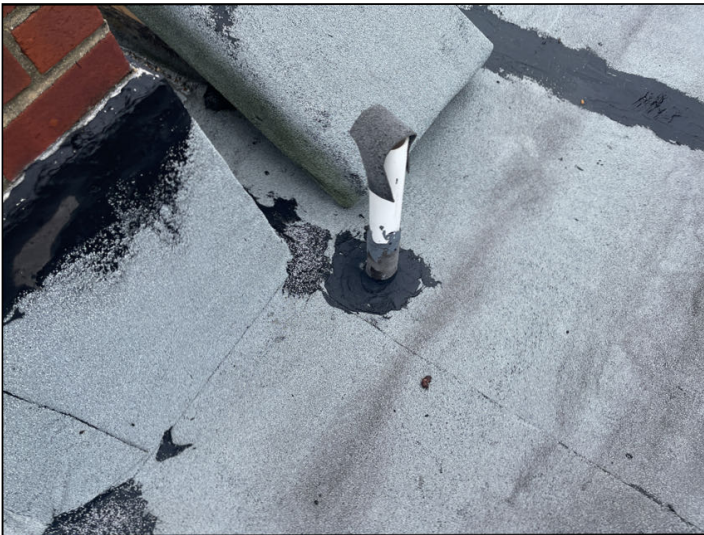
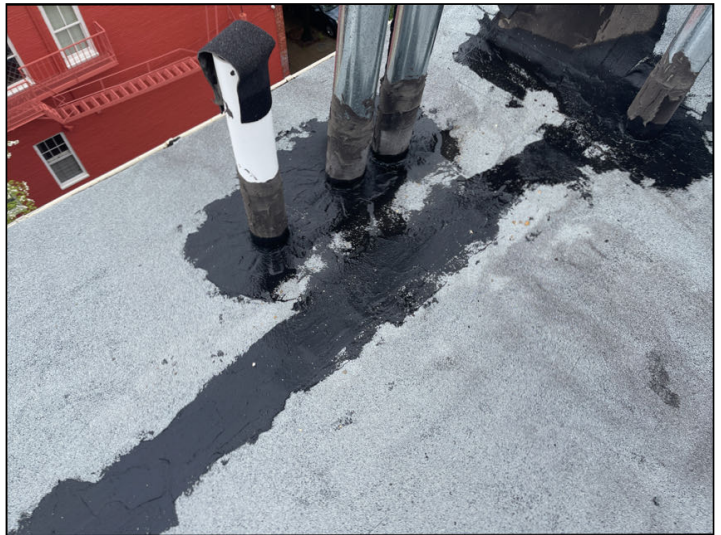
3. Vent Stack

- Appeared to be in good condition at the time of inspection.

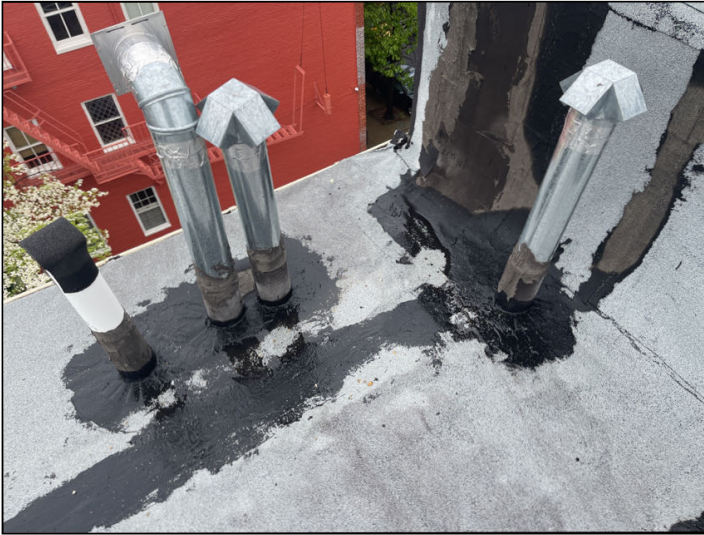
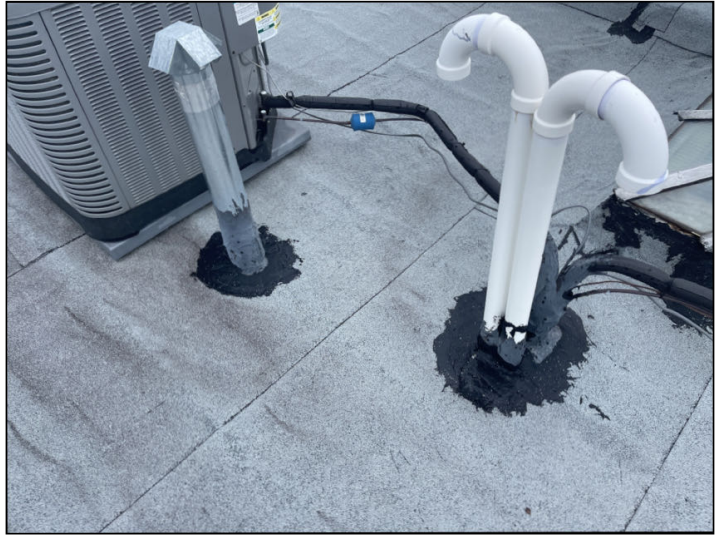
**4. Other Vents**

- Appeared to be in good condition at the time of inspection.

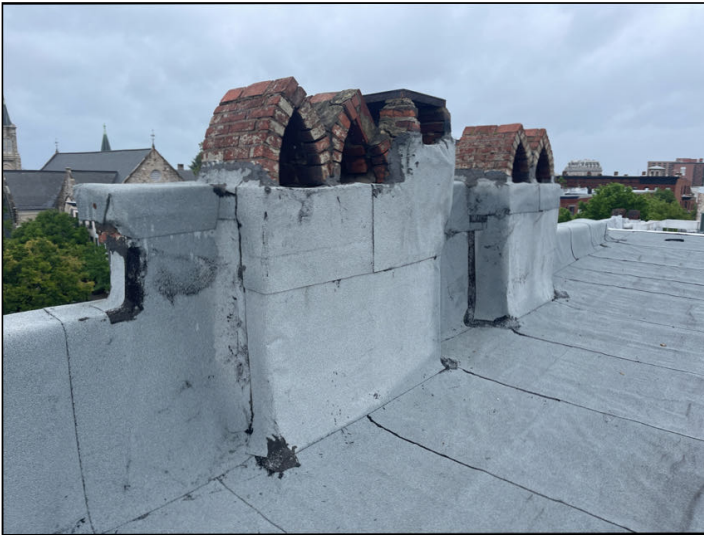
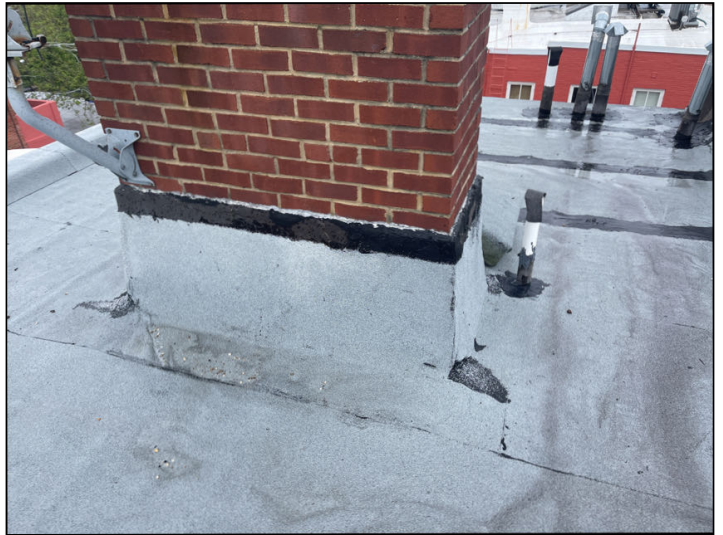
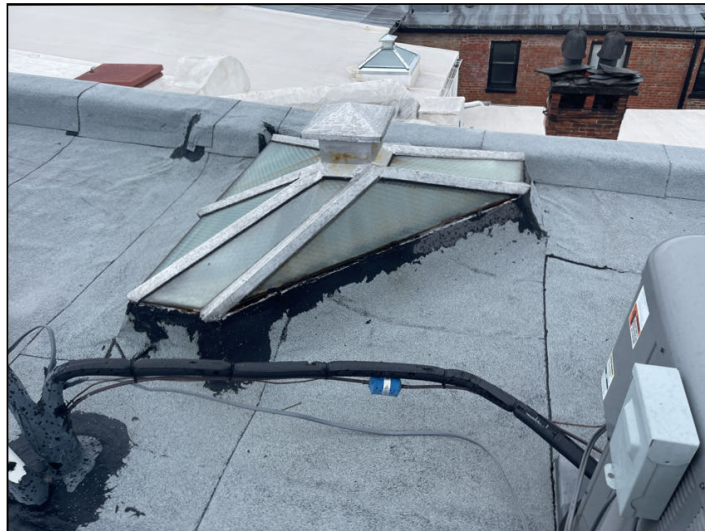
5. Flashing

- Visible portions of flashing appeared adequate and functional at the time of inspection.

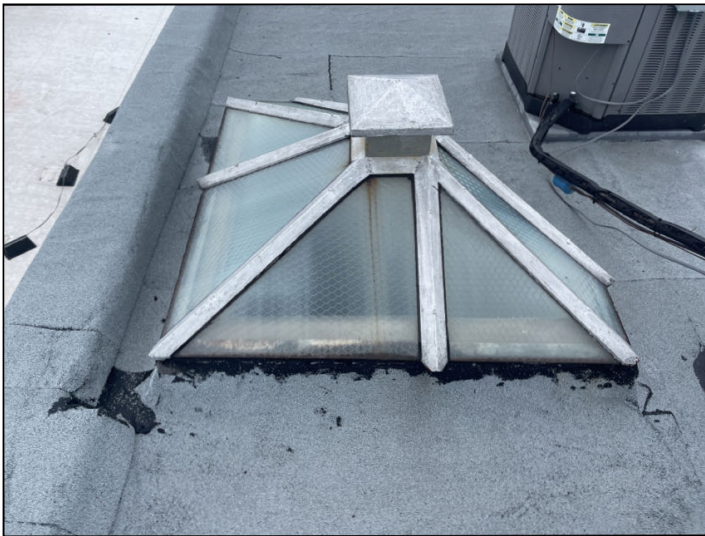
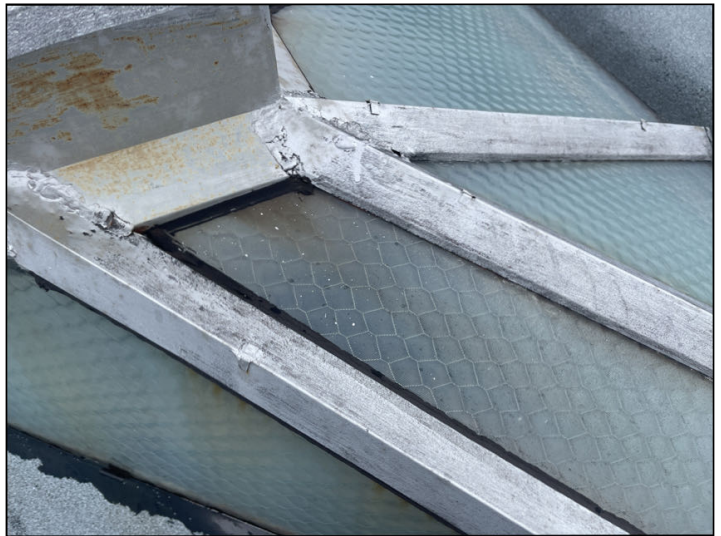
6. Sky Lights

- Cracks and gaps noted in the skylight glass sealant. Repair as needed.

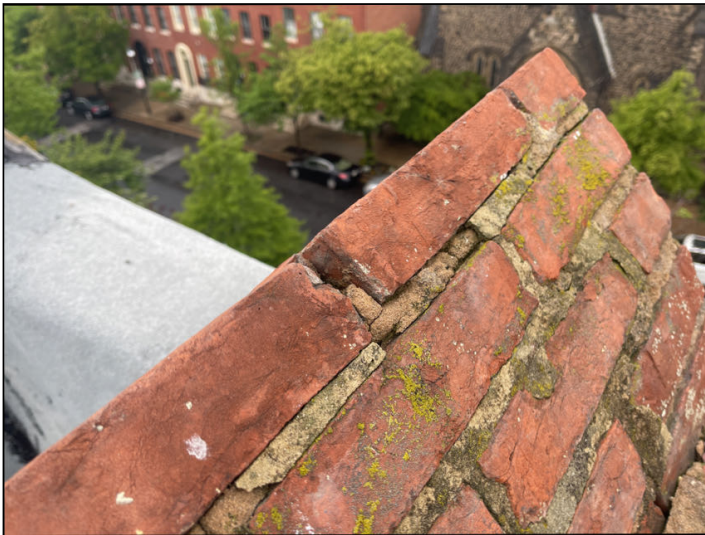
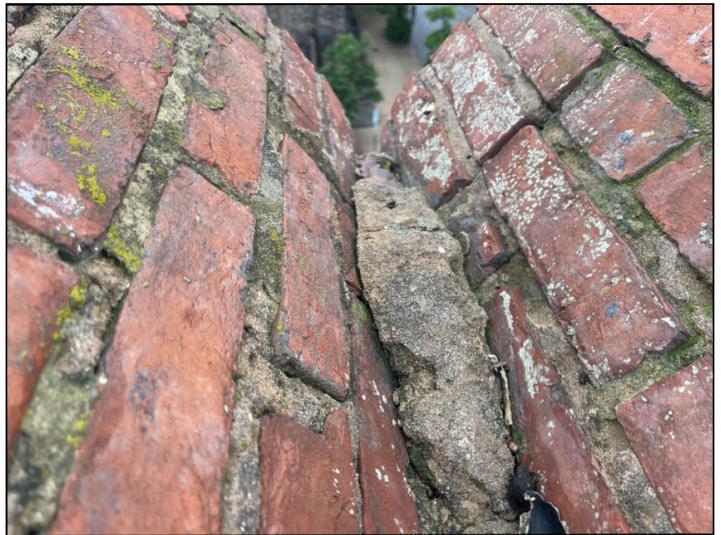
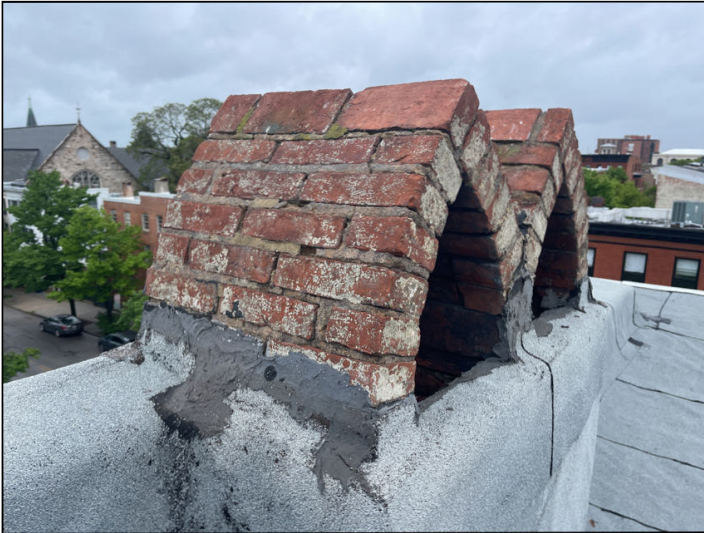
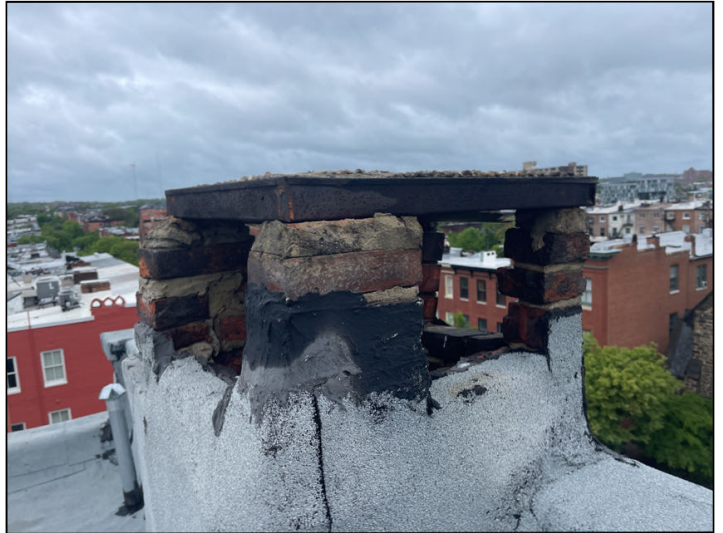
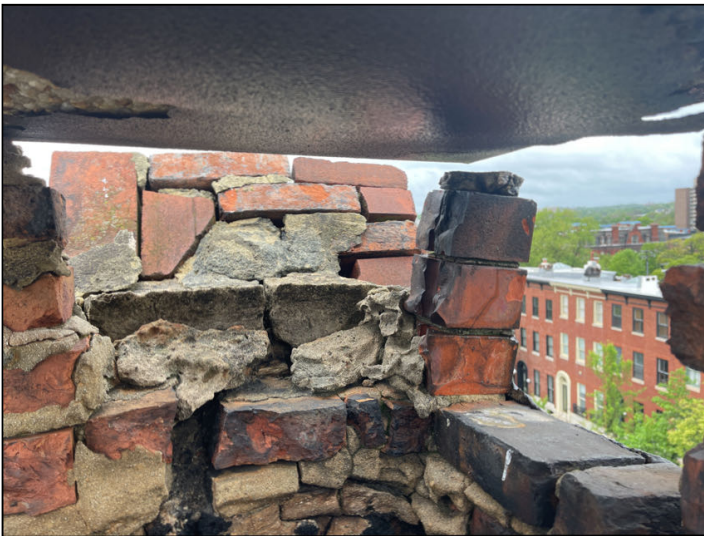
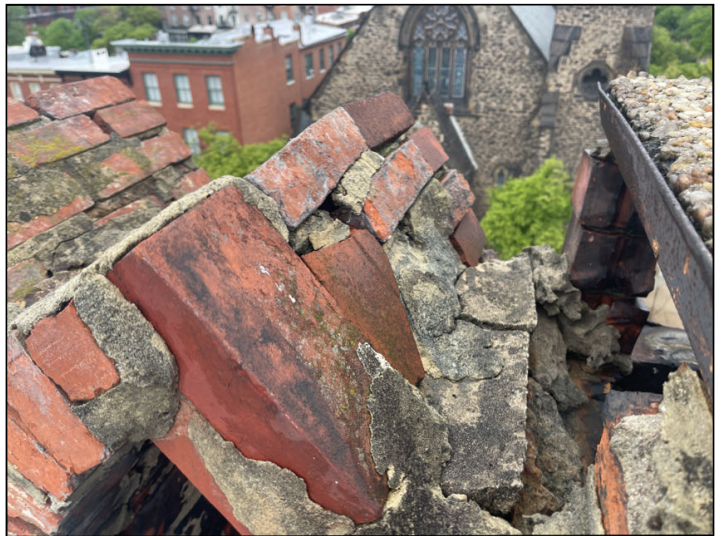
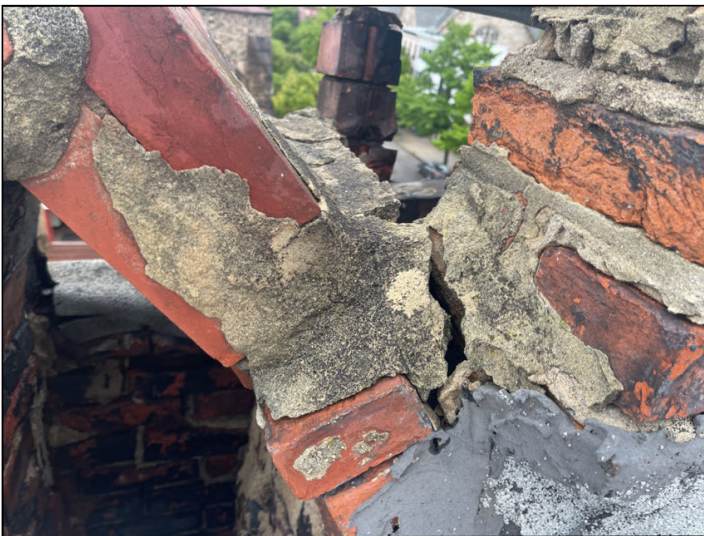
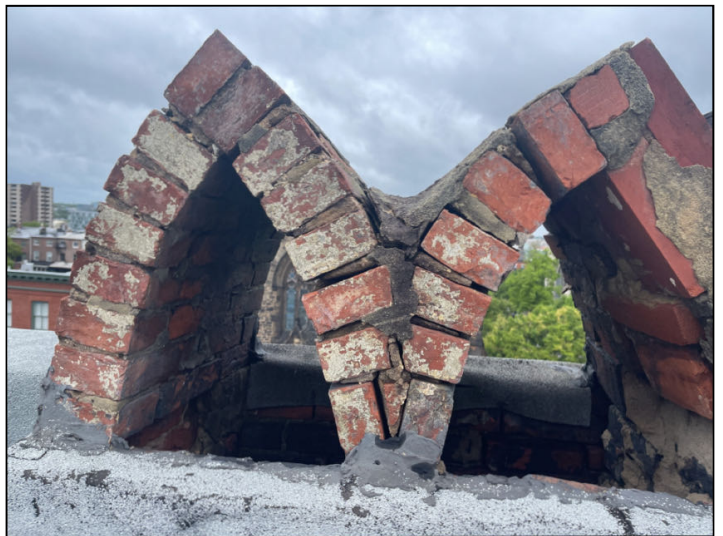
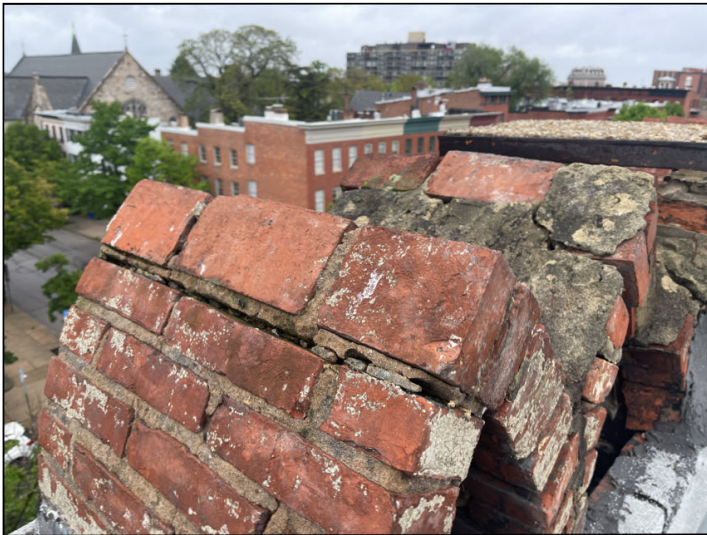
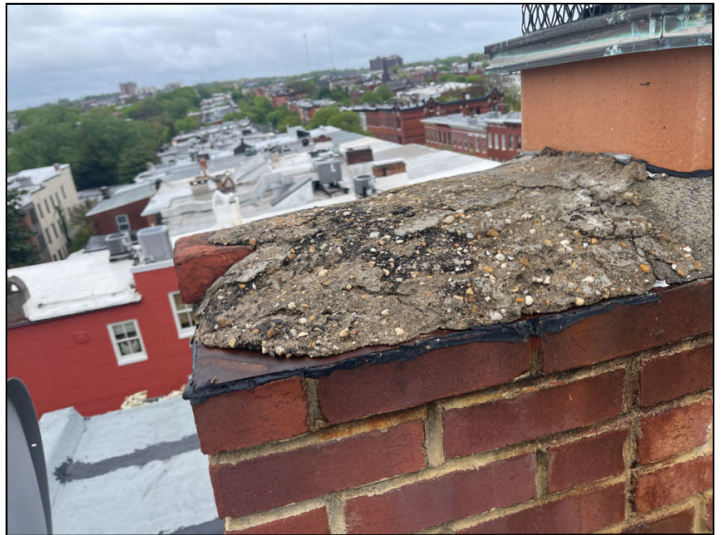
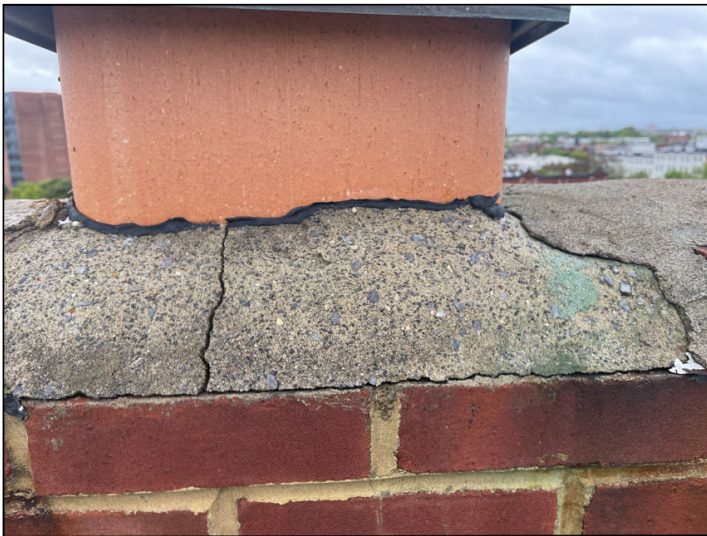
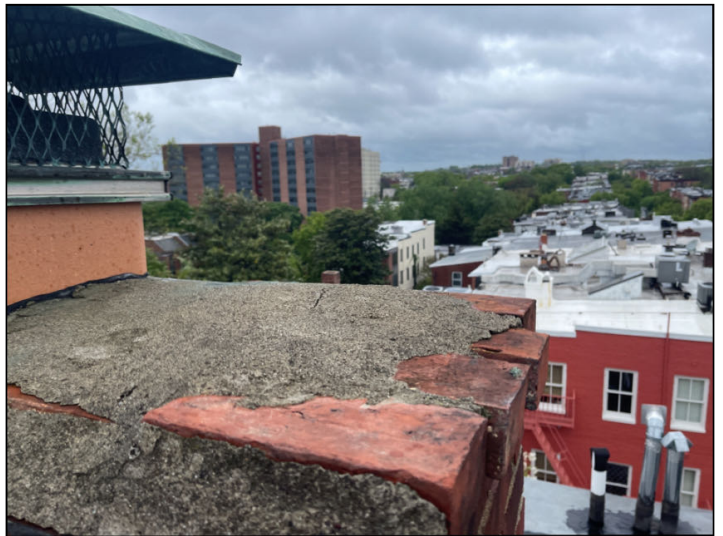
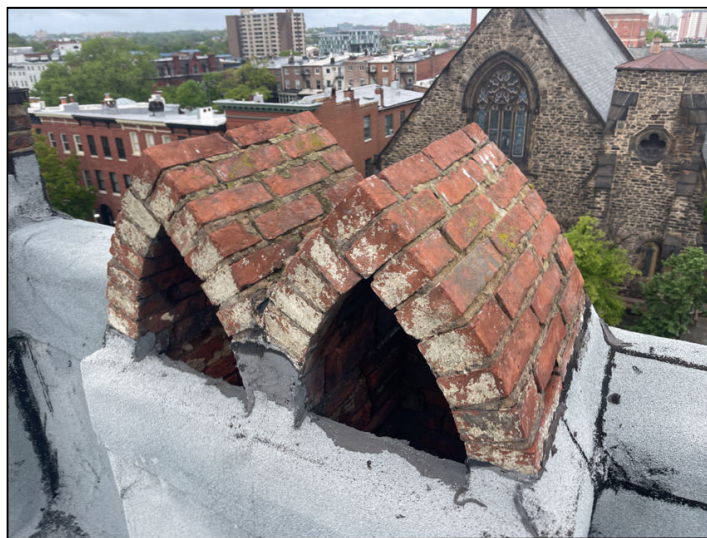
7. Chimney

Page 11 Item: 7	Chimney	• Chimney Cap with cracks noted, potential moisture intrusion. Loose bricks noted. Recommend having a licensed qualified professional correct as necessary.
-----------------	---------	---

- Chimney Cap with cracks noted, potential moisture intrusion. Loose bricks noted. Recommend having a licensed qualified professional correct as necessary.

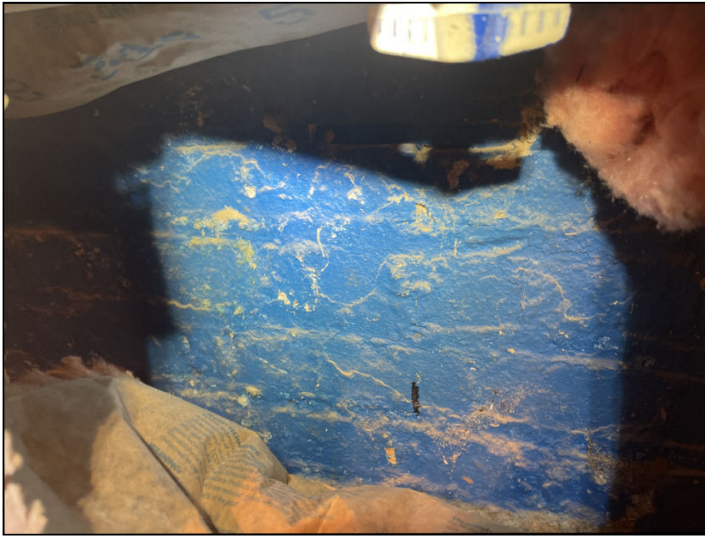
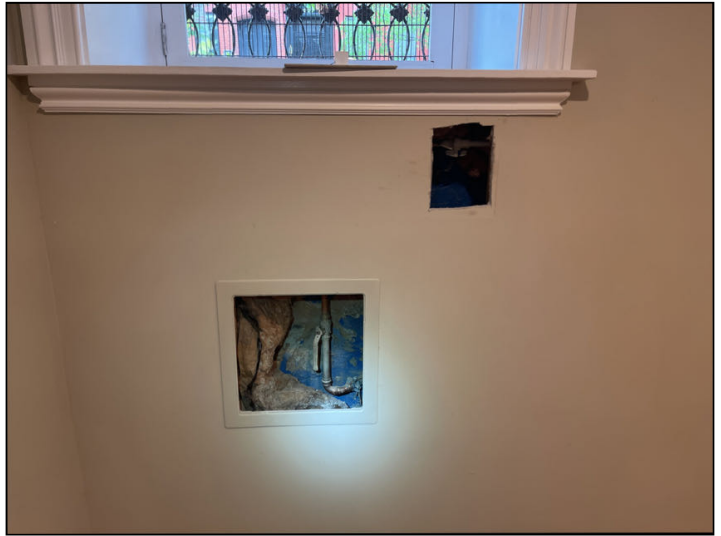
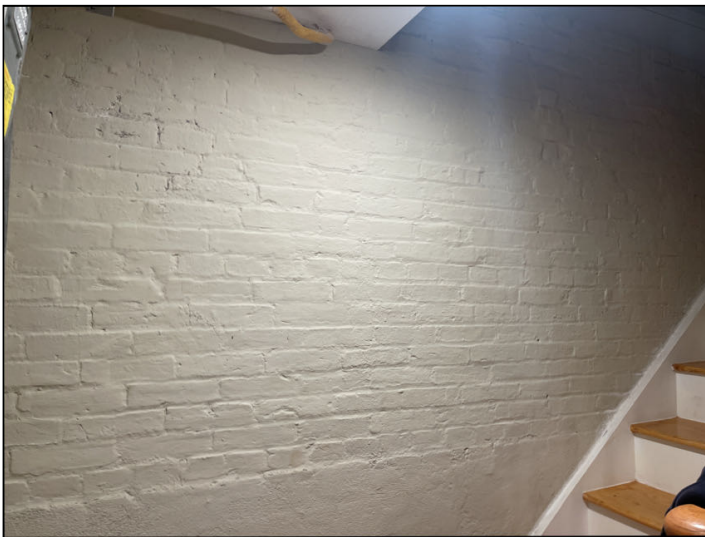
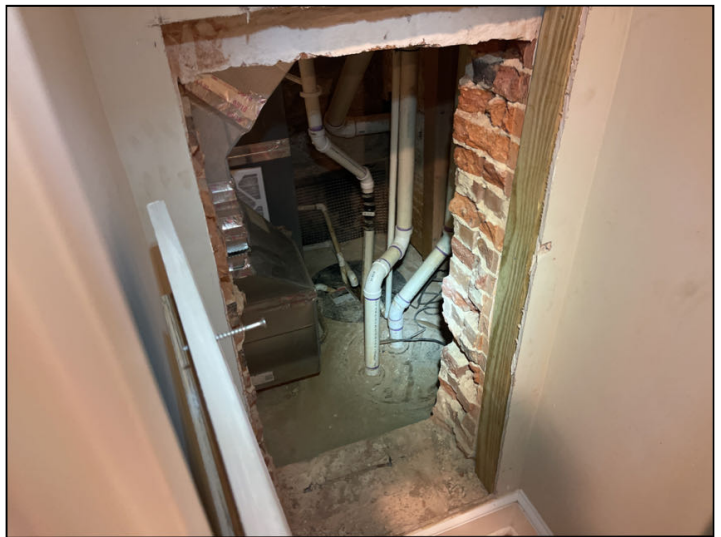
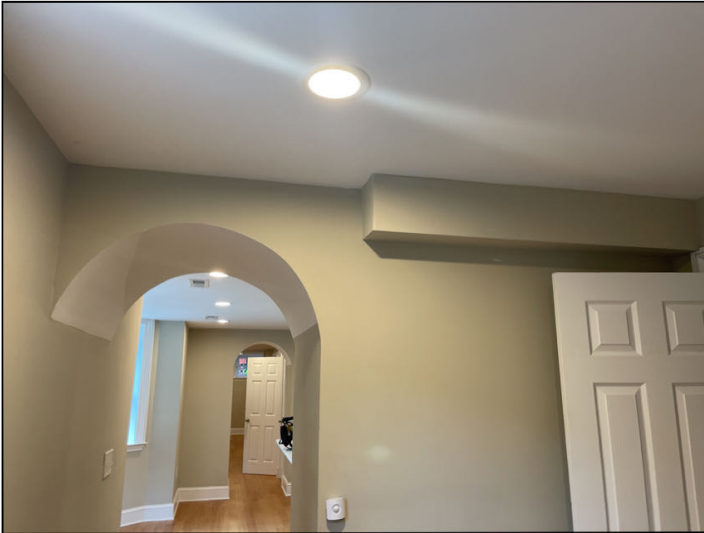
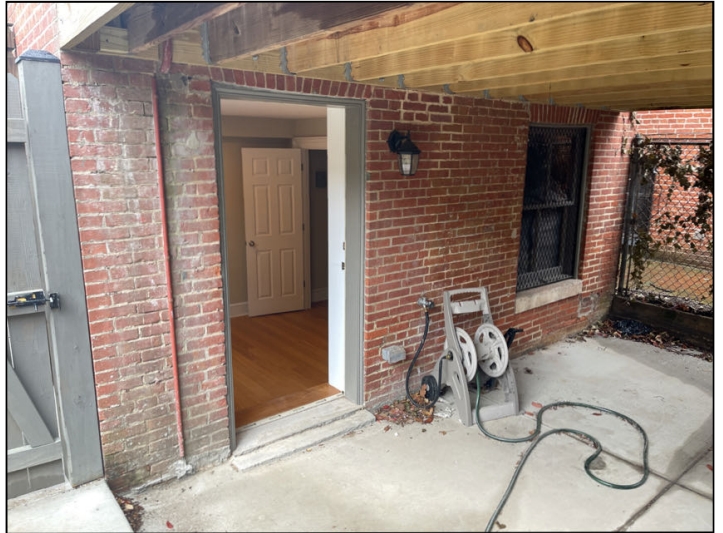
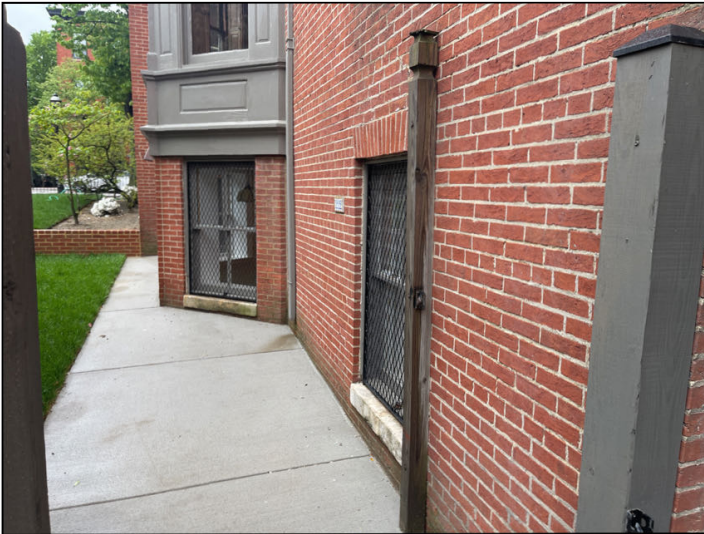
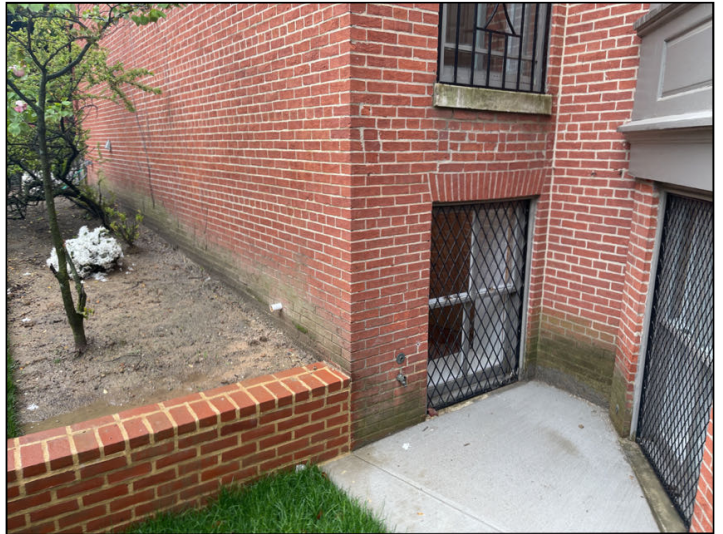
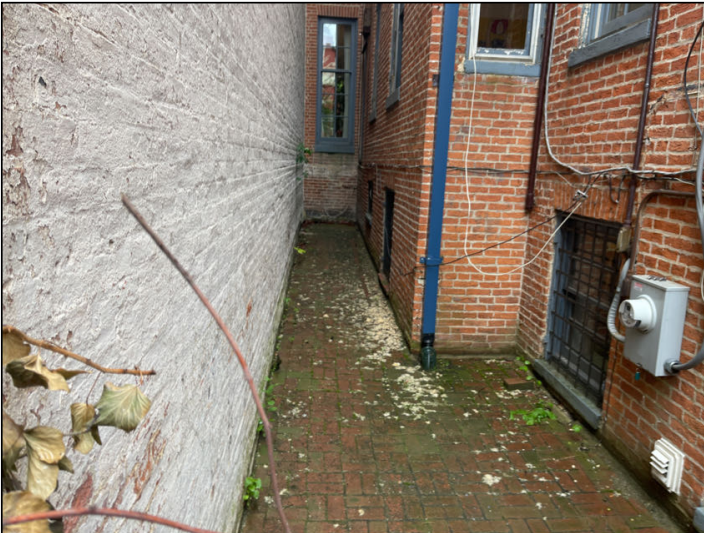
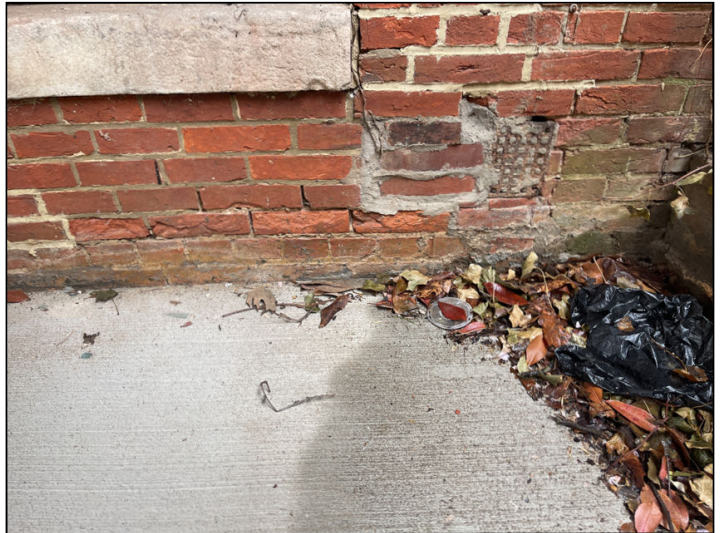
1. Foundation Walls

- Brick walls noted.
- No deficiencies were observed in the brick at the visible portions of the structural components of the home.
- Limited review due to basement being finished

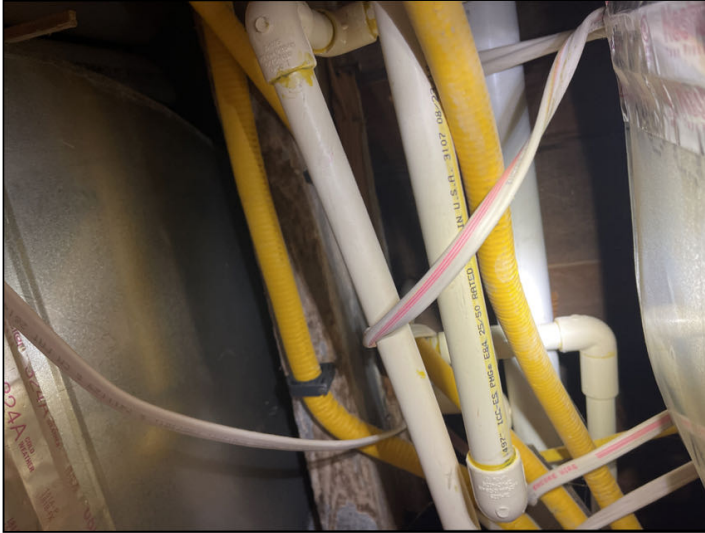
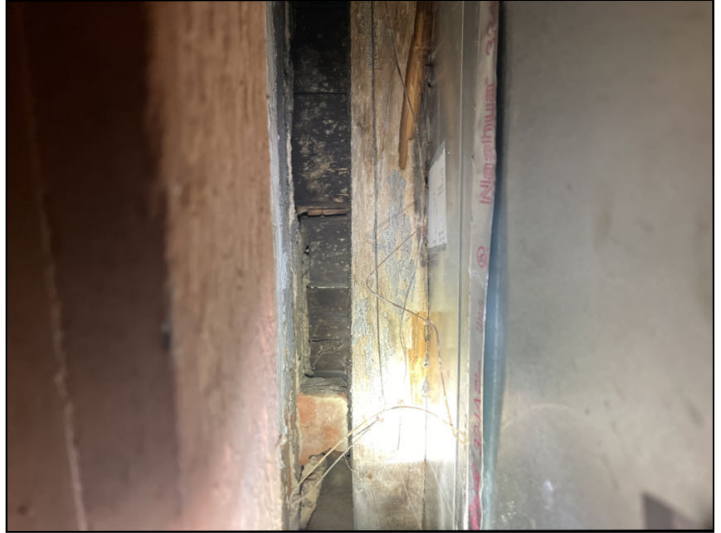
2. Sub Flooring

- ****DECKING****
- Plank subfloor noted.
- ****FRAMING****
- Dimensional lumber wood Joists

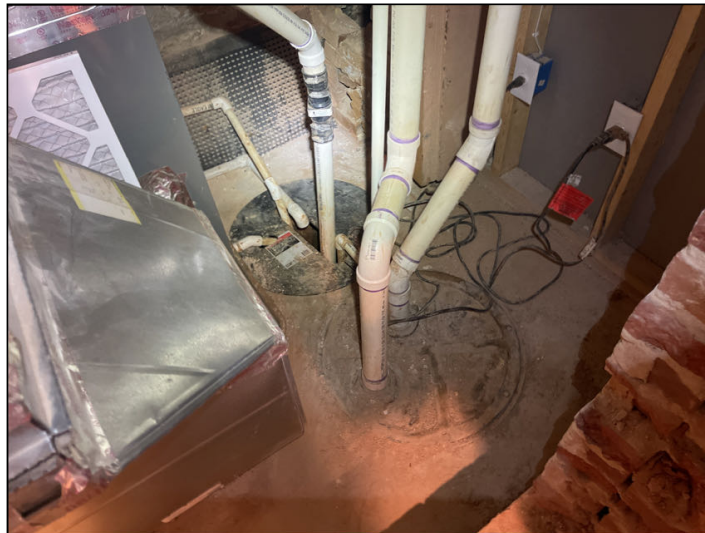
3. Sump Pump

- ****SUMP PUMP****
- Sump pump operated normally when tested. We recommend installing a back up battery to prevent flooding incase of power disruption.
