# INSPECTION REPORT

111 SAMPLE AVE, SAMPLE, VA

Date of Inspection: 2/19/2025 Time: 12:00 PM

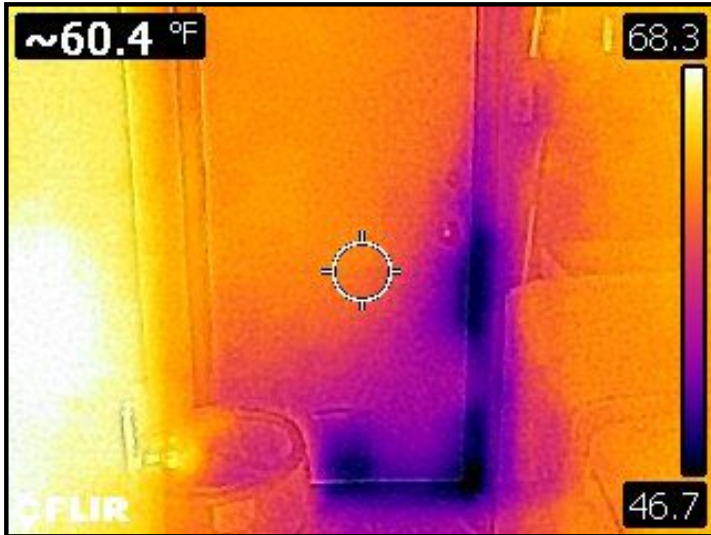
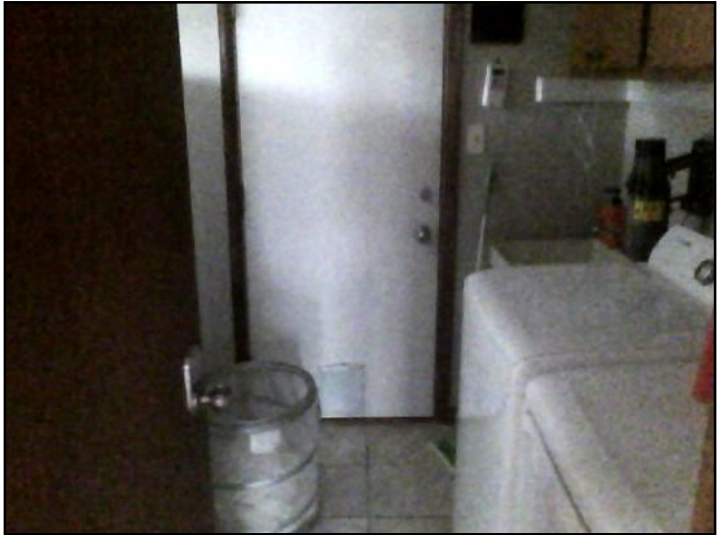
- Infrared images did not show any significant loss of energy through the garage door.

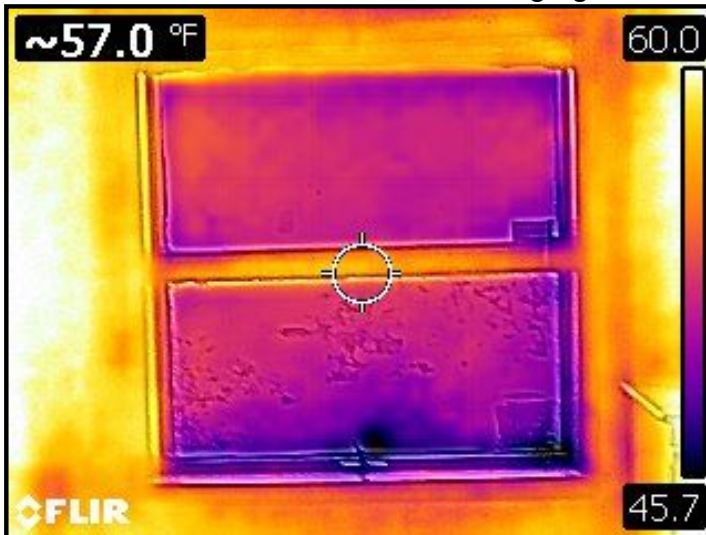
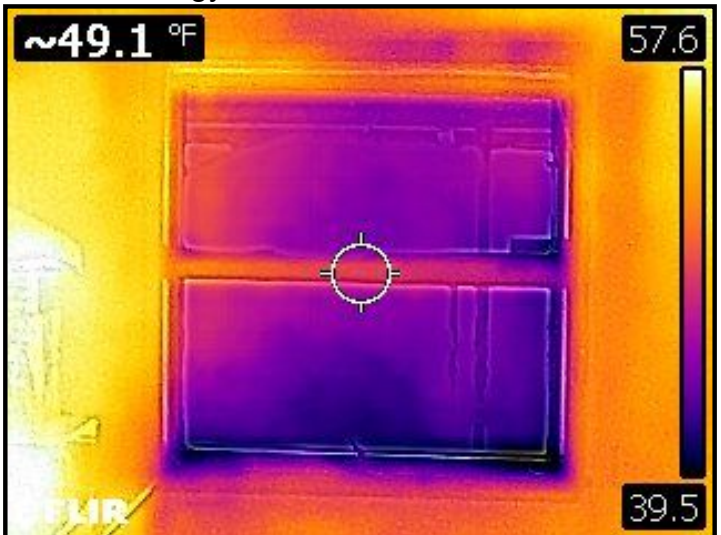
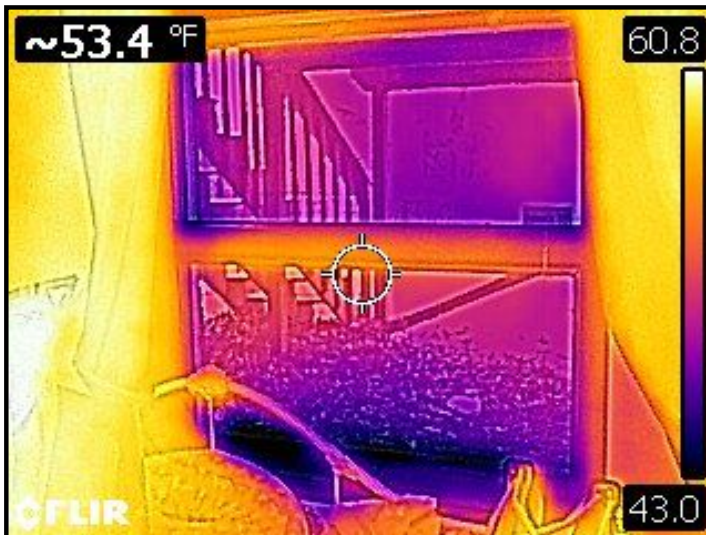
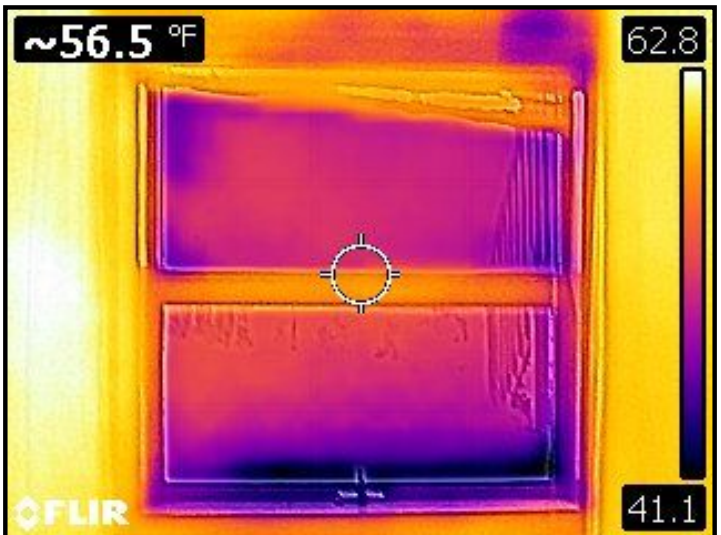
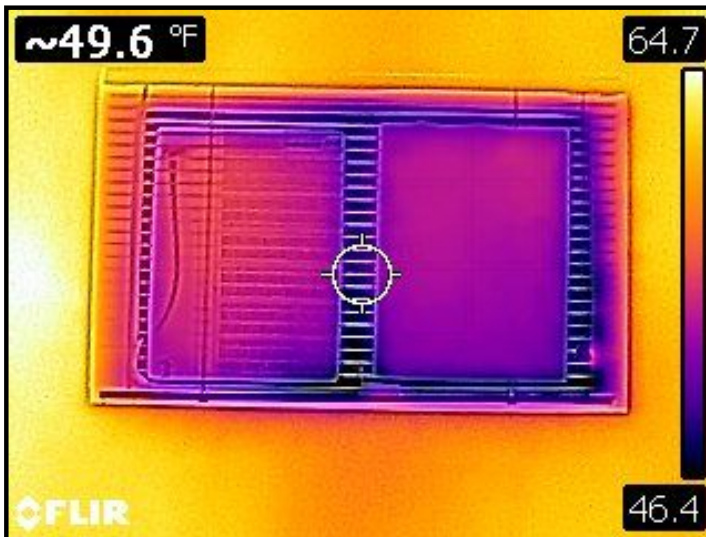
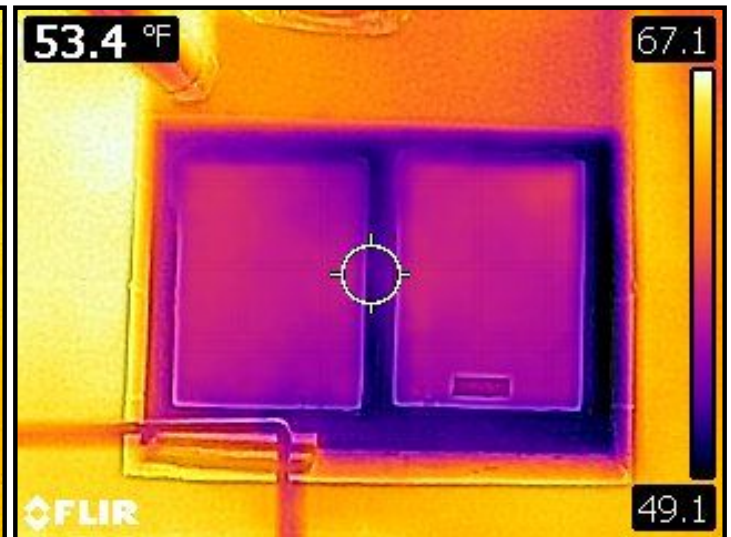
- Thermal imaging show no unusual energy loss.

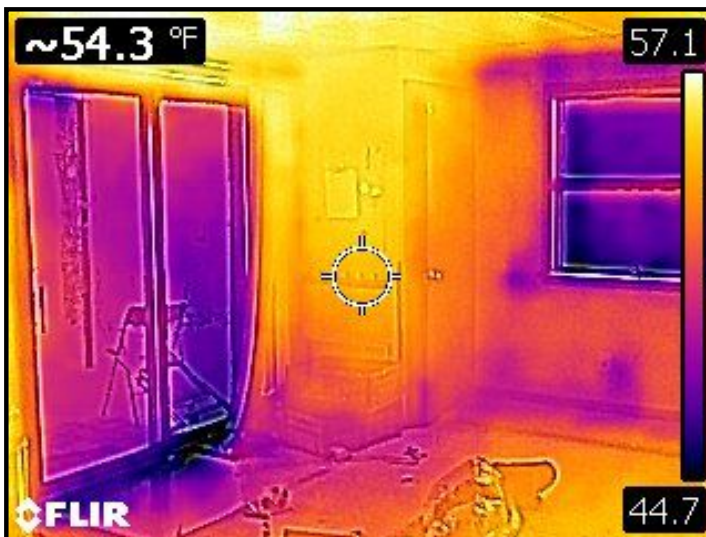
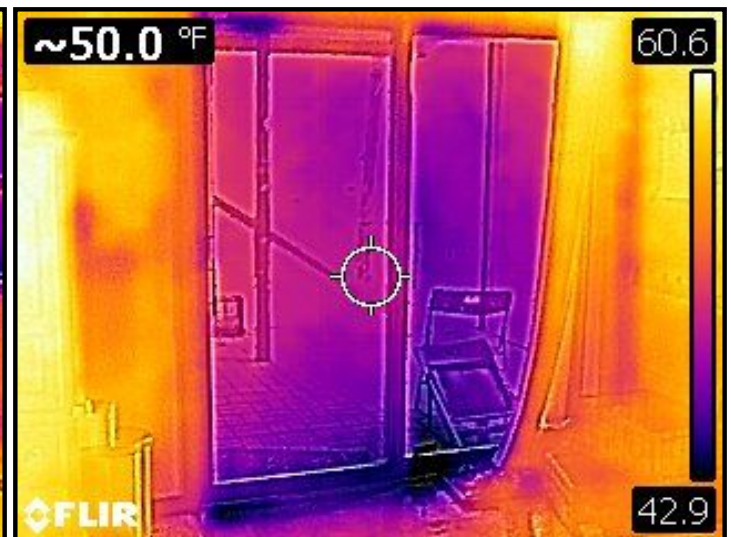
- Thermal imaging show no unusual energy loss.

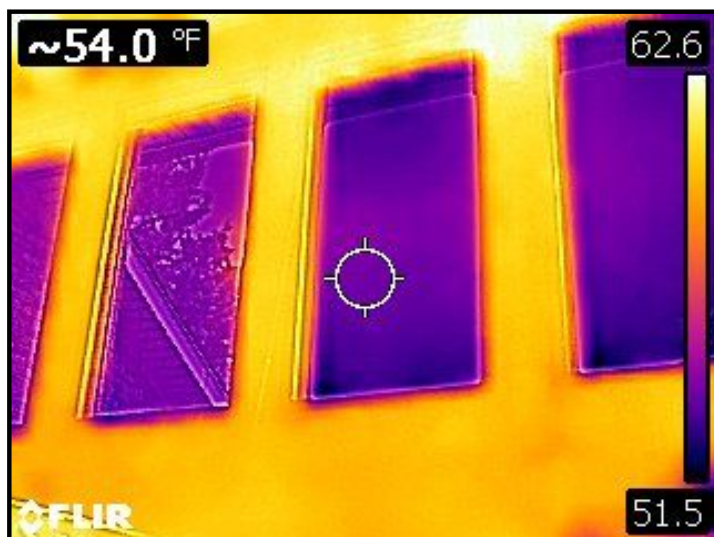
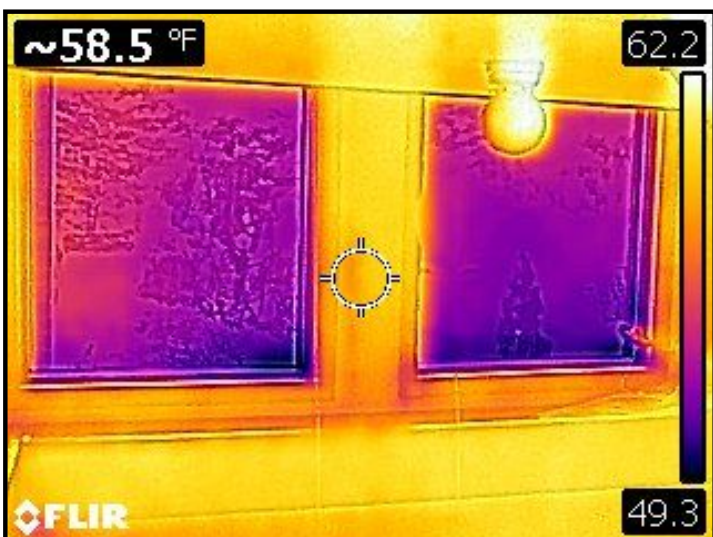
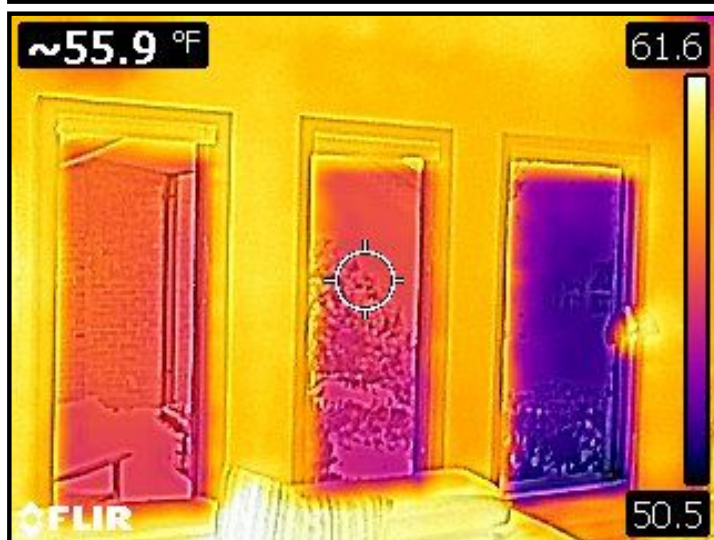
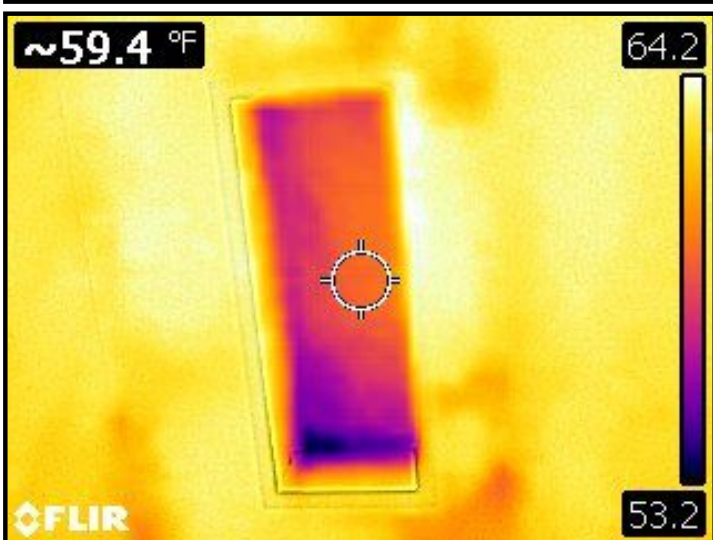
Skylight

- Thermal imaging show no unusual energy loss.

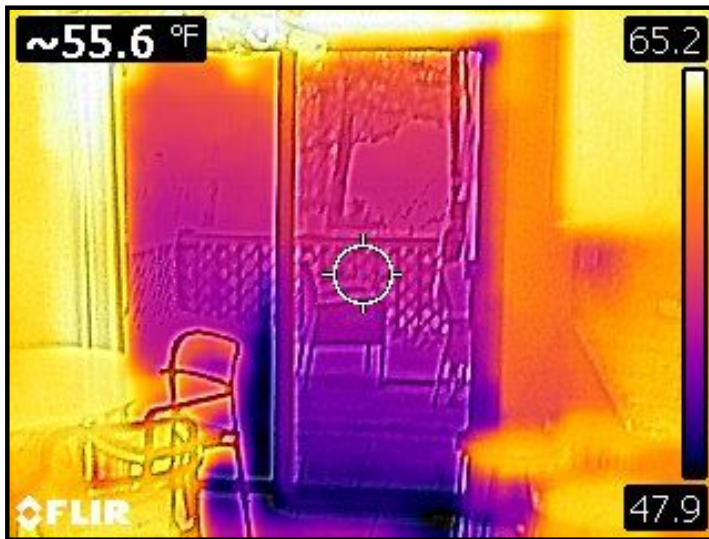
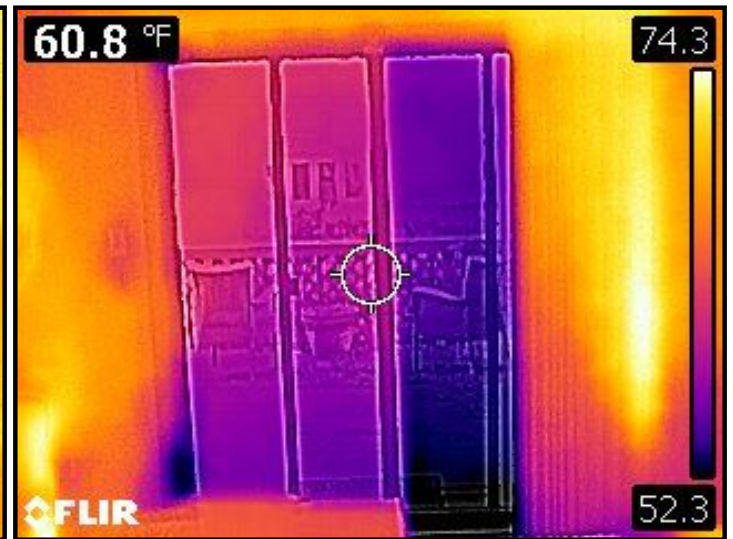
- Thermal imaging show no unusual energy loss.

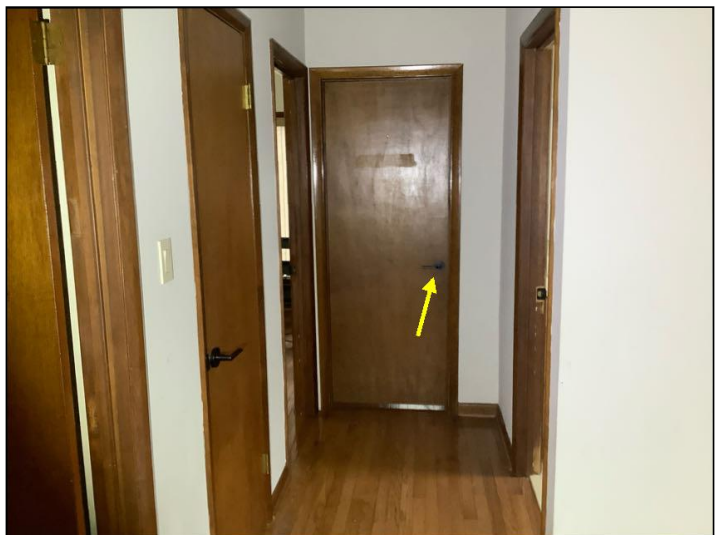
Closet door locked at the time of the inspection

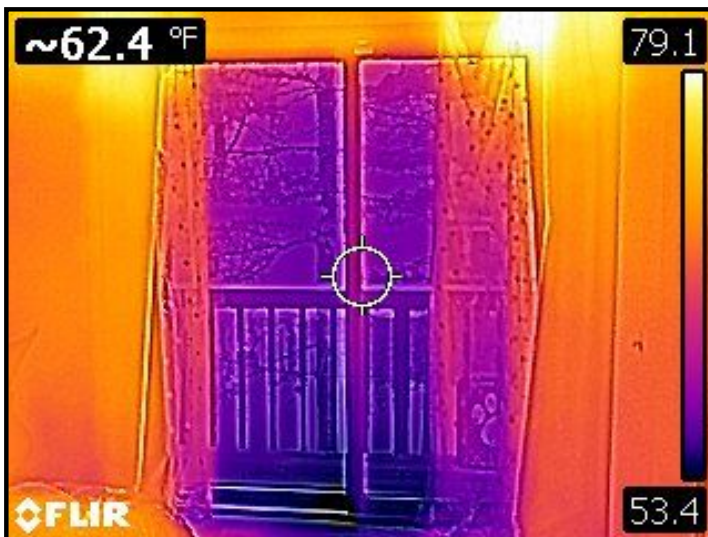
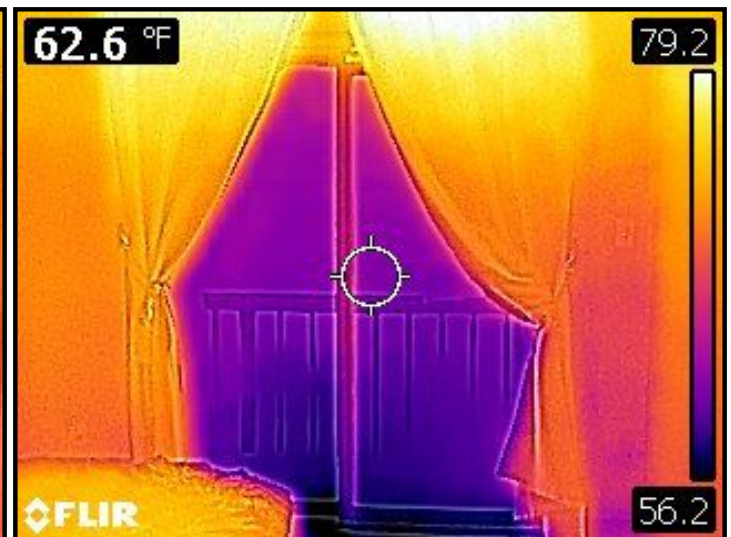
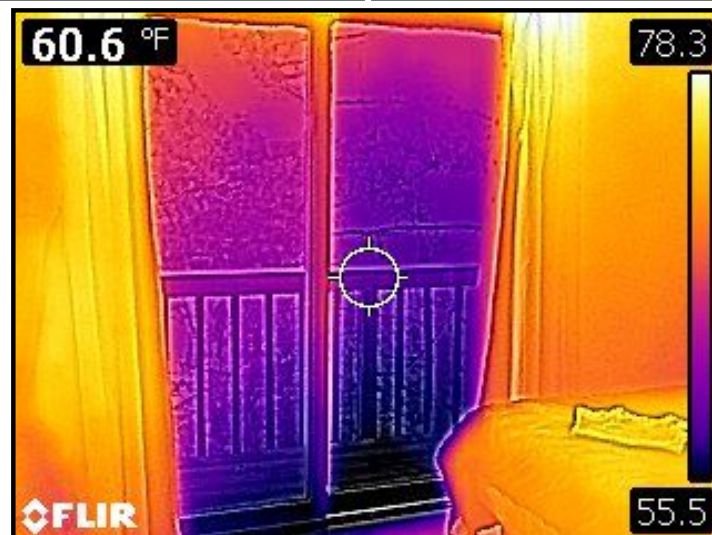
- Thermal imaging show no unusual energy loss.
