# INSPECTION REPORT

1001 Sample Ave, Sample, MD 10101

Date of Inspection: 4/17/2026 Time: 9:00 AM

Age of Home: 2006 Size: 3219 sq feet

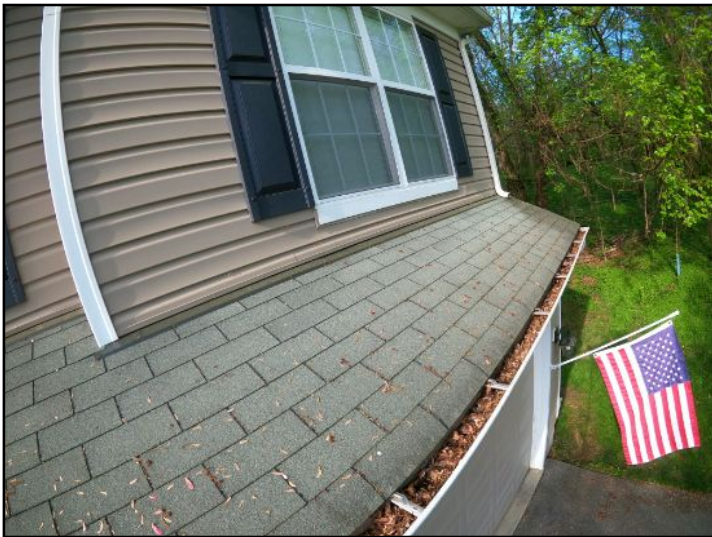
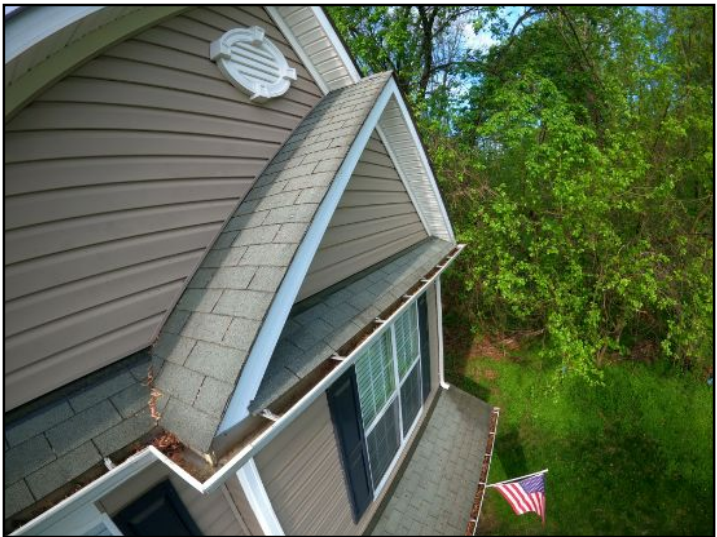
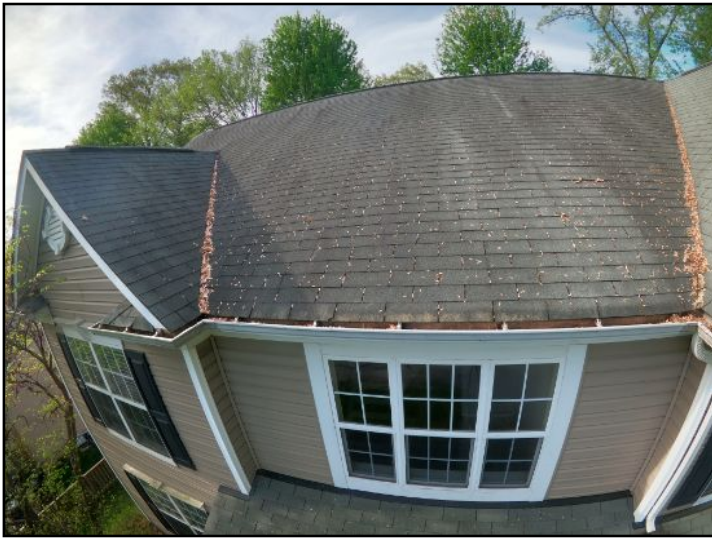
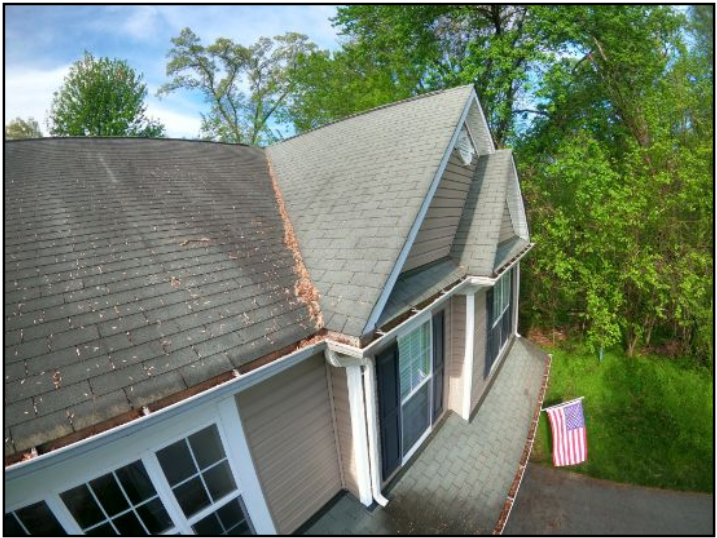
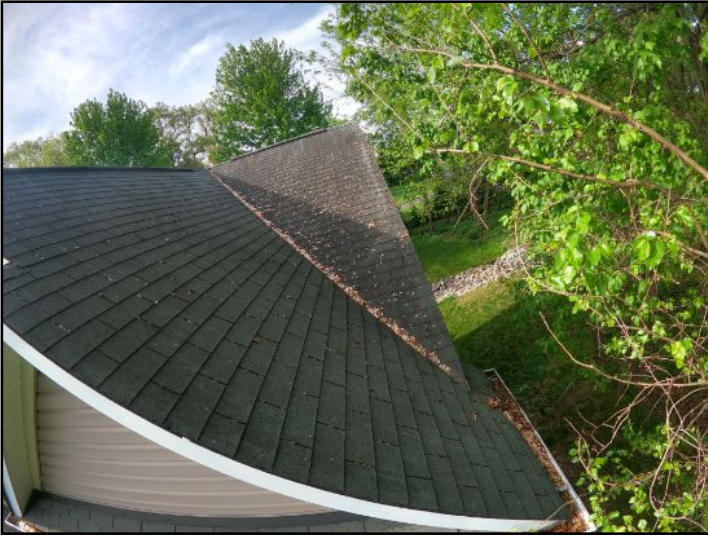
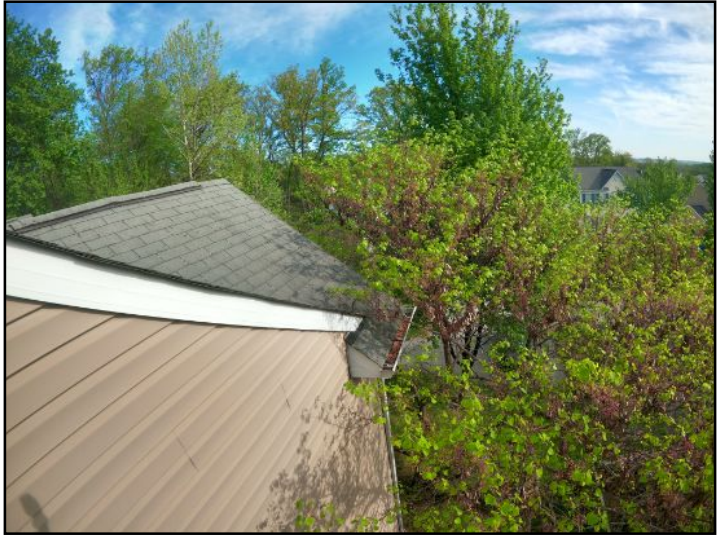
- Damaged/lifted shingles observed throughout. Recommend repair/replacement by roofing professional as needed to prevent leak.
- Roof appeared weathered, with damaged/lifted/stained shingles throughout. Recommend budgeting for new roof.
- Clean roof areas: Significant amounts of organic debris evident.
- Tree branches overhanging roof and/or against siding. Trim trees that are in contact or proximity to home, as branches can abrade siding and damage roofing.

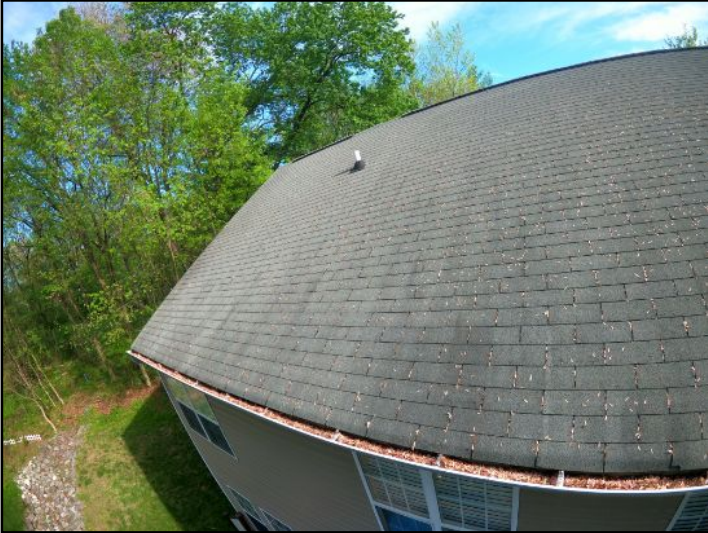
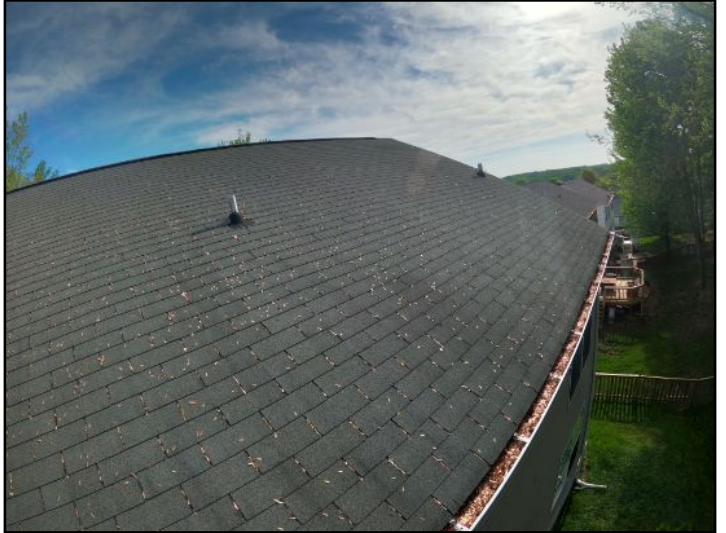
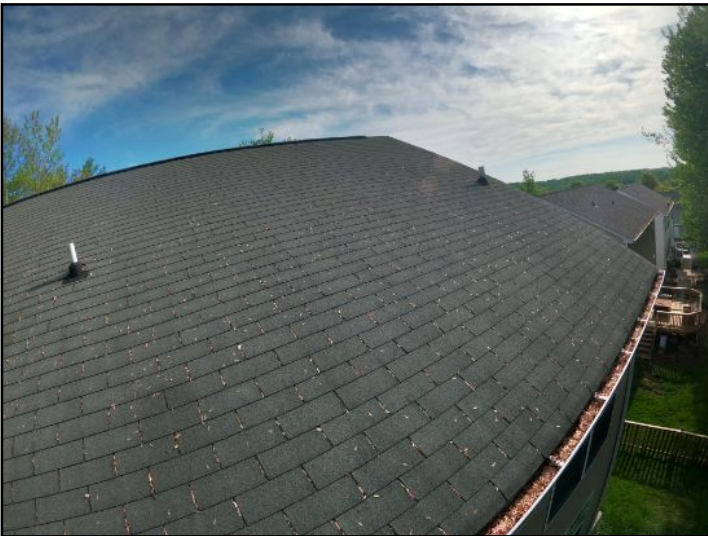
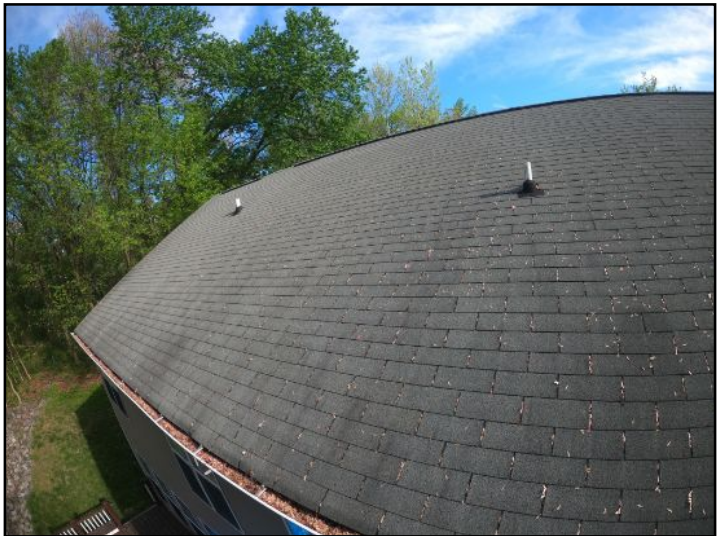
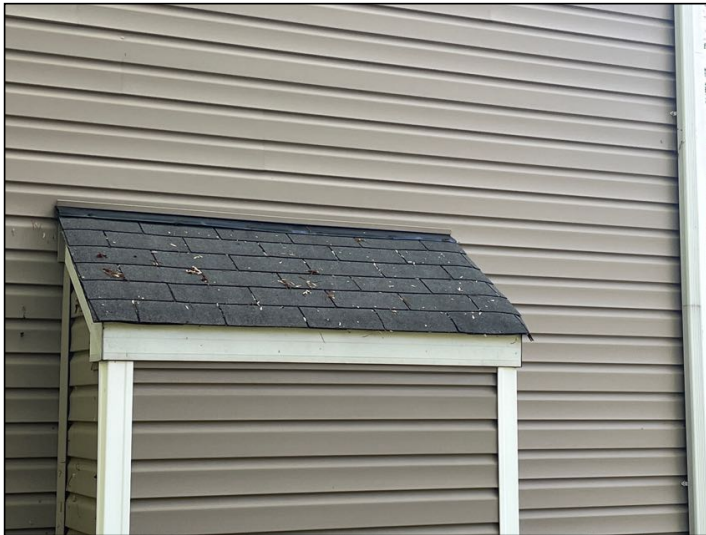
Tree branches next to roof

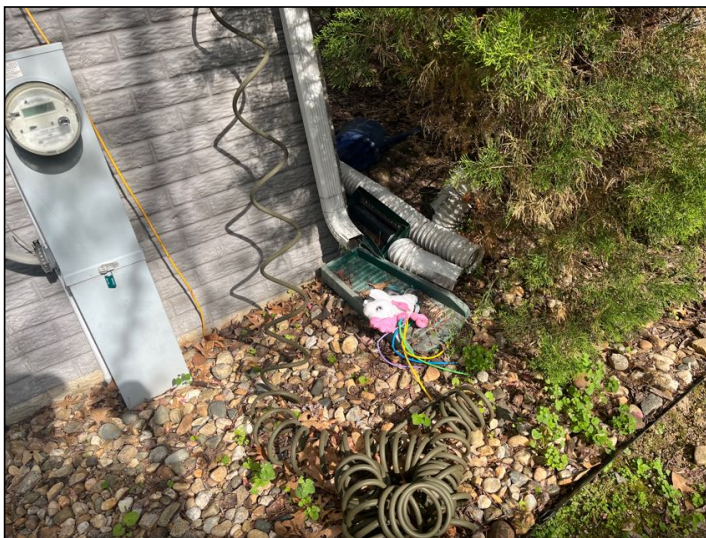
- Downspout discharging near the foundation wall noted. It is recommended to install 6' downspout extensions on a slope to divert water away from structure foundation.
- Debris noted in gutter. Recommend cleaning gutters so that water can properly drain.
- Downspout drains from one roof section onto another roof section; this will lead to premature wear of the roofing materials and increase likelihood of water damage. Downspouts should drain directly into another gutter or away from the house. Recommend installing/modifying downspout to direct water directly into lower gutter or away from house.

Terminates near foundation

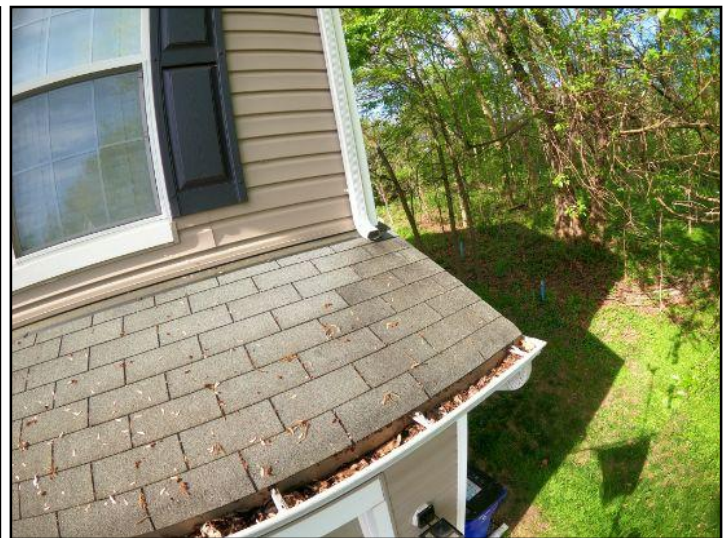
Terminates on roof, causing staining

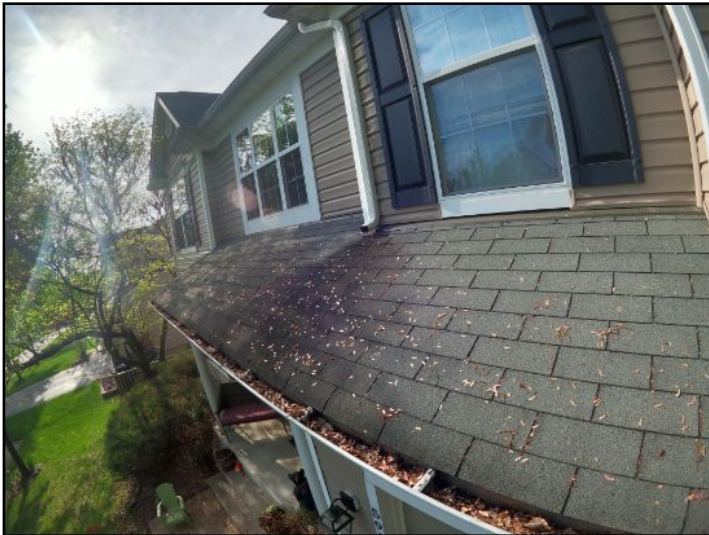
Terminates on roof, causing staining

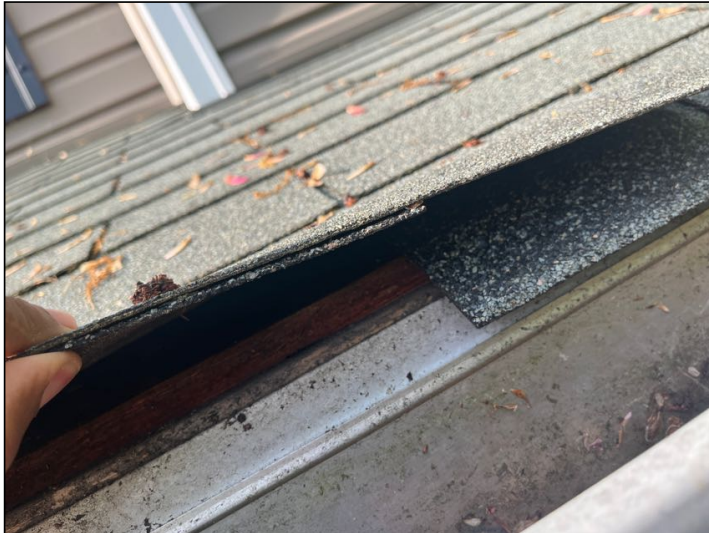
- Poor roof flashing it appears there are no **drip edges** installed.

Missing drip edge

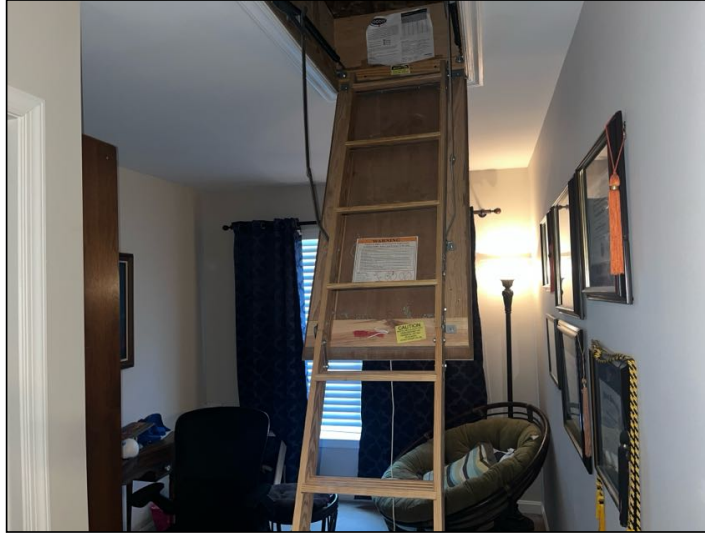
- Access cover has no insulation. Recommended insulating the access cover to minimize energy loss.

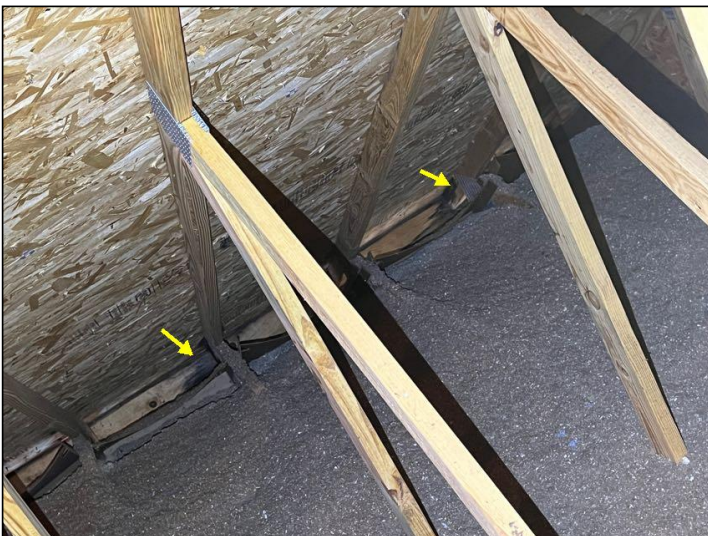
- Evidence of past leaks, mainly near the edges of the roof/attic. Roof is likely missing drip edge flashing. Recommend evaluation of roof areas for repair/replacement as needed by roofing professional.

Signs of moisture intrusion

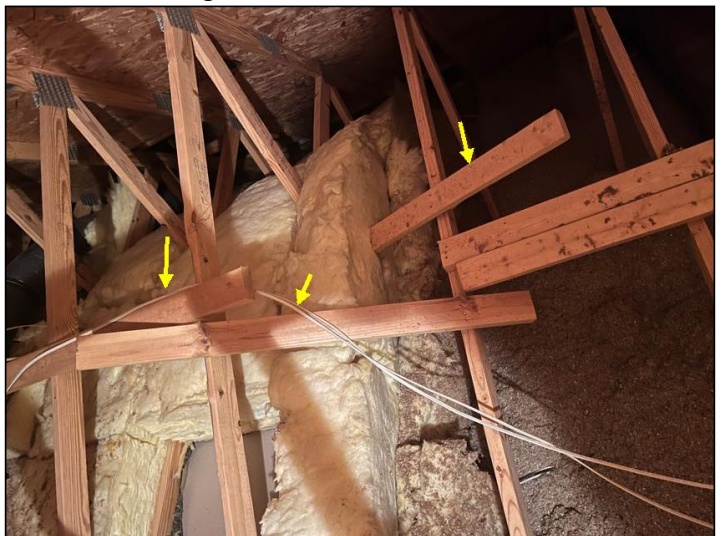
Signs of moisture intrusion

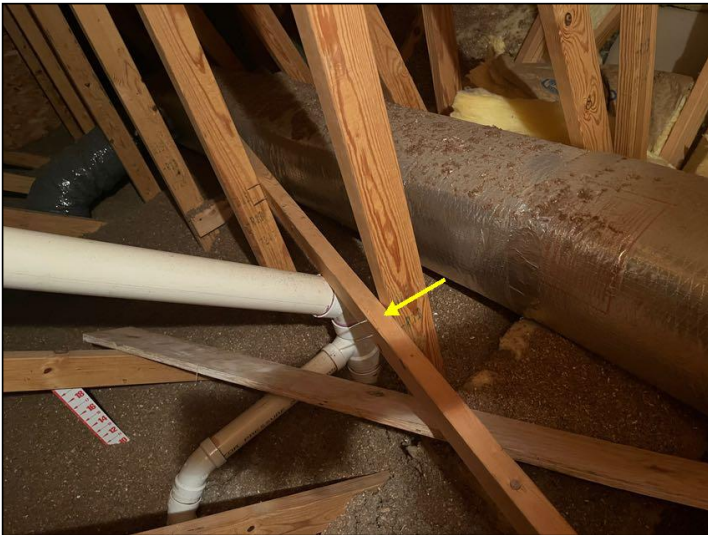
- Loose horizontal wood bracing was observed in the attic that does not appear to be securely fastened, and several nails were noted protruding outward from the boards. These conditions present a potential safety hazard for anyone accessing the attic and could damage nearby wiring or insulation. A licensed general contractor should further evaluate the attic framing and correct or remove the loose bracing and address the exposed nails as needed.

Loose bracing

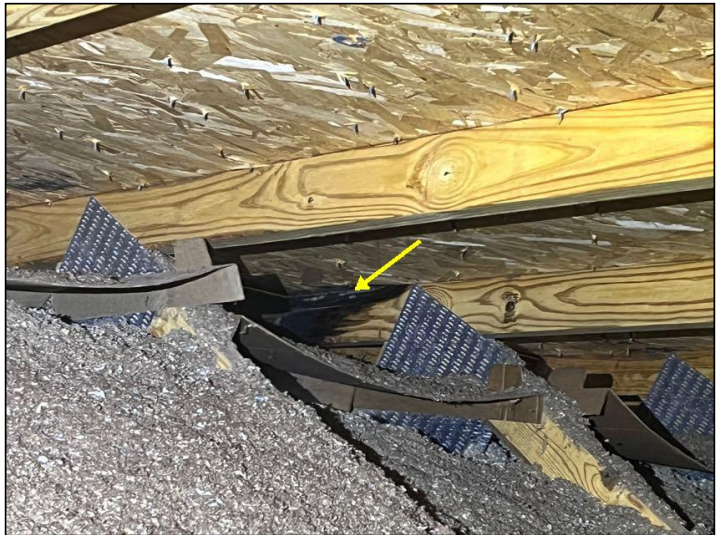
Loose bracing; Nails sticking outwards

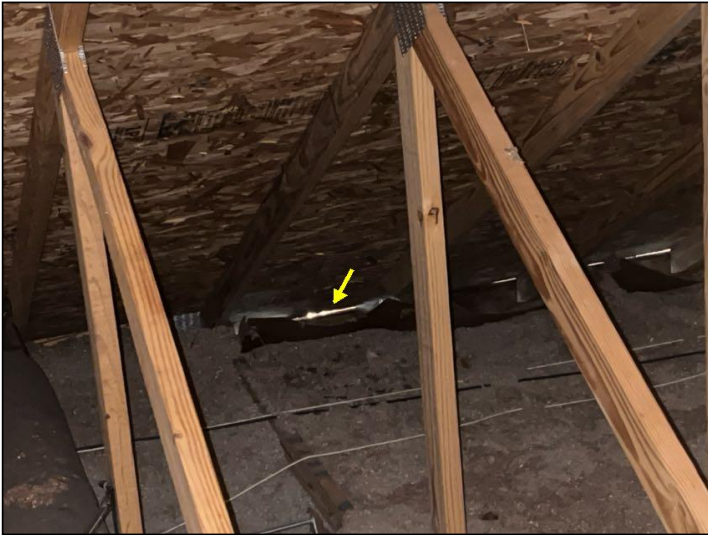
- The stained areas of the roof were scanned using a thermal imaging camera, the areas were dark, however it was difficult to determine if the stained areas were moist. The reason being the areas in which the attic was blackened were also near the soffit vents which are a cooler area possibly causing the area to appear darker using thermal imaging. It is likely this damage is active, the client reported no roof repairs since the home was first built.

Stains noted

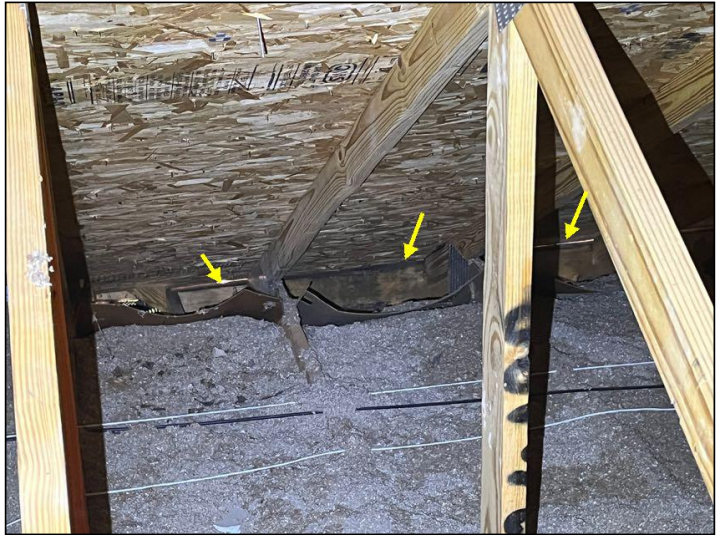
Daylight visible

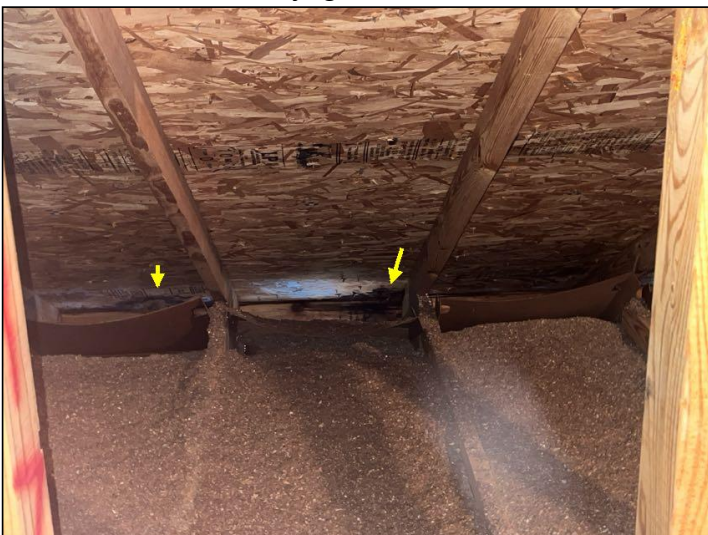
Stains observed

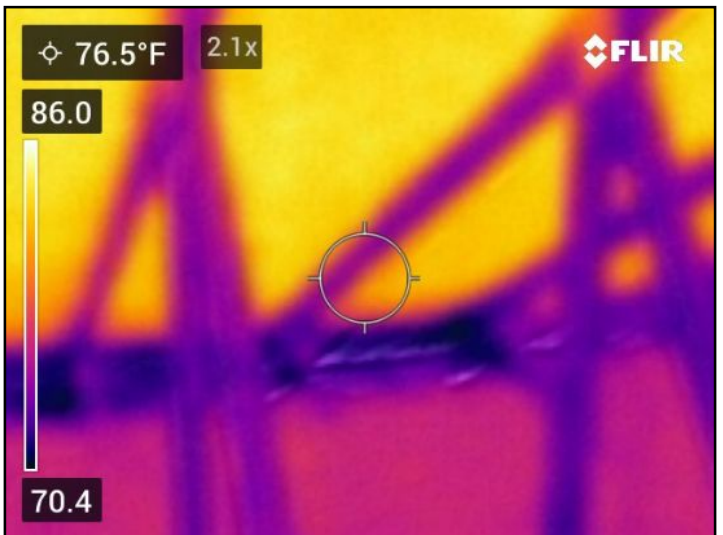
Stains and some deterioration noted to sheathing

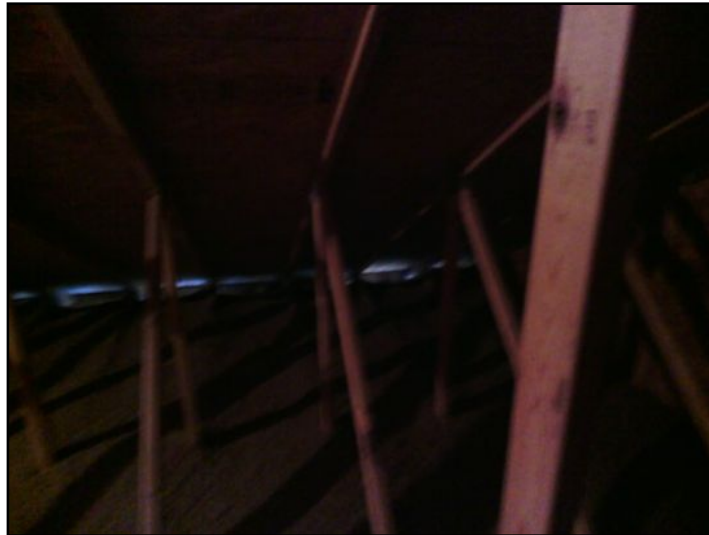
Dark areas noted

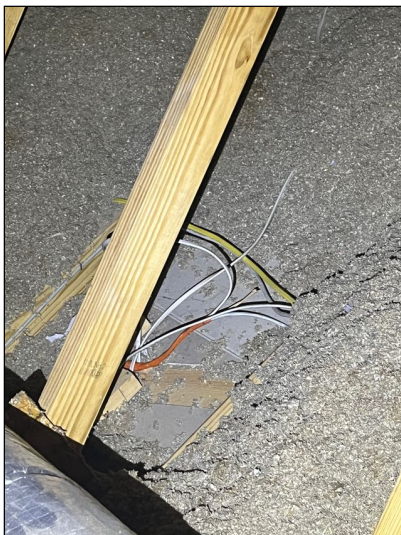
- Uninsulated areas/sparse insulation observed. Recommend insulating properly by qualified professional to reduce energy escape.

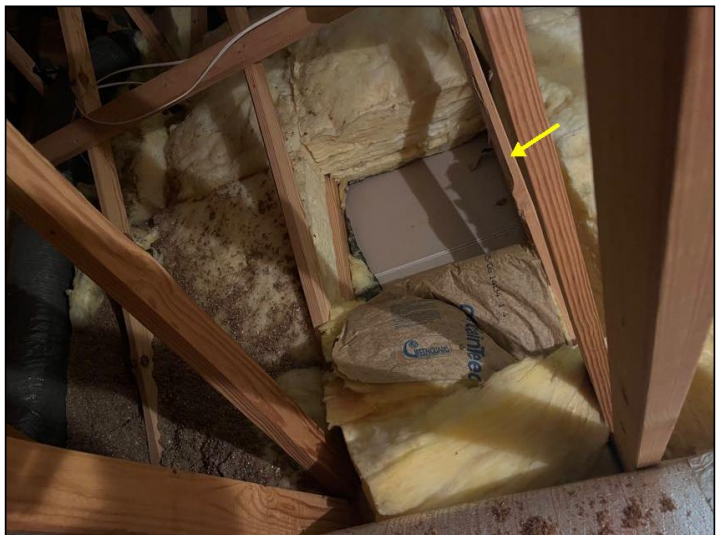
Missing insulation in some areas

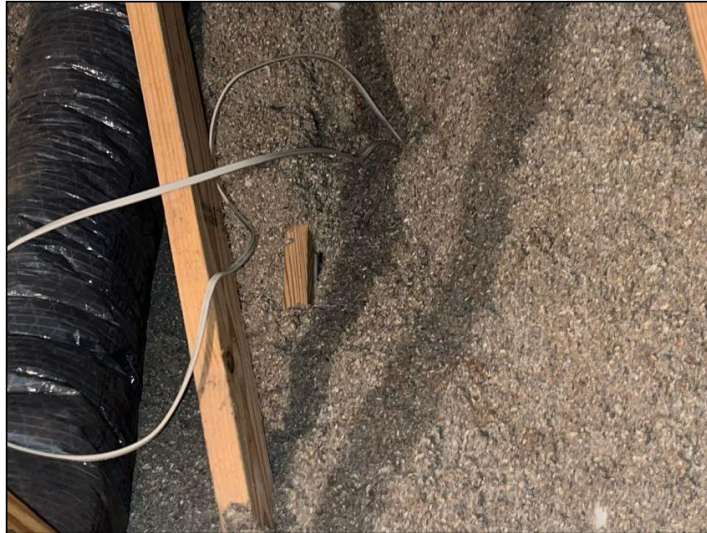
Missing/loose insulation

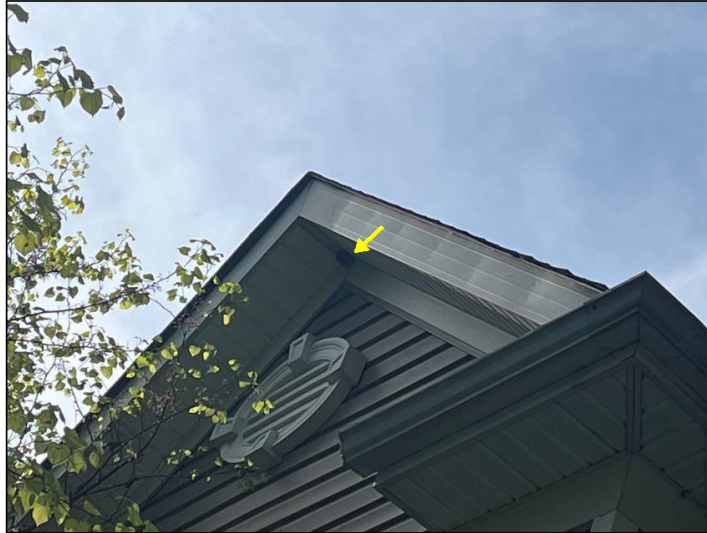
Low insulation

- Evidence of insects and/or rodents was observed throughout the home. Recommend evaluation and remediation by a licensed pest control professional to prevent damage and potential health concerns.
