Next Day Inspect

Commercial Inspection Report

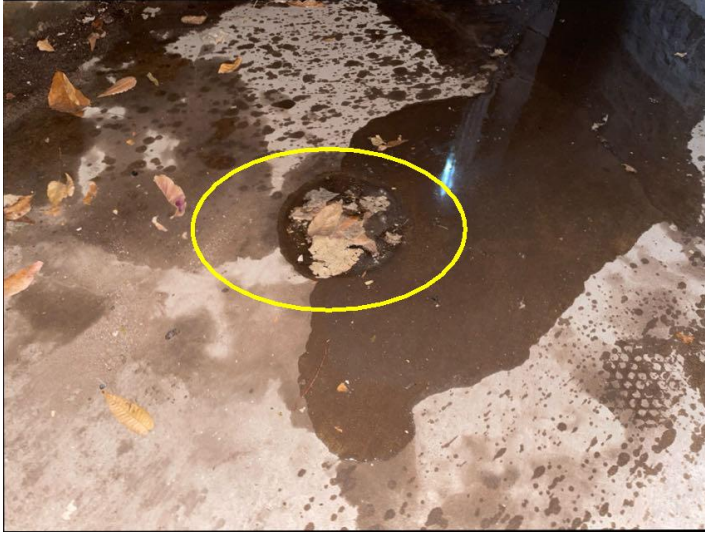
- Dirt and debris noted at several drains. Clean or repair as needed.
- Loose drain cover noted. Secure or replace as needed.

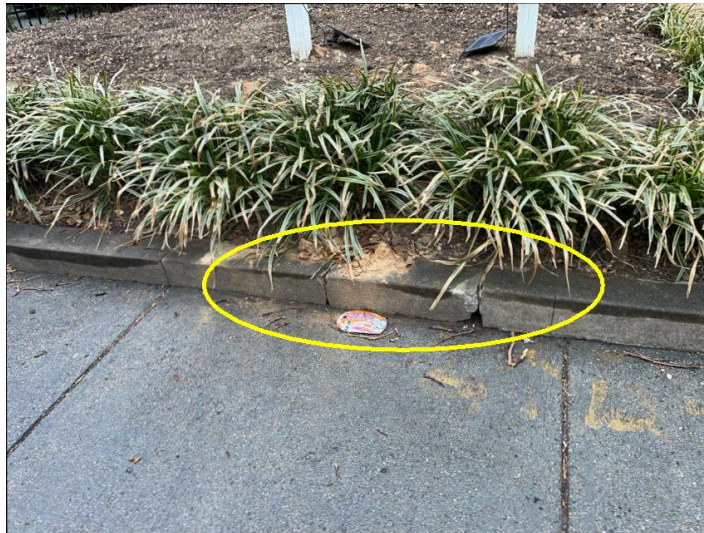
Damaged landscaping curb

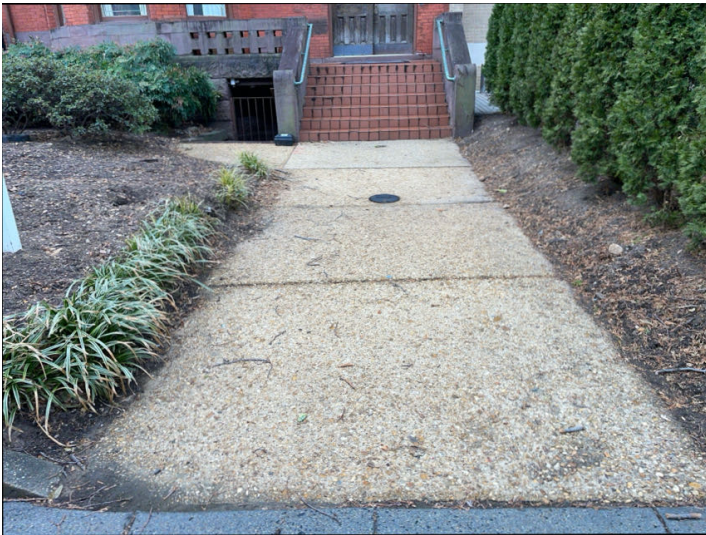
- Concrete walkway and tile landing noted at the front of the building.
- Elevated wood walkway at the back of the building noted.
- Cracked tiles noted on the front door landing. Recommend repair or replace as needed.
- Deteriorated joists and joist hangers noted on wood walkway. Recommend repair.
- Some joists were not properly supported. Recommend review and repair as needed.

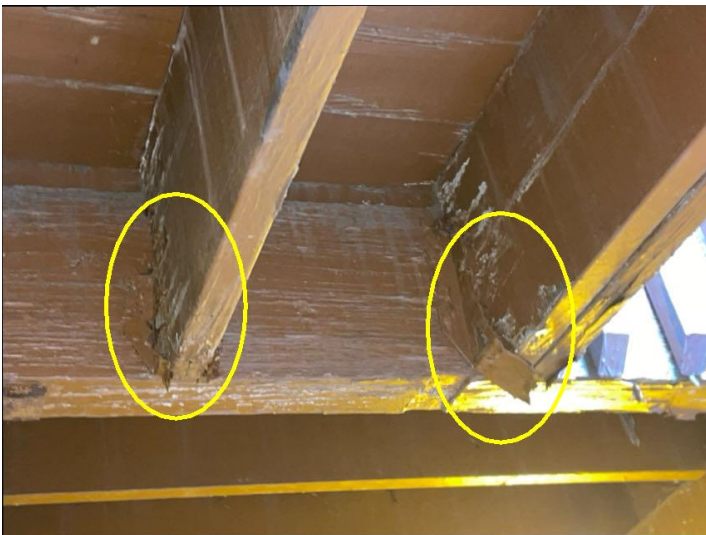
Corroded / failed joist hangers

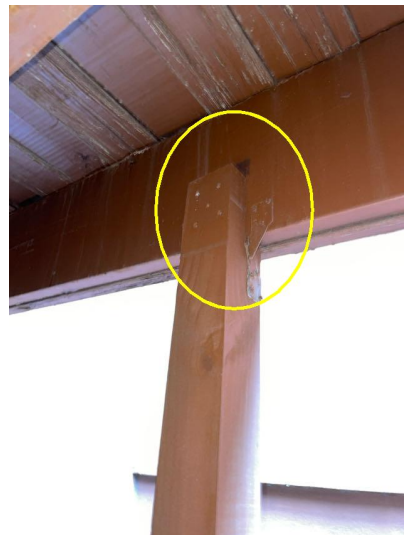
Not properly attached

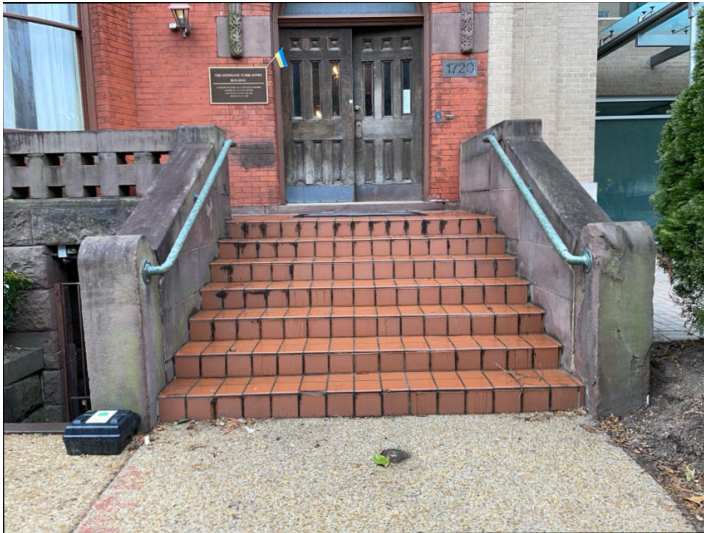
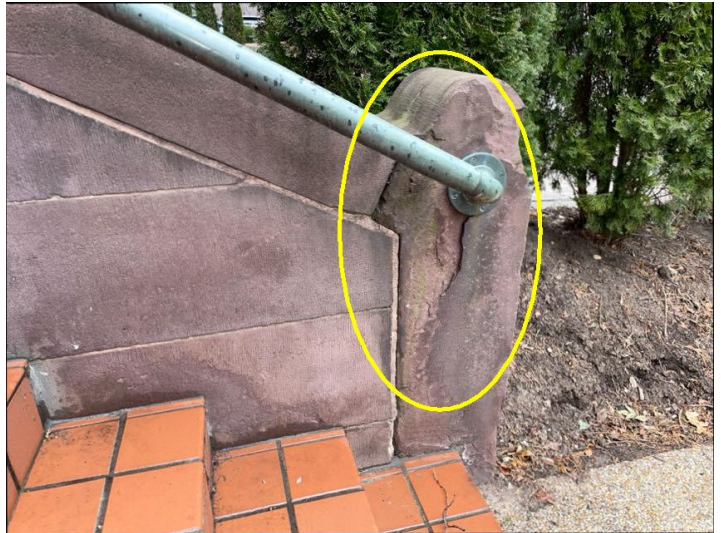
Deteriorated concrete

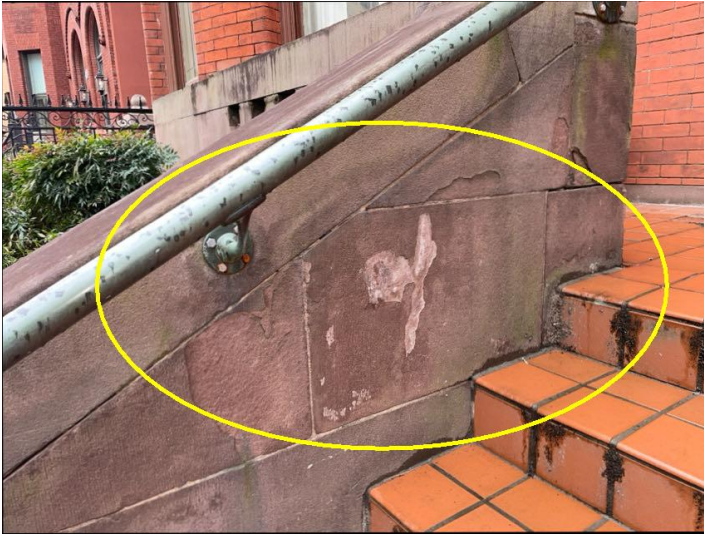
Deteriorated concrete

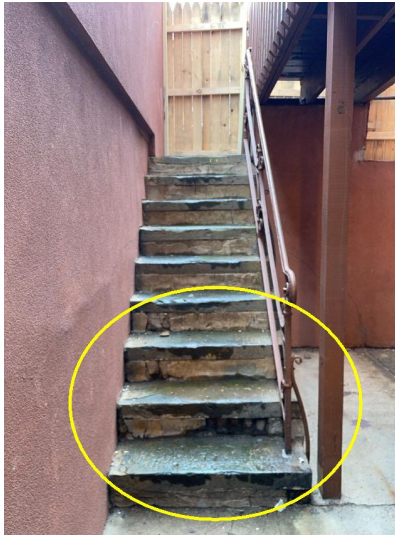
Deteriorated concrete

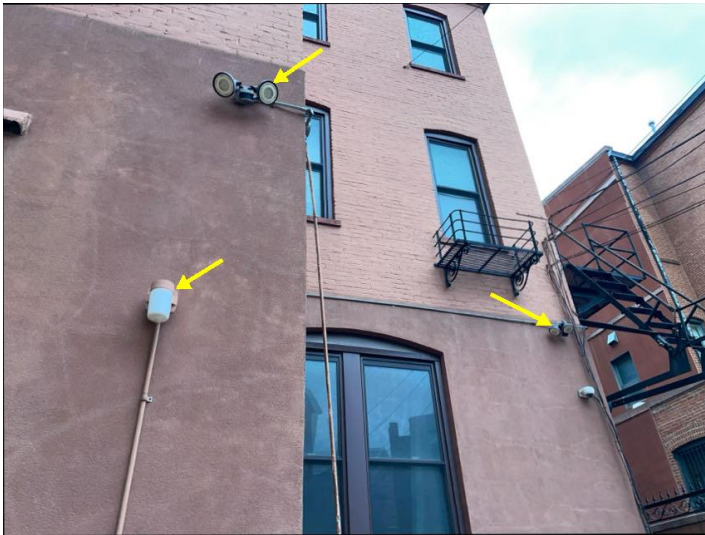
- Several lights were sensor operated.
- Loose fixture noted at the front of the building. Recommend repair.
- Light at front basement entrance did not work. Replace bulb and check for operation. Repair or replace fixture as needed.

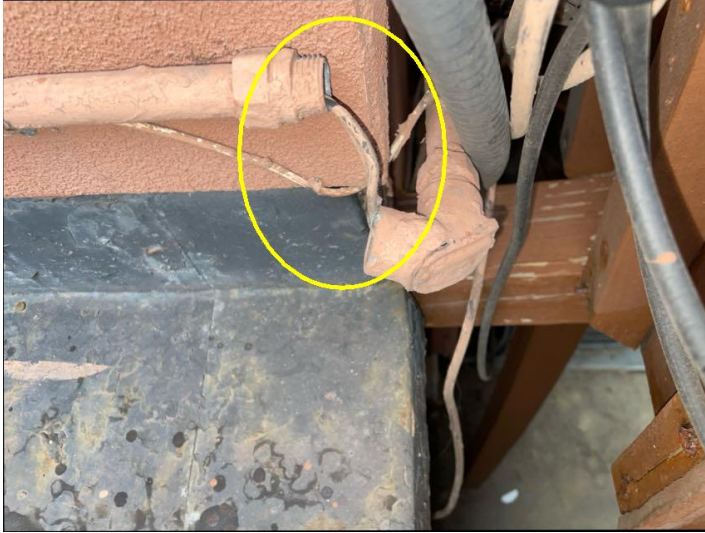
Disconnected conduit

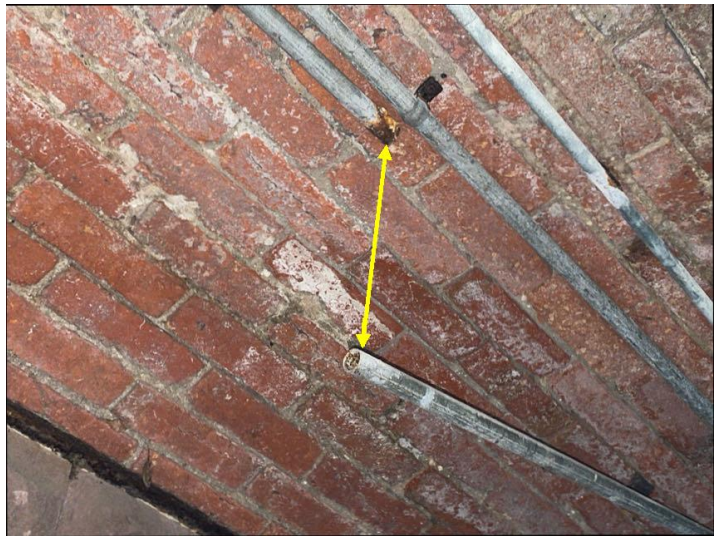
Disconnected conduit

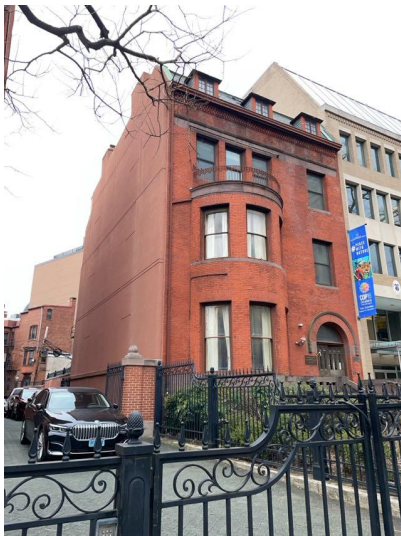
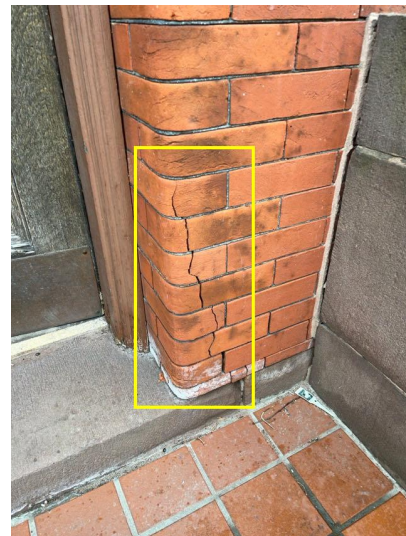
- Cracked bricks noted at the front of the building. Recommend review and repair as needed by a qualified contractor.
- Hole noted at the back of the building near the roof. Nesting material observed inside hole. Recommend repair.

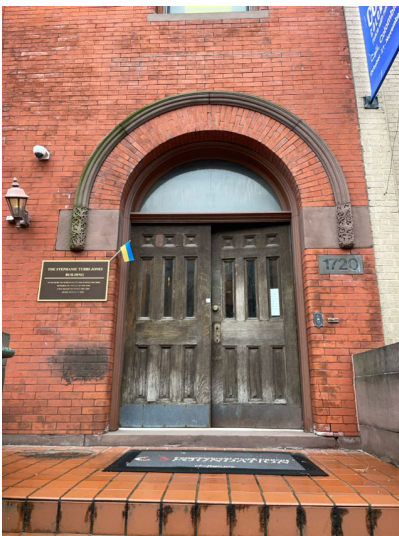
- Security gate and door to closet under front stairs was locked. Unable to inspect.
- Wood doors were weathered with deterioration noted. Recommend seal or repair as needed.
- Front door was missing the handle set. Recommend repair.
- Minor corrosion noted on the metal exterior doors. Repair and seal as needed.
- Emergency egress door opened into wall pack light. Recommend review and repair for safety.
- Peeling paint noted around basement level door frames. Possible lead paint due to age of building. Recommend paint or seal as needed.

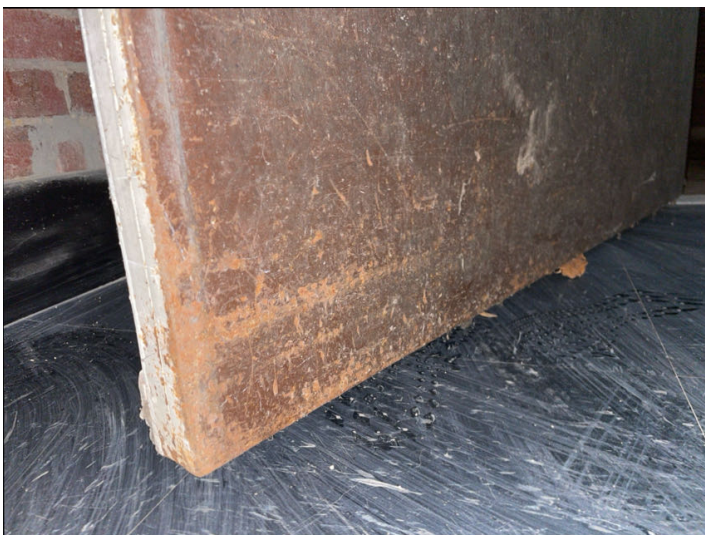
Front lower level door

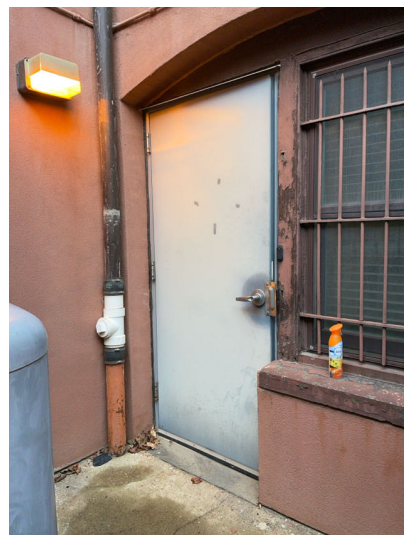
Back lower level door

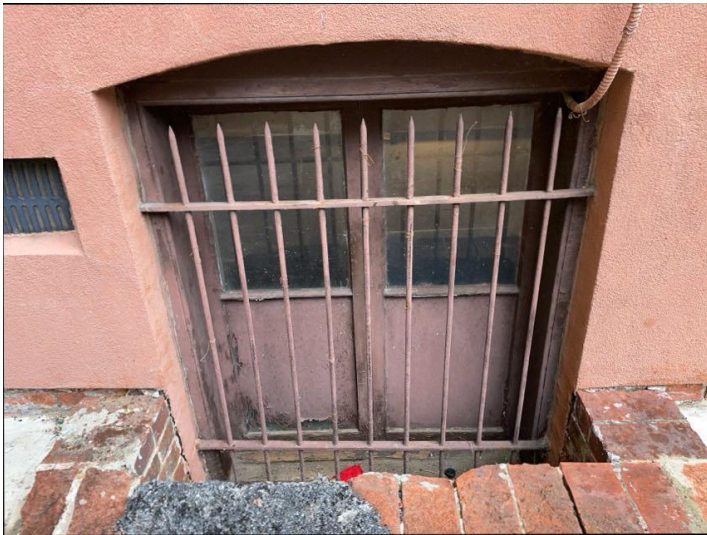
- Single pane glass noted on basement windows. No cracks observed. Consider upgrading to energy efficient windows.
- Peeling paint noted around basement level window frames. Possible lead paint due to age of building. Recommend paint or seal as needed.
- Hole noted in fourth level window. Possible opening for vent. Recommend repair or replace as needed.

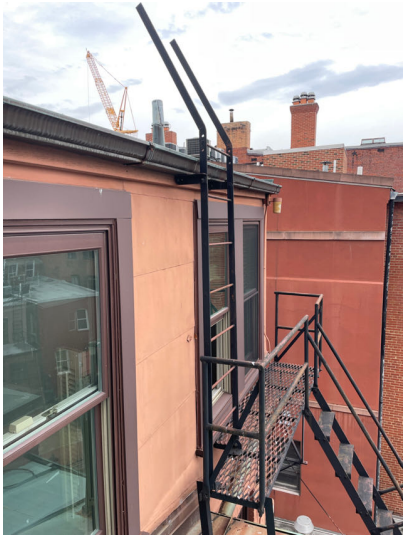
2. Roofing Condition

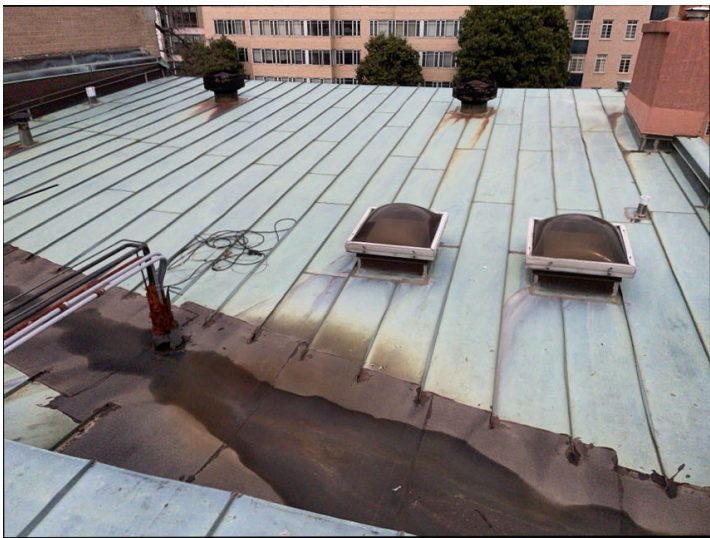
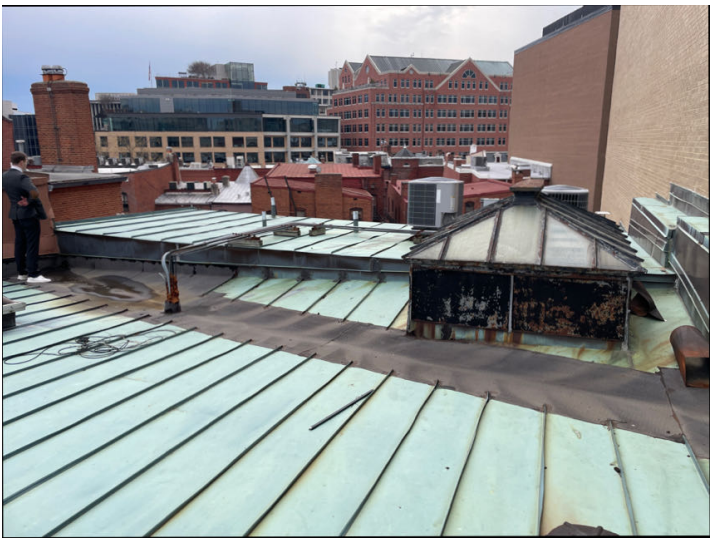
Materials: Metal standing seam roofing • Slate tiles
Observations:
• Corrosion noted on areas of the roof. No holes observed. Recommend further review and repair as needed.
• The roof penetration of the AC electrical cables and refrigerant lines was sealed with spray foam. Recommend installing line set flashing to better prevent water penetration.
• Several slate tiles on the front dormer windows were broken or loose. Recommend repair by a qualified contractor.

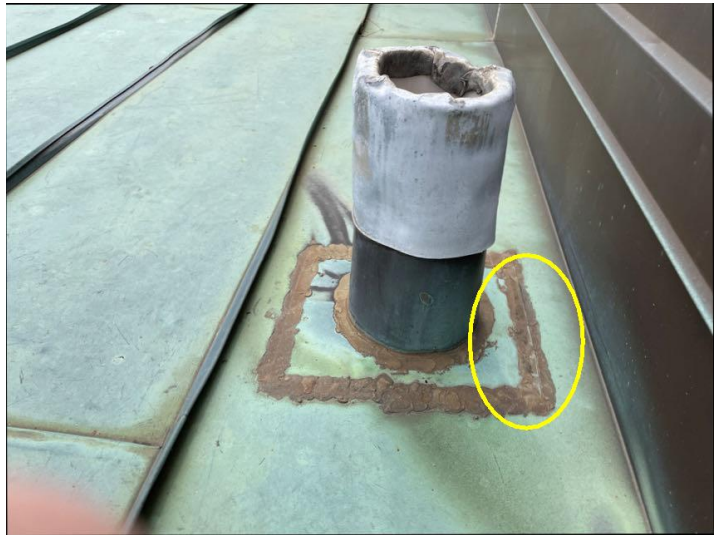
Deteriorated sealant

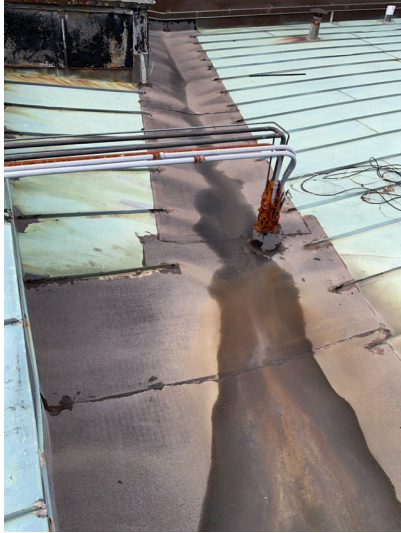
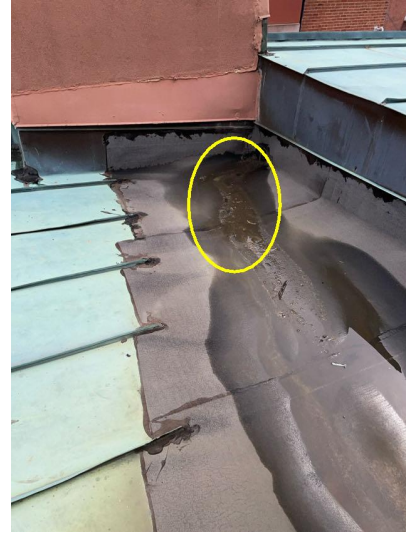
- The roof appeared to be properly sloped to allow water to flow to the roof drainage system.
- Standing water noted near gutter downspout. Early rain during the day of inspection. Recommend monitor for 48 hours to see if pool evaporates.
- Gutter appeared to sag. Standing water noted in gutter. Recommend repair.
- Organic debris noted in gutters. Recommend cleaning and continued maintenance to prevent clogged downspouts.

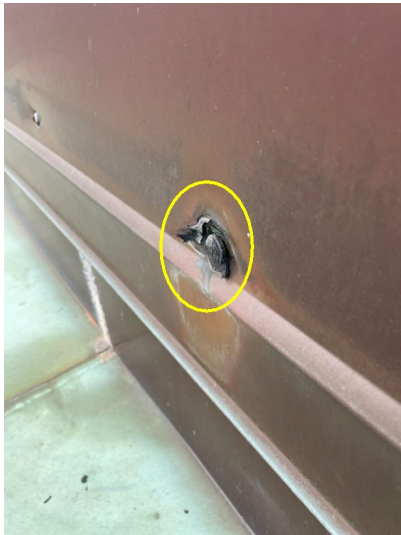
Deteriorated sealant

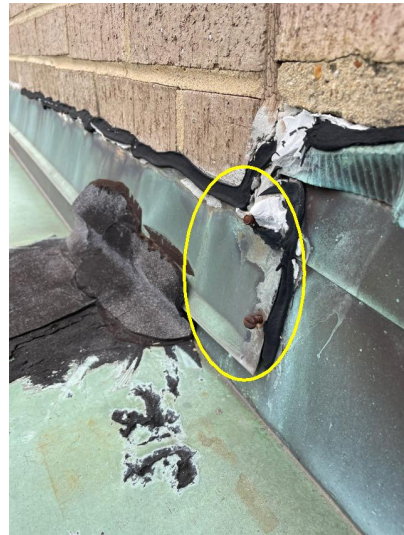
Loose / unsealed fasteners

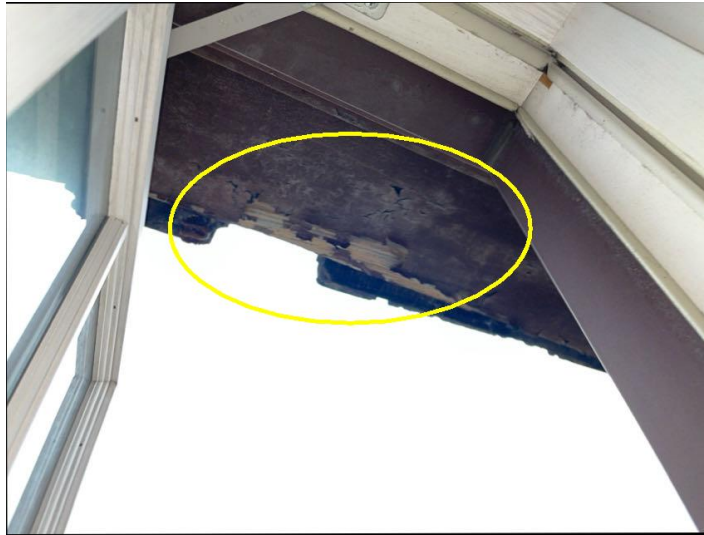
- Peeling paint and wood deterioration noted on front eaves. Recommend repair.

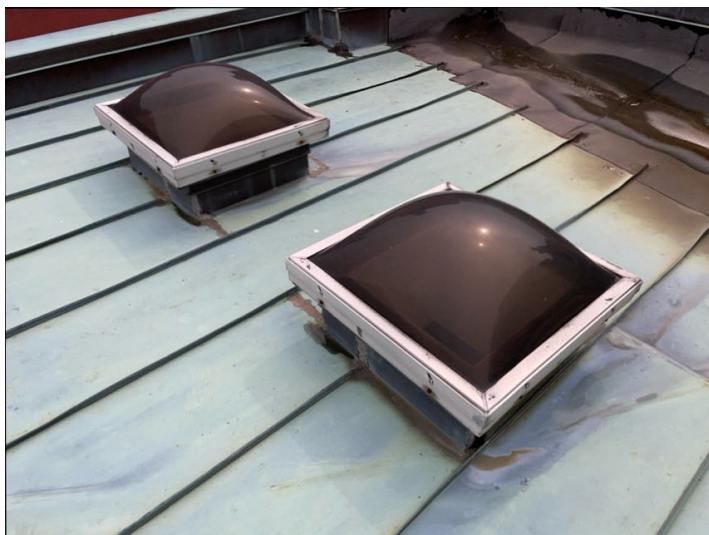
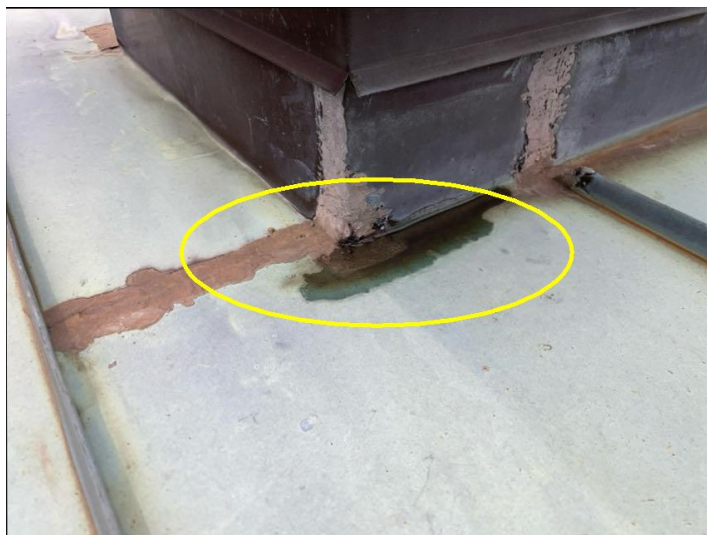
- Minor puddle noted at small skylight. No active leaks noted on the interior.
- Deteriorated sealant noted around the large skylight curb. Seal or repair as needed.

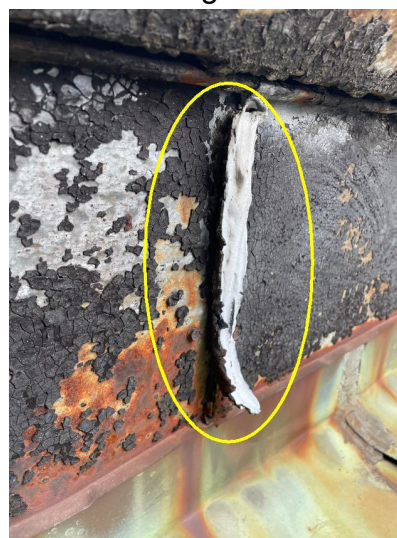
Deteriorated sealant

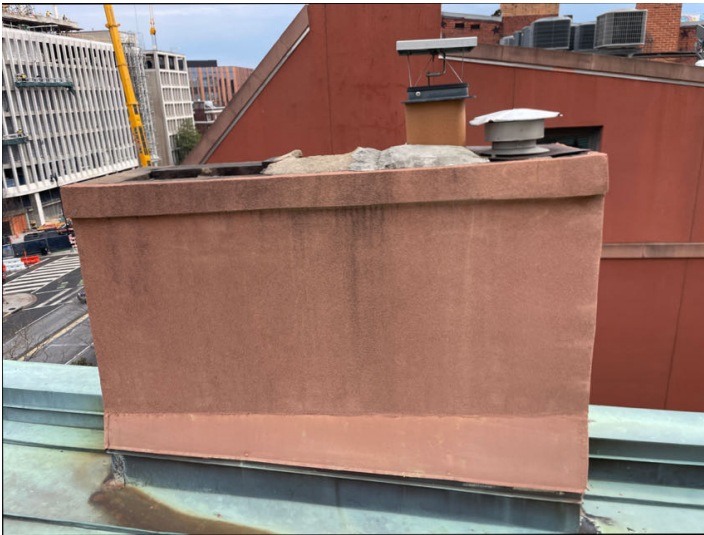
- Stucco covered masonry chimneys noted.
- Open flues noted at the front chimney. Recommend repair by a qualified contractor.
- Gaps noted around the rain cap flashing. Recommend repair by a qualified contractor.
- Deteriorated mortar and sealant noted on the chimney crown of the back chimney. Recommend repair.

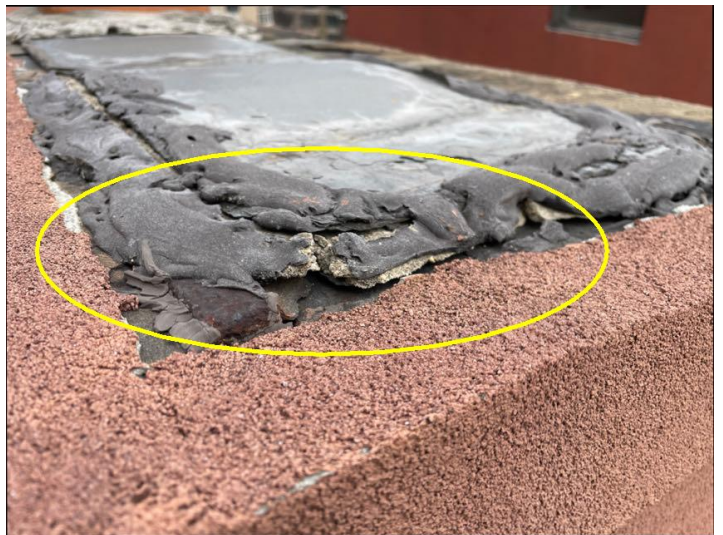
Deteriorated sealant

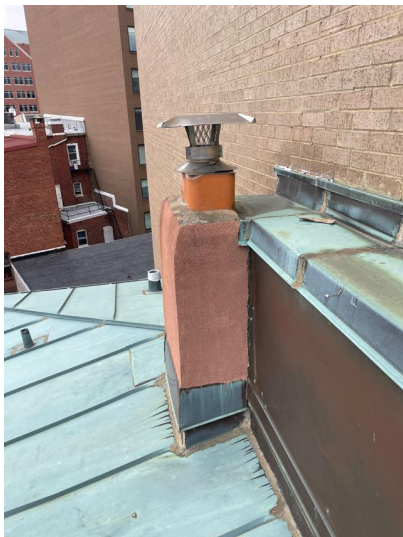
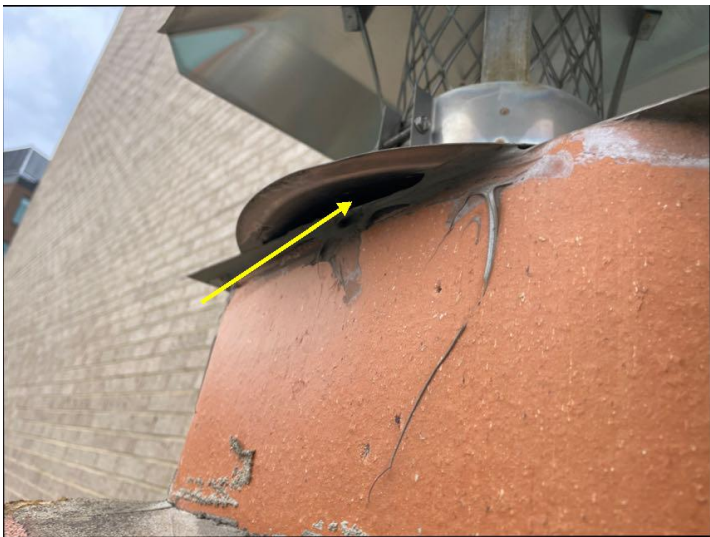
- Furnace flue rain cap did not fit the tile flue. Gaps noted. Recommend review and repair as needed.

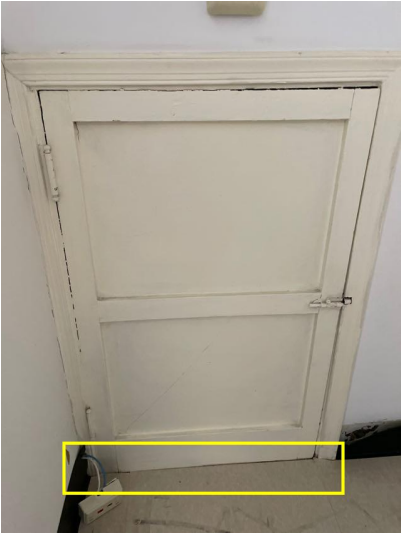
- Flooring was installed in front of the access panel. Unable to open hatch.

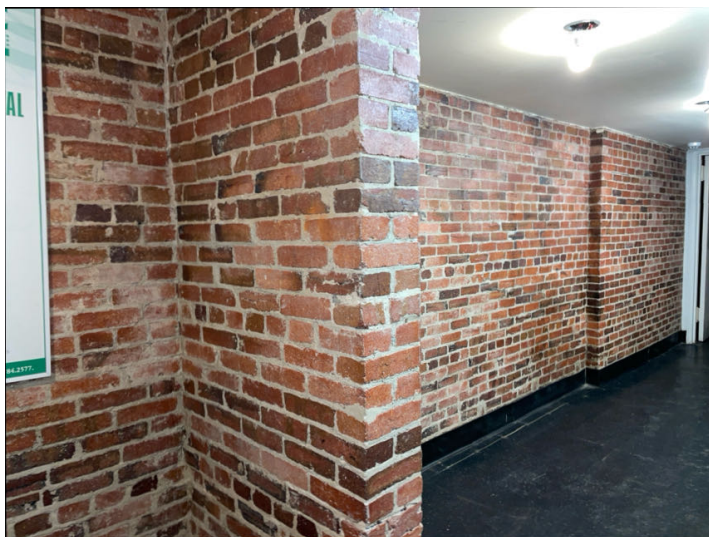
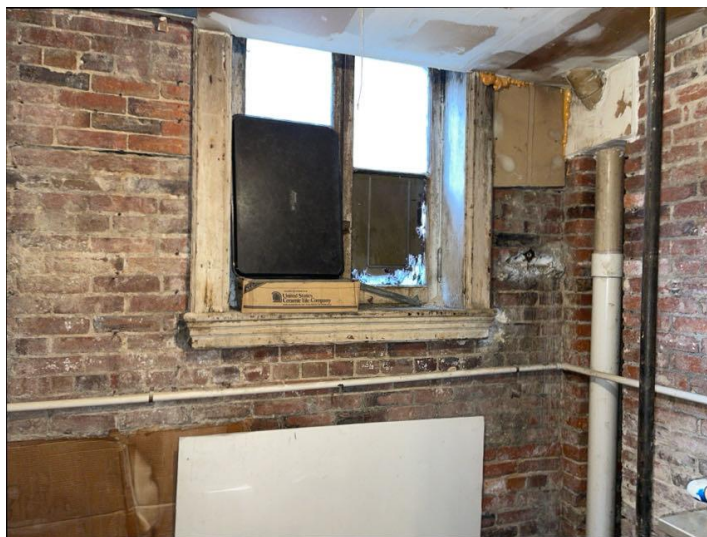
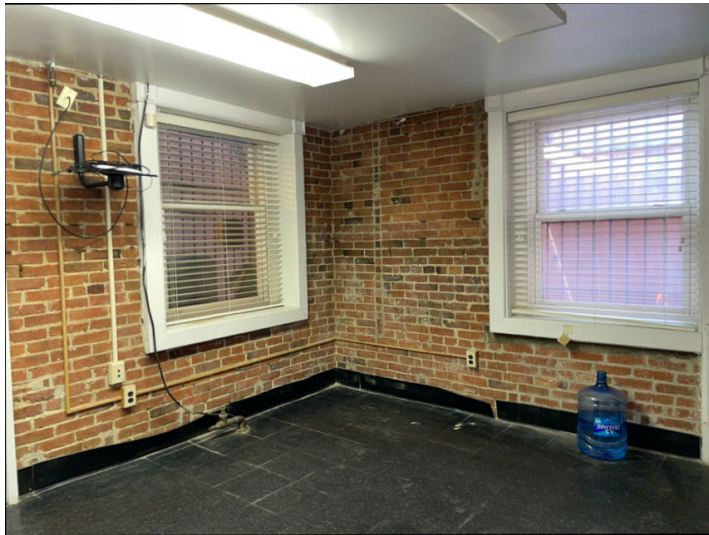
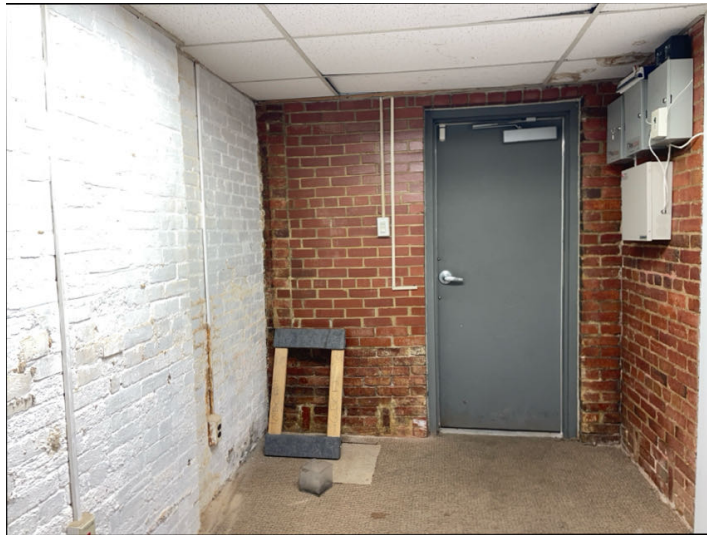
- Brick and mortar walls observed.
- Deteriorated plaster noted in electrical closet. No moisture indicated when tested.
- Efflorescence observed on exterior foundation walls. Moisture indicated when tested on several areas. Recommend further review and repair by a qualified contractor.

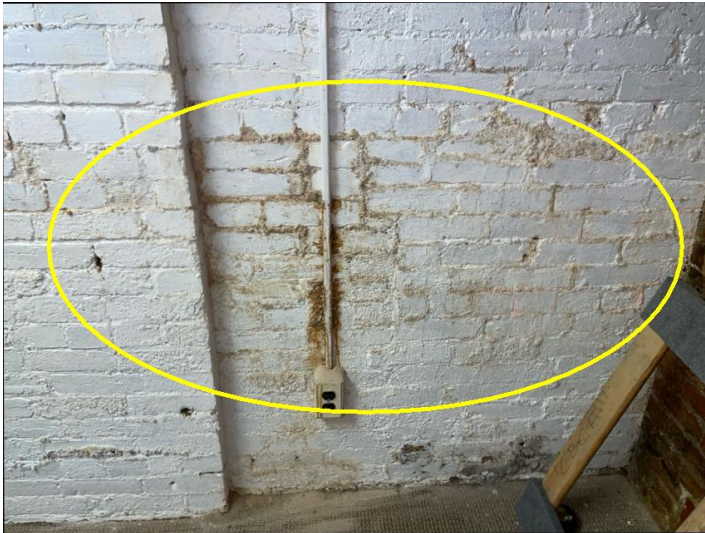
Stains and efflorescence

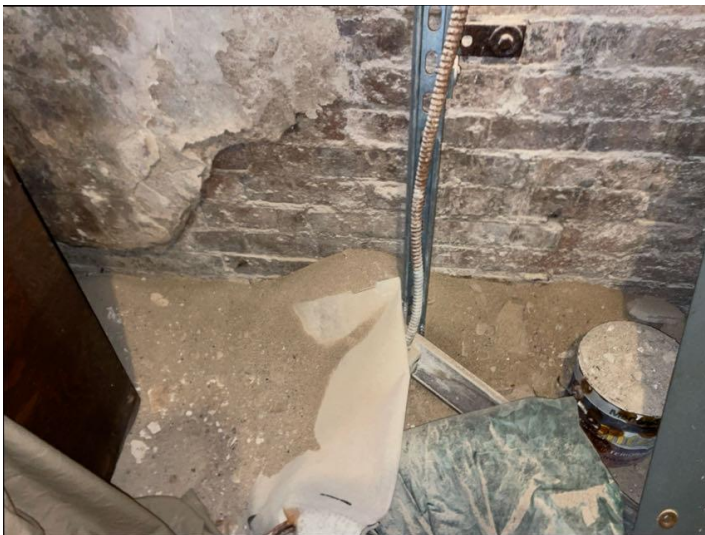
Deteriorated plaster

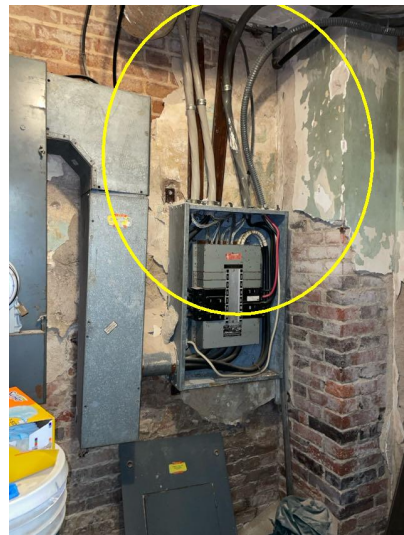
Deteriorated plaster

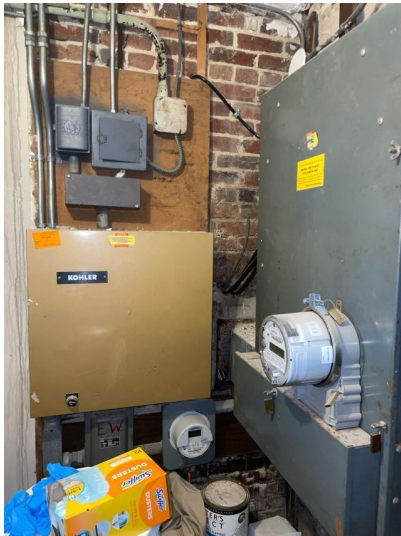
- Fuse box noted. These are not designed to meet modern electrical loads. Recommend updating.

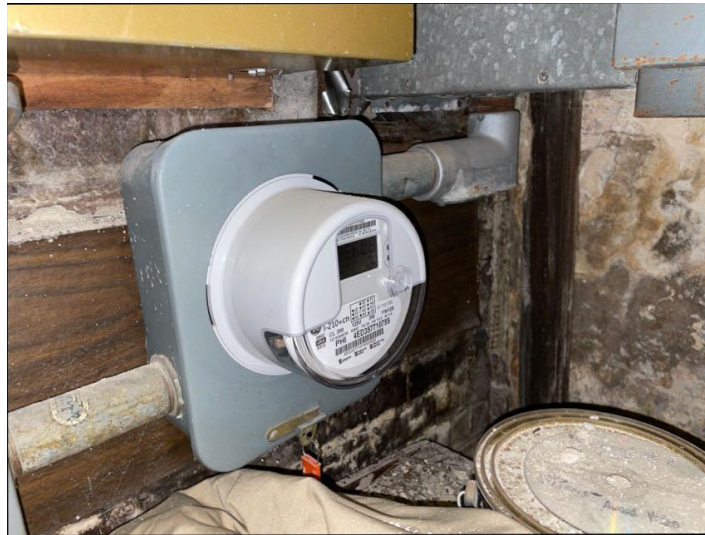
- Meter enclosures appeared in good condition.

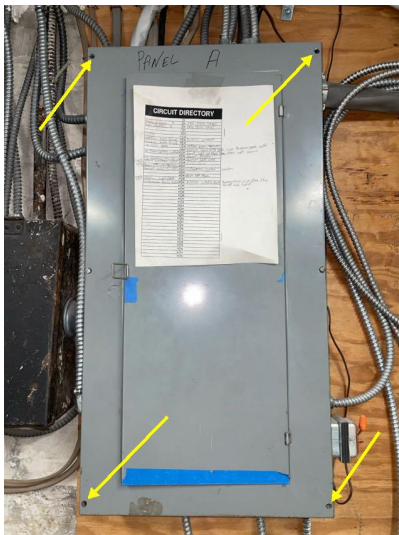
- Sub panels A and B were located in the basement. One sub panel was located on the third floor and one sub panel was located on the fourth floor.
- Panel screws were missing on some panels. Replace screws for safety.

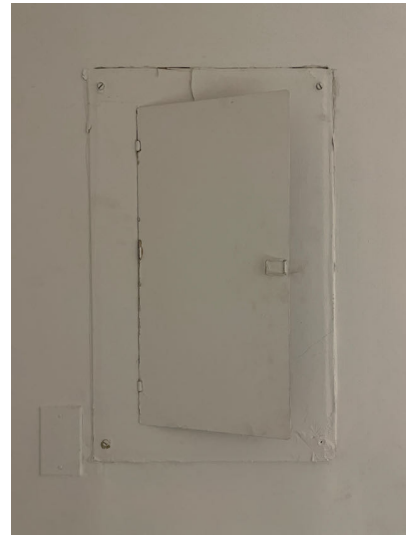
Fourth floor sub panel

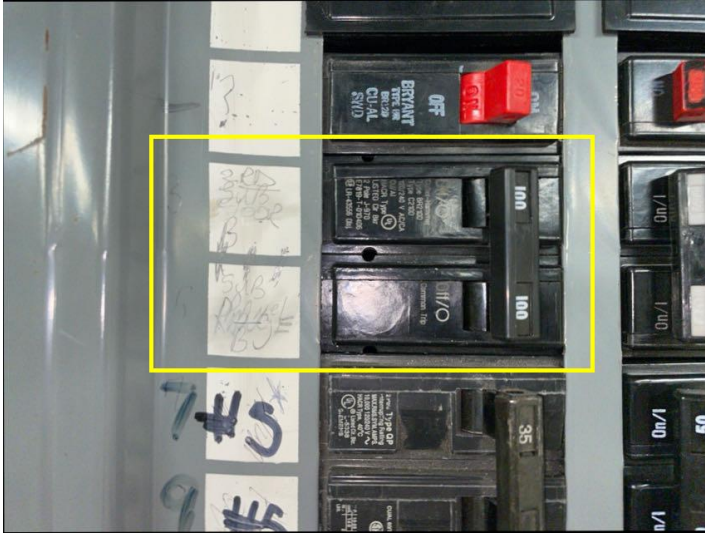
Third floor sub breaker

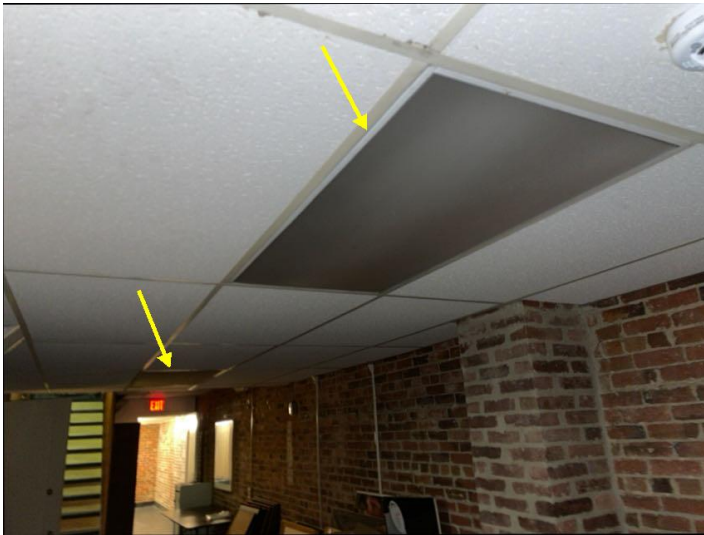
- Several lights on all floors did not work or bulbs were missing. Recommend replacing bulbs and checking for operation. Repair or replace fixtures as needed.
- Light fixtures in the basement and in the third floor mechanicals room were loose. Recommend repair by a licensed electrician.
- Cover plate was missing on the basement light switch. Recommend replacing for safety.

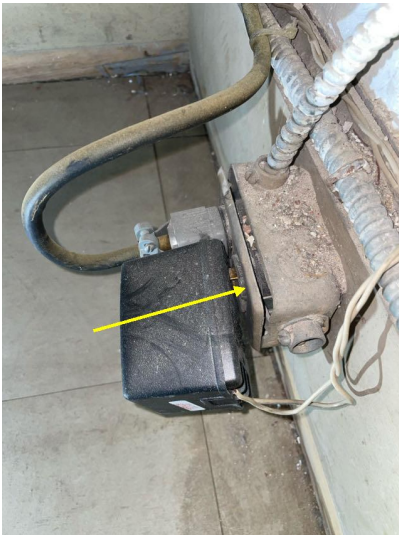
- Loose and missing outlet covers noted in several areas. Recommend replacing covers for safety.
- Outlet on fourth floor was obstructed. Recommend replacing by a licensed electrician.
- Outlet on the third level did not operate. Recommend review and repair by a licensed electrician.
- Open ground noted on outlet on the second level. Recommend repair.
- Wall outlet observed being used as a floor outlet on the first floor. Recommend repair.

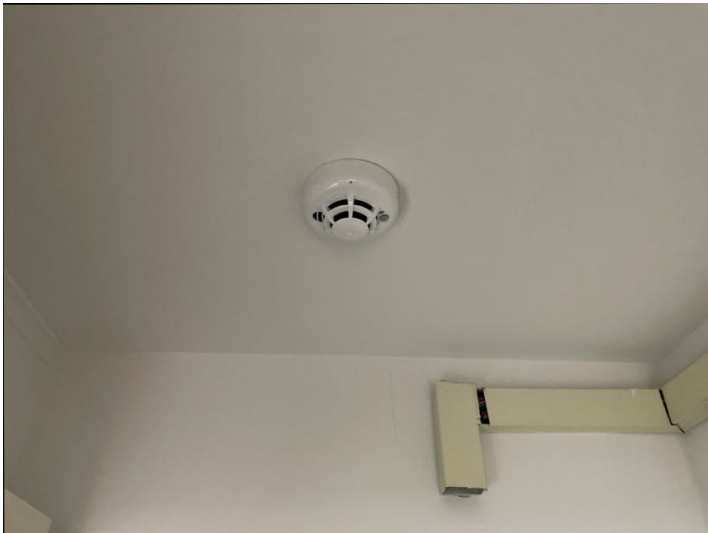
- Smoke detectors were missing on the main level hallway. Recommend installing.

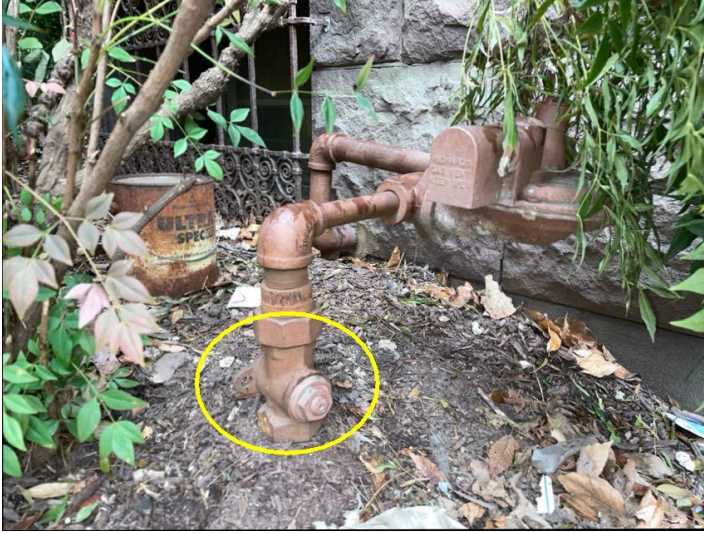
Exterior shut off valve

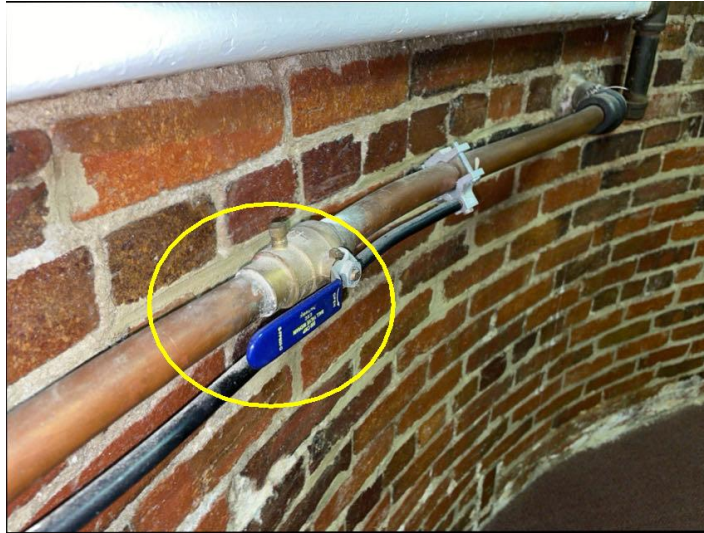
Main water shut off valve

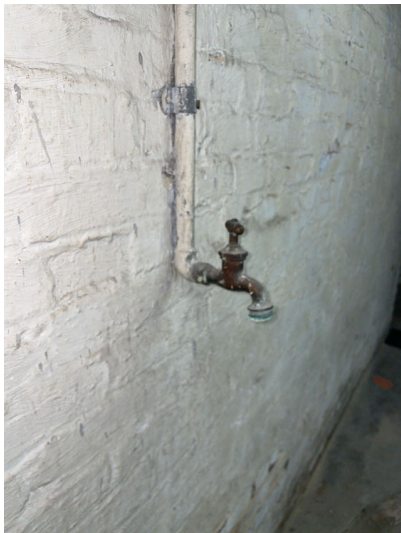
- Corrosion noted on the utilities sink drain. No active leak observed.
- Water spigot in the basement did not work. Repair or replace as needed.
- Utilities sink on the third floor was missing a leg. Repair or replace as needed.

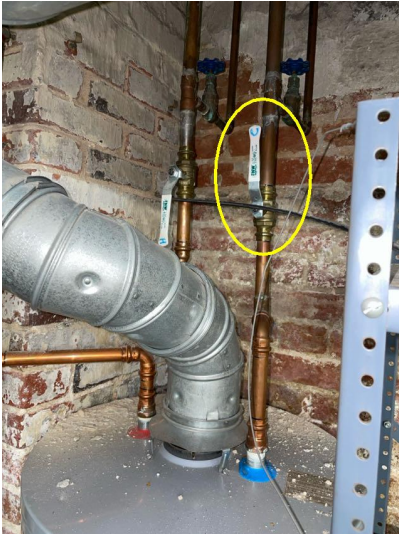
Water shut off valve

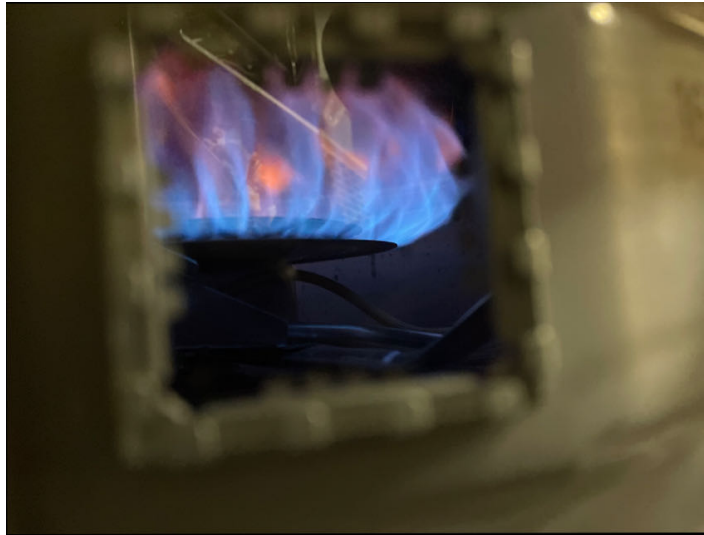
- Orange flames noted. This is an indication of incomplete combustion. Recommend further review and repair by a licensed plumber.

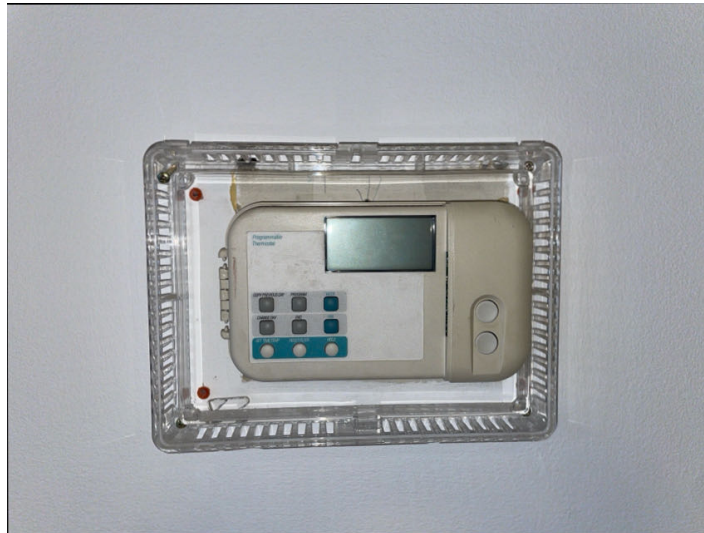
- The thermostat was not functional at the time of inspection. Recommend review and repair as needed by a HVAC contractor.

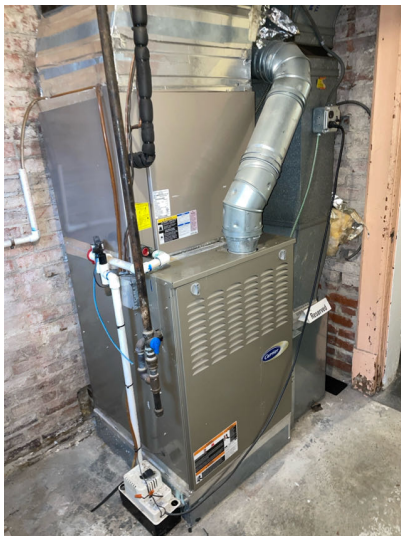
- Unit was located in the basement.
- Date of manufacture was 2010. Life expectancy around 20 years.
- The indoor unit was disconnected at the time of inspection. Recommend further review by a HVAC contractor.

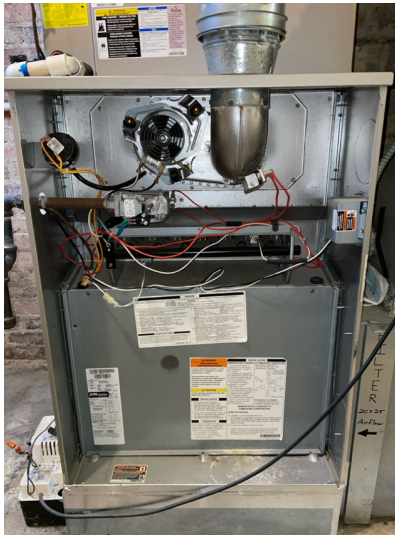
- No deficiencies observed.

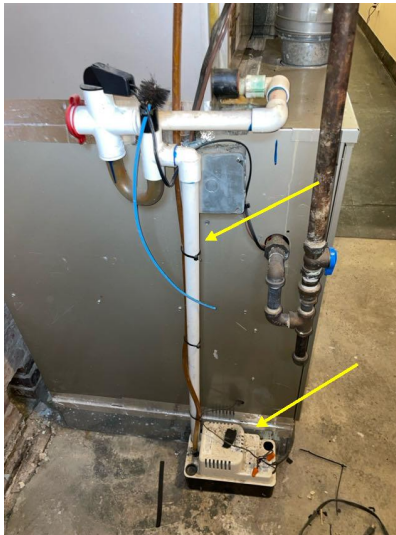
Condensate drain and pump

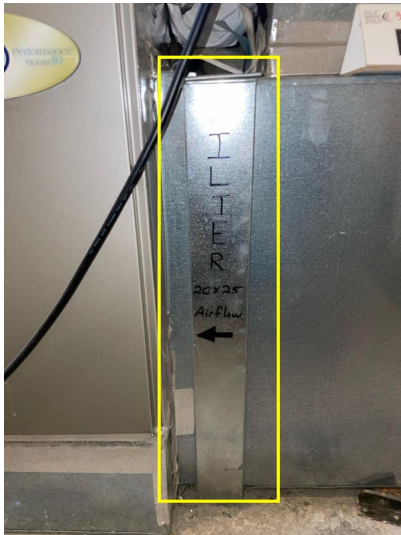
- The filter was dirty. Recommend replacing and inspecting monthly.

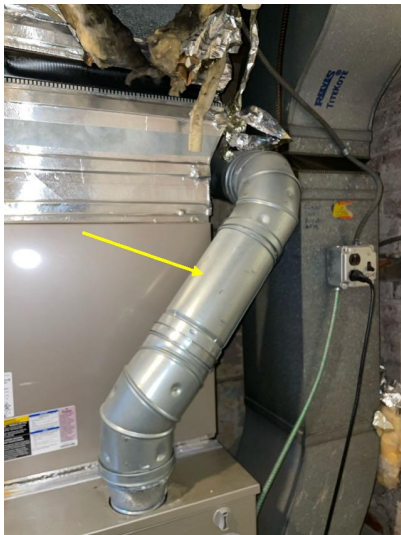
- Venting appeared in good condition.

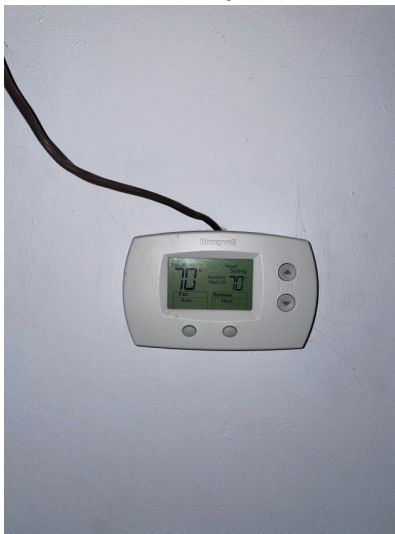
- Functional at the time of inspection.

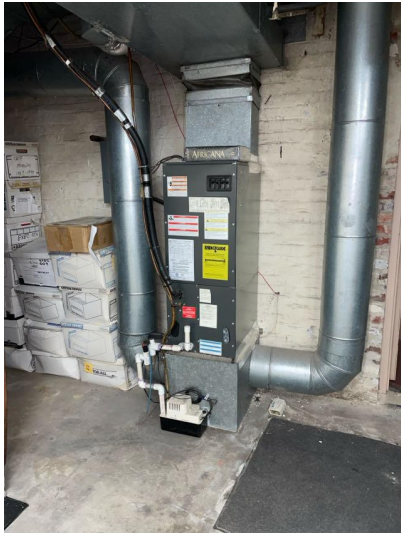
- Unit was located in the basement and served basement level.
- Date of manufacture was 2009. Life expectancy around 20 years.
- Unit operated properly using normal controls.
- Last service date was unknown. Recommend servicing by a HVAC contractor.

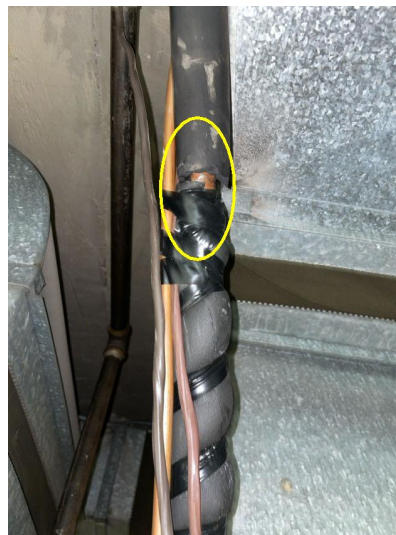
- Gaps noted in the refrigerate line insulation at the indoor unit. Recommend repair.

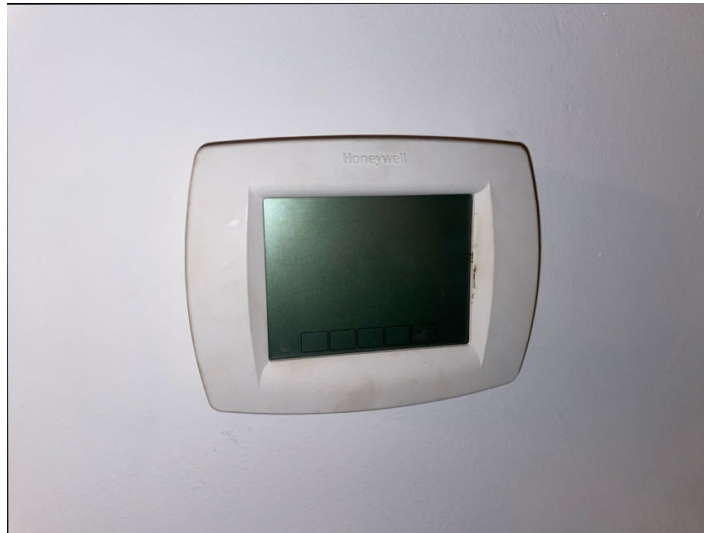
- Thermostat was not functioning at the time of inspection. Recommend review and repair as needed by a HVAC contractor.

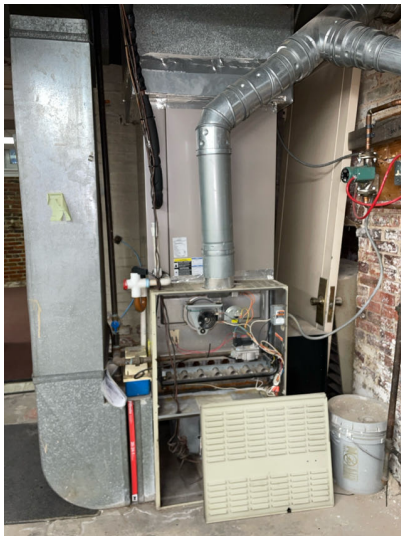
- Unit was located in the basement.
- Date of manufacture was 2000. Life expectancy around 20 years.
- The furnace was beyond its life expectancy. Consider replacing.
- The unit was not operated at the request of the seller. Recommend review and repair or replace as needed by a HVAC contractor.

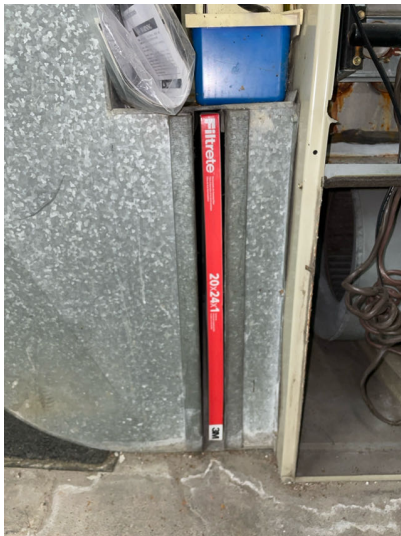
- Filter door was missing. Recommend installing to prevent debris from entering HVAC unit.
- The filter was dirty. Recommend replacing and inspecting monthly.

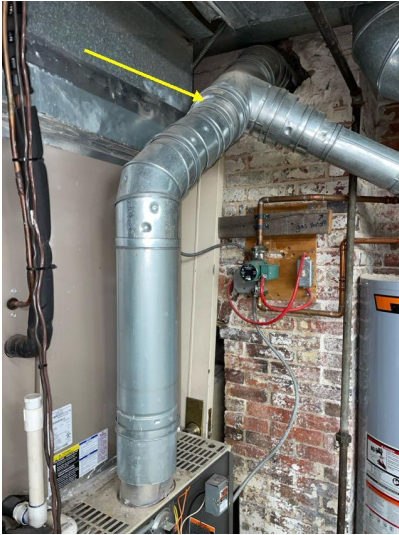
- The vent pipe was not sealed at the chimney penetration. Recommend repair.

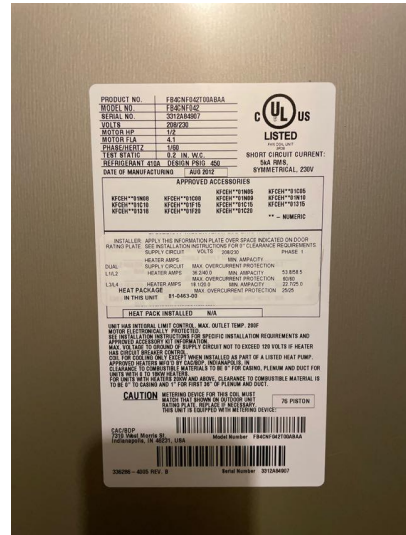
- Unit was located on the third floor.
- Date of manufacture was 2012. Life expectancy around 20 years.
- Furnace operated properly using normal controls.
- Last service date was unknown. Recommend servicing by a HVAC contractor.
