Next Day Inspect

Commercial Inspection Report

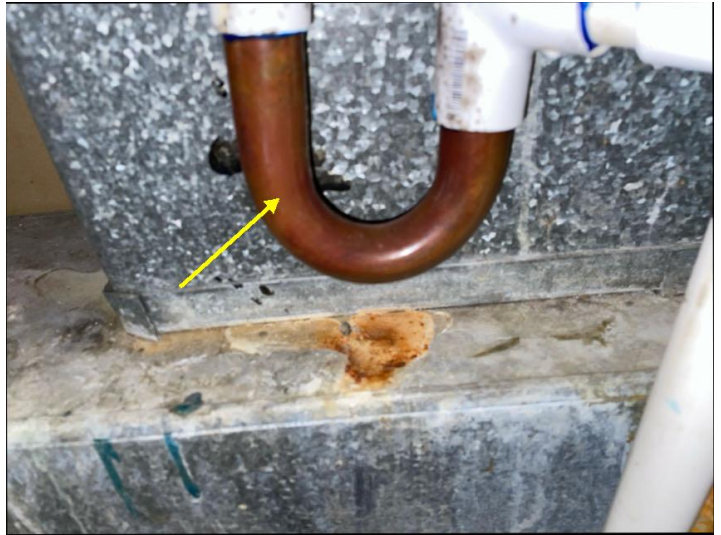
- Condensate drain appeared dirty. Recommend service by a HVAC contractor.

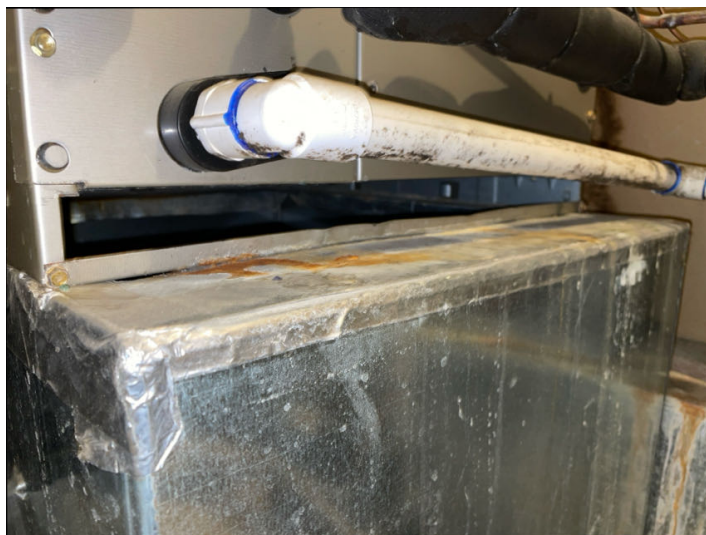
Cover and filter missing

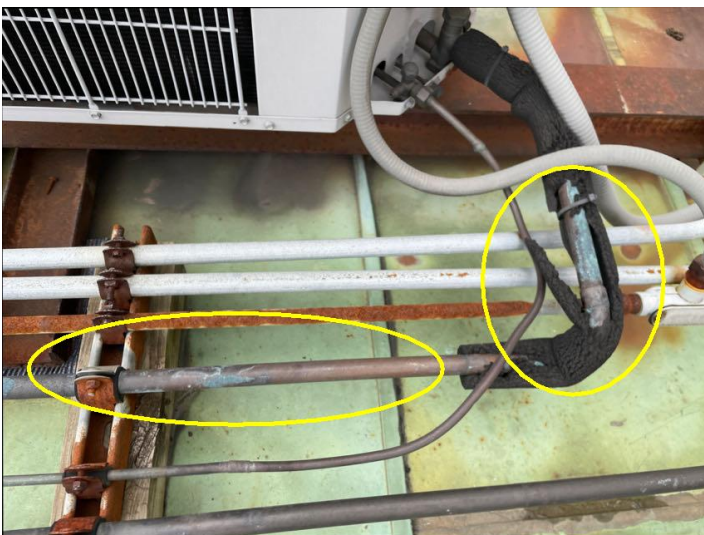
Deteriorated insulation

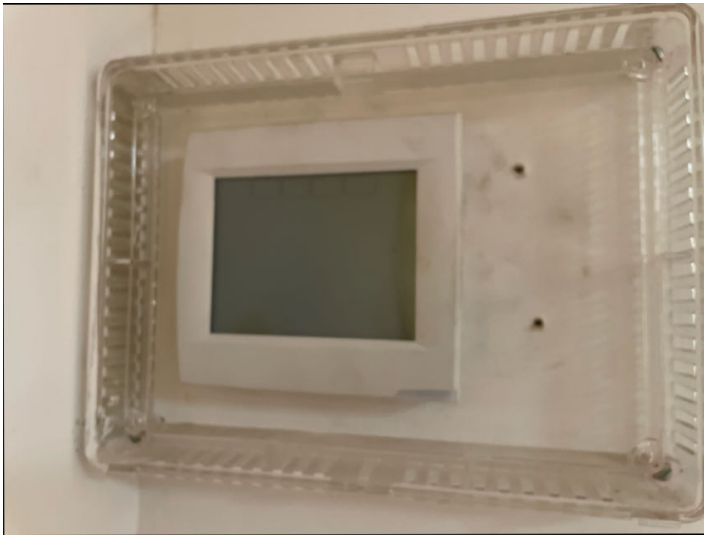
- The thermostat did not operate properly at the time of inspection. Possible low battery. Recommend review and repair as needed.

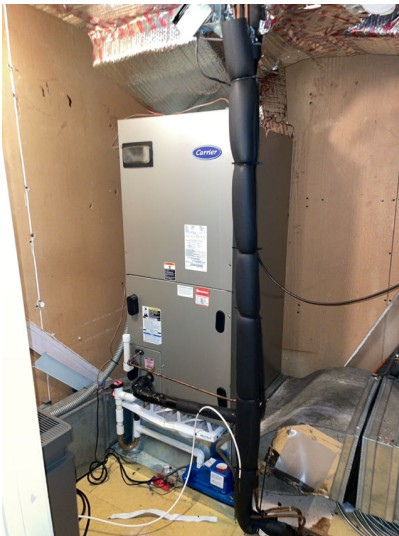
- Unit was located on the fourth floor.
- Date of manufacture was 2013. Life expectancy around 20 years.
- Unable to operate unit due to inoperable thermostat.
- Last service date was unknown. Recommend servicing by a HVAC contractor.

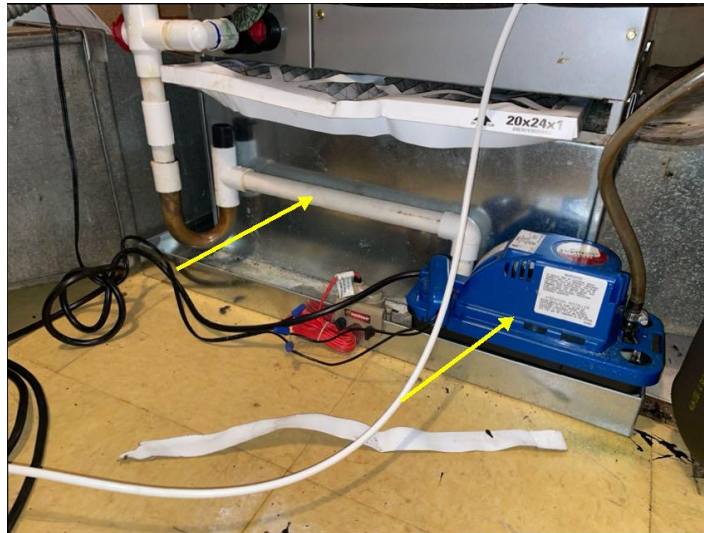
Condensate drain and pump

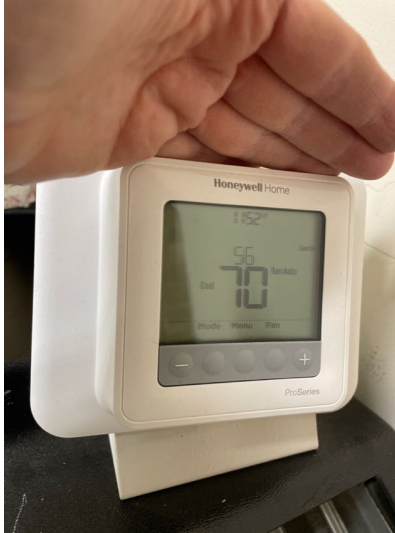
- Functional at the time of inspection.

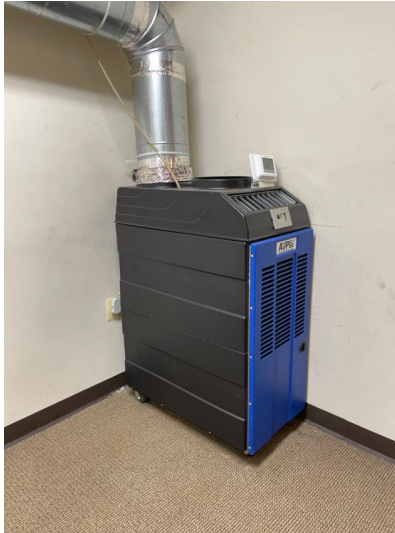
- Portable AC unit noted in server closet.
- Unit required water for cooling. Not operated due to empty container.

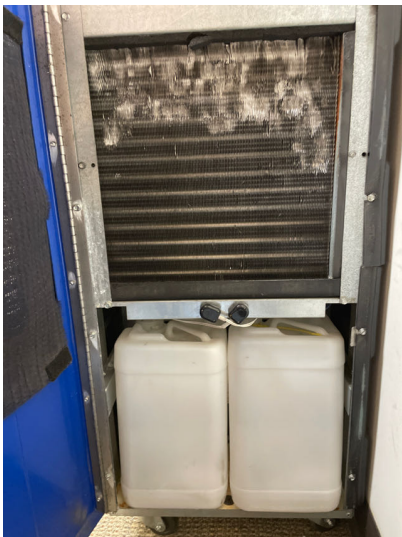
- Damaged fins noted. Recommend service by a qualified contractor.

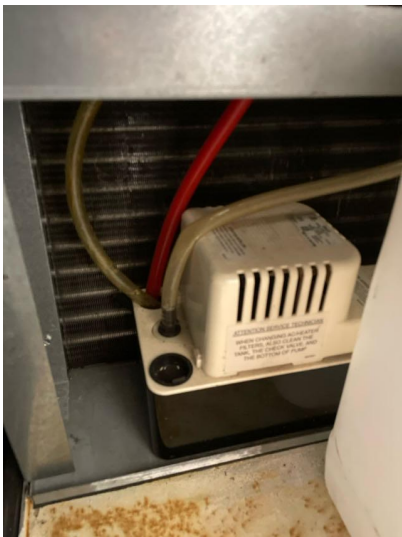
Condensate drain pump

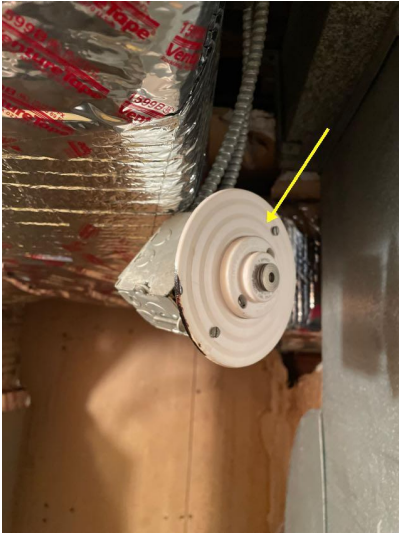
Unsecured heat detector

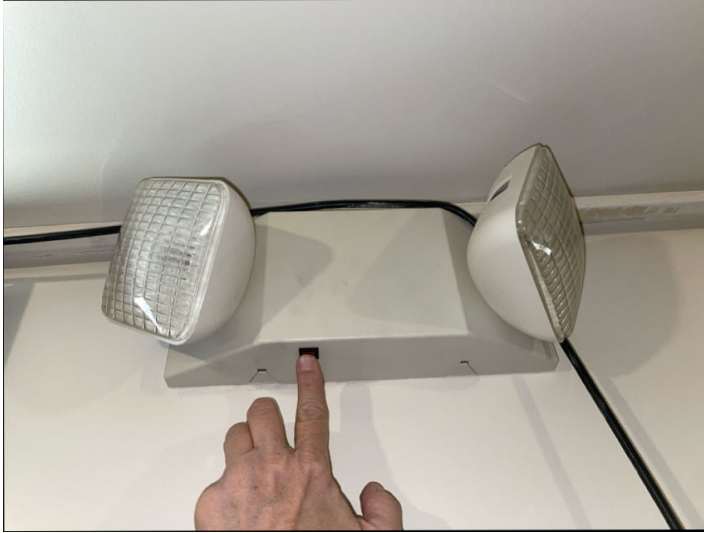
- Emergency lights were broken or inoperable. Recommend repair.
- The exit sign lighting turned off when testing the frog lights on the combination units. Recommend repair.

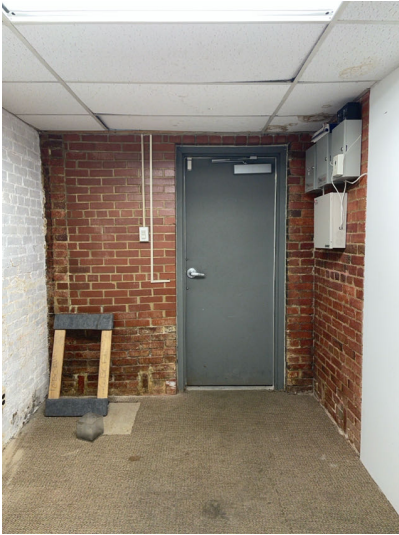
Sign missing - basement

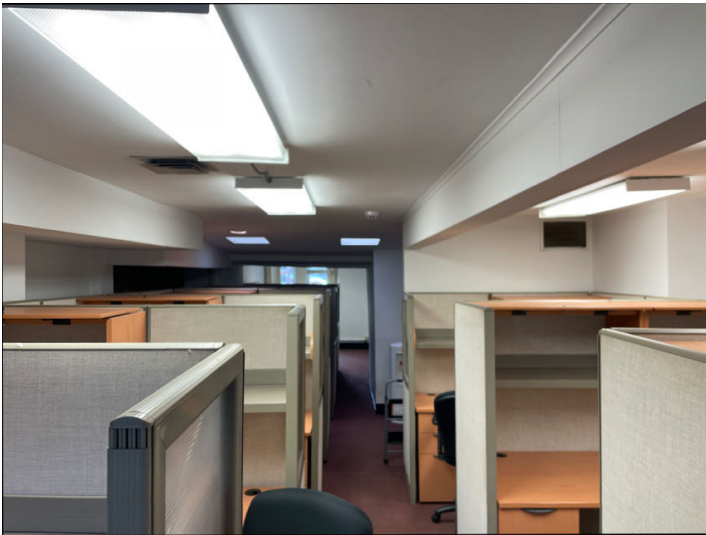
Signs missing - 4th floor

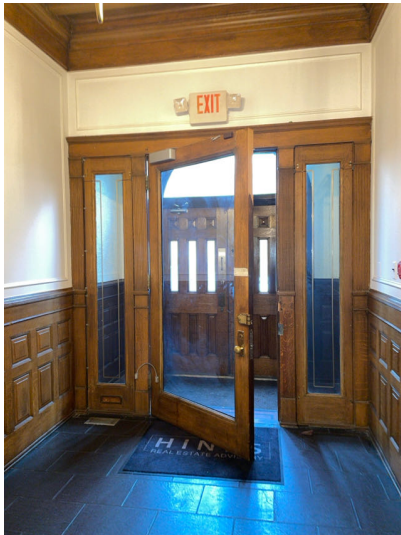
- At least 2 exit doors to exterior observed.
- Main level exit sign at back of building did not illuminate. Recommend repair.
- Basement level back exit sign was hidden by open door to room. Recommend relocating sign.
- Front basement level egress door auto-closure was broken. Recommend repair.

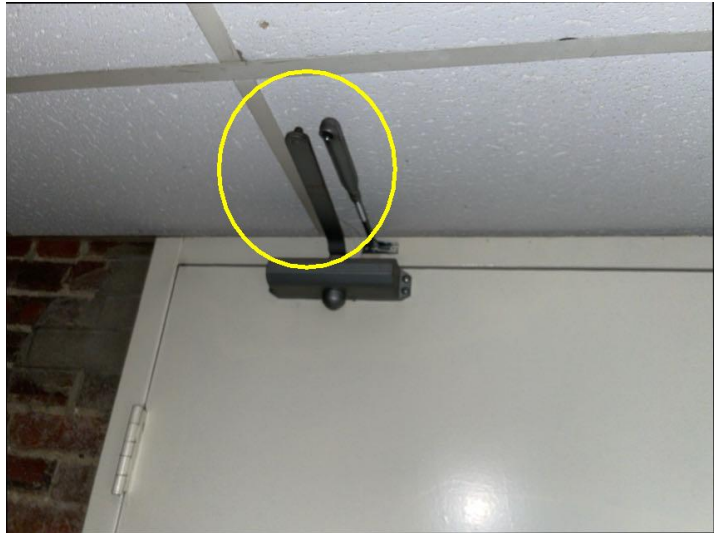
Broken auto-closure device

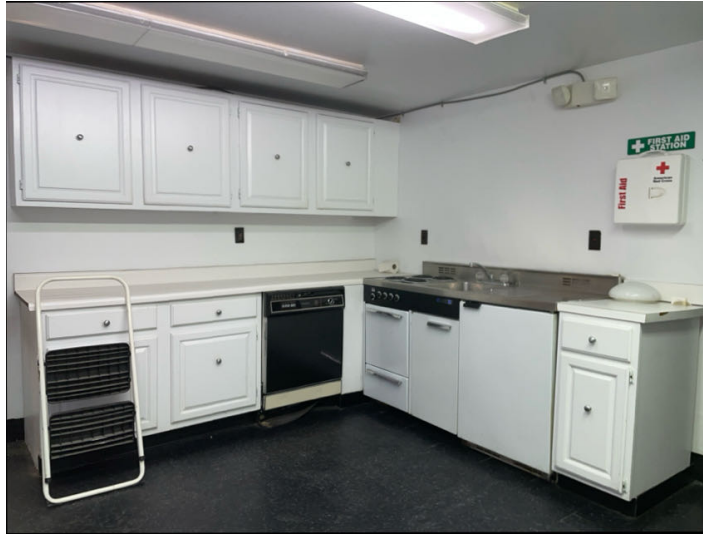
- Acceptable condition. Some repairs recommended.
- Appliances were old and did not function.

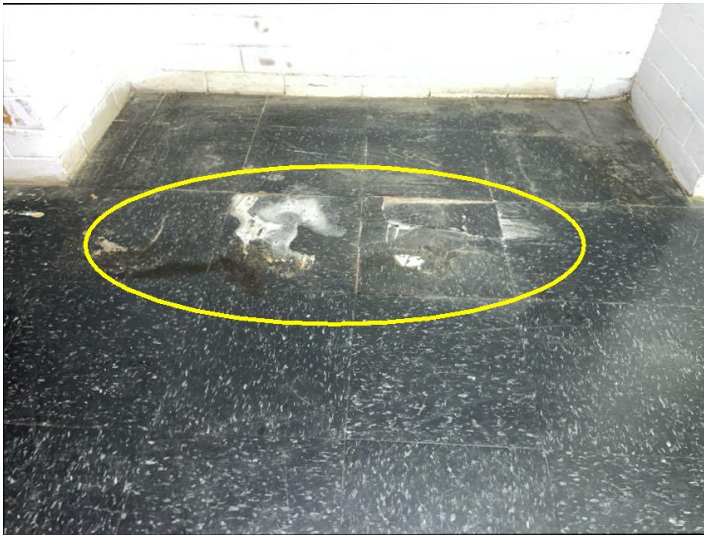
Efflorescence / loose tiles

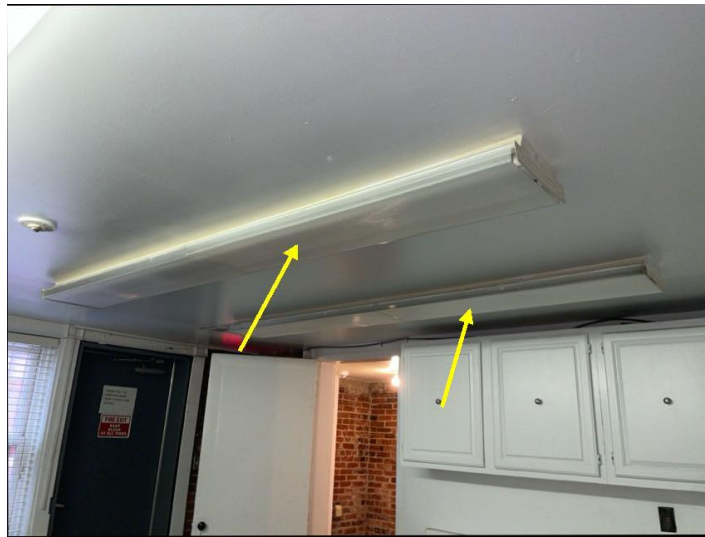
- Several lights did not work at the time of inspection. Replace bulbs and check for operation. Repair or replace fixtures as needed.

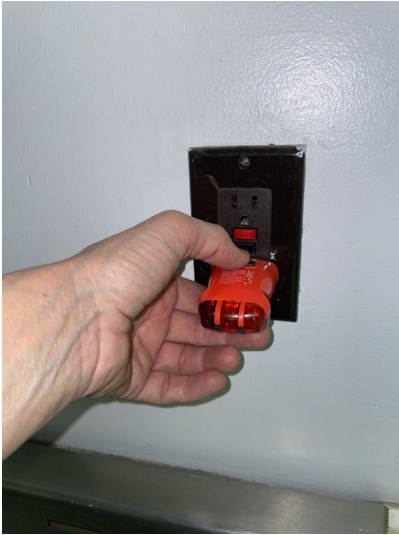
- **GFCI** outlets were installed and operational.
- Open electrical boxes observed under kitchen sink. Recommend repair.

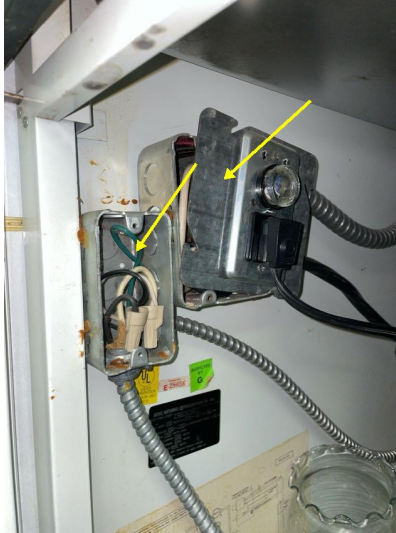
Loose / missing cover plates

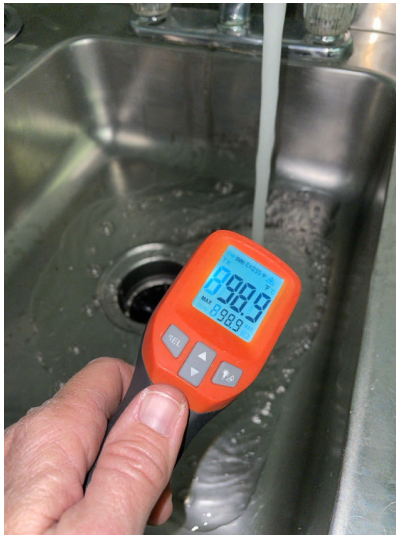
- Kitchen sink was operational with no major defects noted.
- Garbage disposal functioned properly.

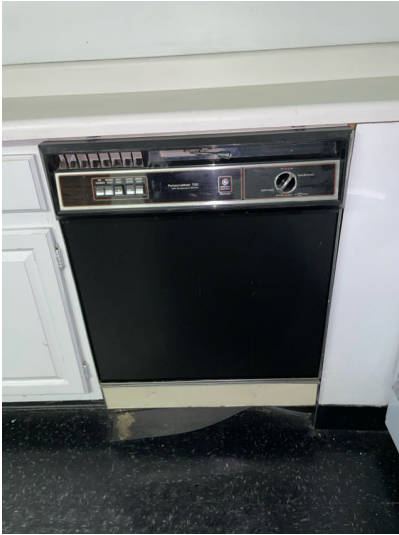
- Dishwasher made irregular noise when started. Old unit noted. Recommend repair or replace as needed.
- Dishwasher drain hose was missing the high loop to prevent backflow. Recommend repair.

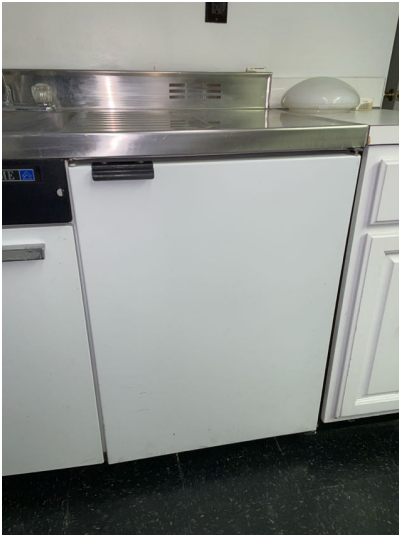
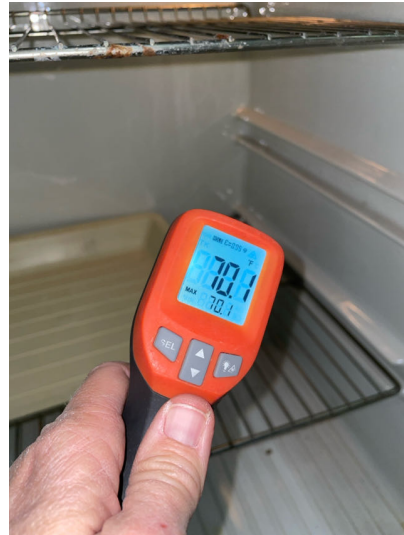
- Refrigerator was warm at the time of inspection. Repair or replace as needed.

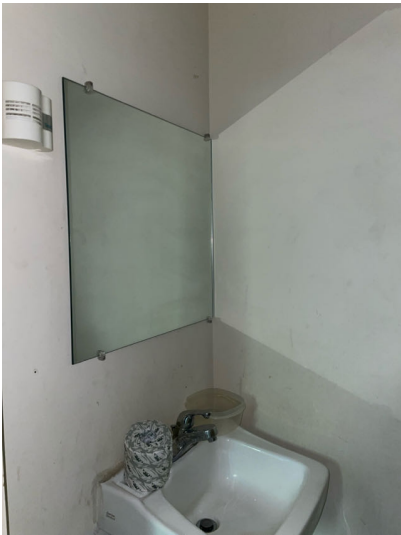
- Acceptable. Some repairs required.

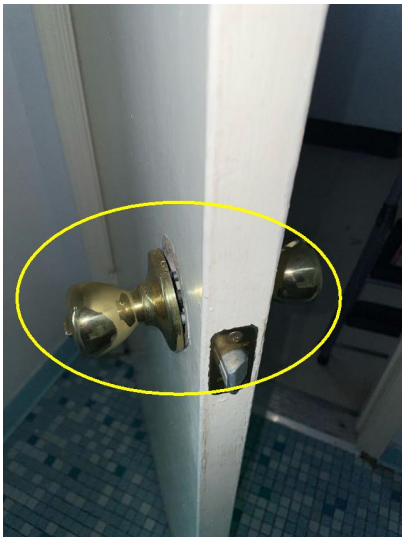
- Fourth floor bathroom door knob was loose. Recommend repair.

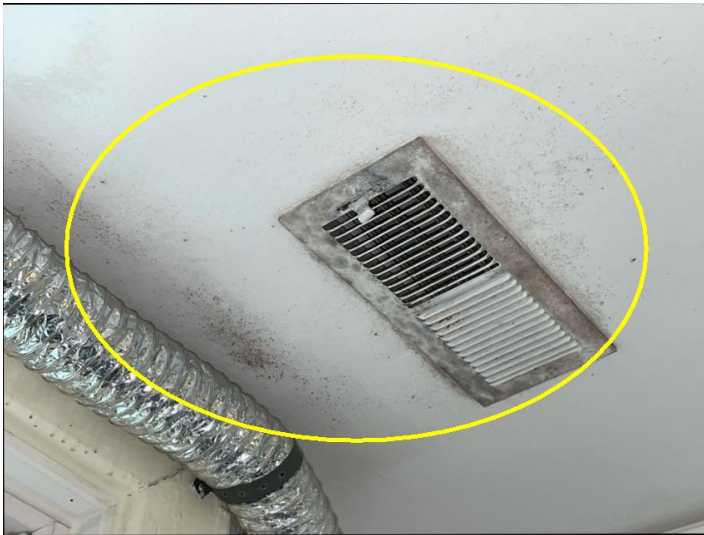
- Mold-like stains noted on fourth floor bathroom ceiling. Area tested dry.
- Stains and holes noted on the main floor bathroom ceiling. Area tested dry. Recommend repair.

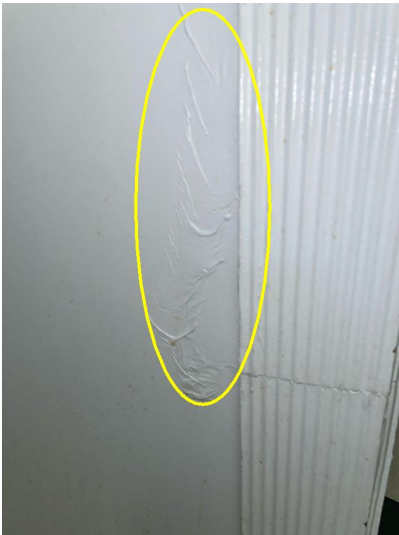
- Peeling paint noted on the second floor bathroom wall. Area tested dry. Recommend repair.
- Peeling wall paper noted on the main level bathroom wall. Recommend repair.

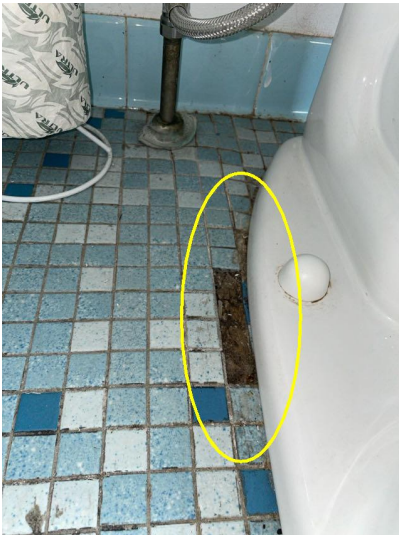
- Missing tiles noted on the fourth floor bathroom floor. Sub floor appeared uneven. Recommend review and repair as needed.
- Lifted vinyl tiles noted on the third floor bathroom floor. Recommend repair or replace as needed.

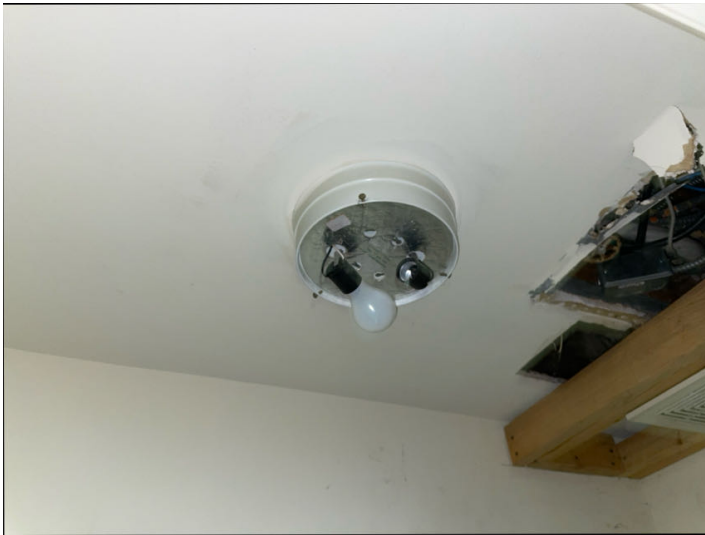
- Bulbs were missing or did not work at several fixtures. Replace bulbs and check for operation. Repair or replace fixtures as needed.
- Electric baseboard heaters on the second and third floors did not work. Repair or replace as needed.

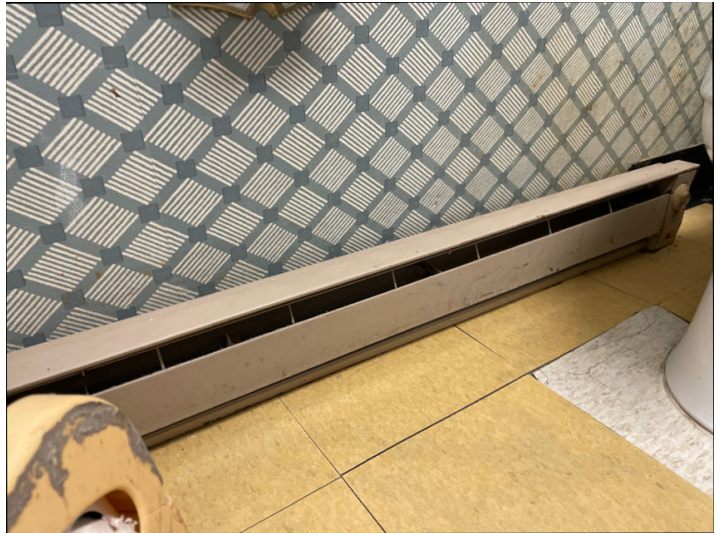
Baseboard heater - third floor

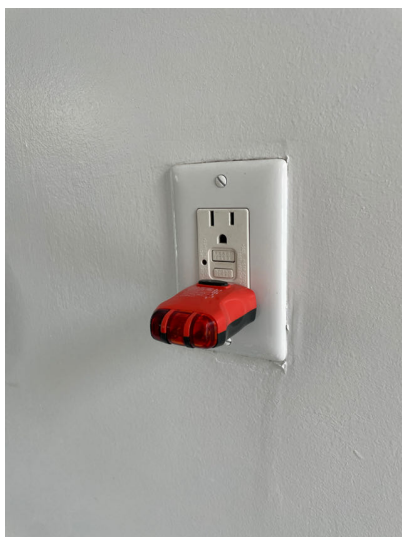
Light off - no power

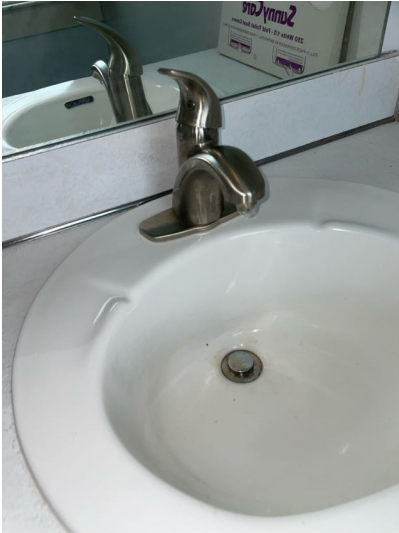
- Water was shut off at basement sink.
- Sink on the main floor bathroom was cracked. No leak observed.
- Water did not get hot at sinks. Recommend review water heater temperature setting.

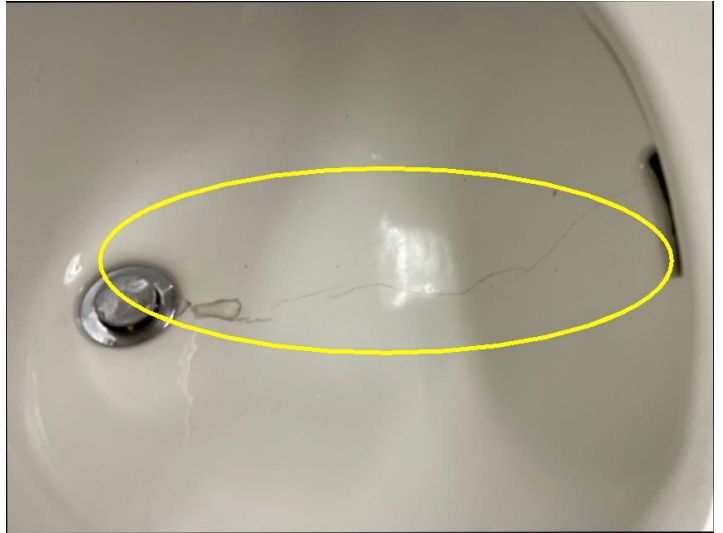
Cracked sink - main level

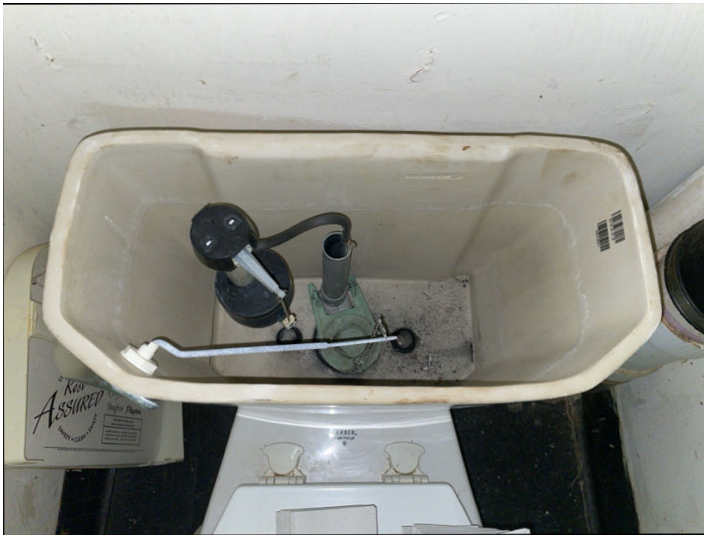
- Lower level toilet tank was empty. Unable to operate.
- Fourth floor toilet tank did not completely fill. Review and repair as needed.

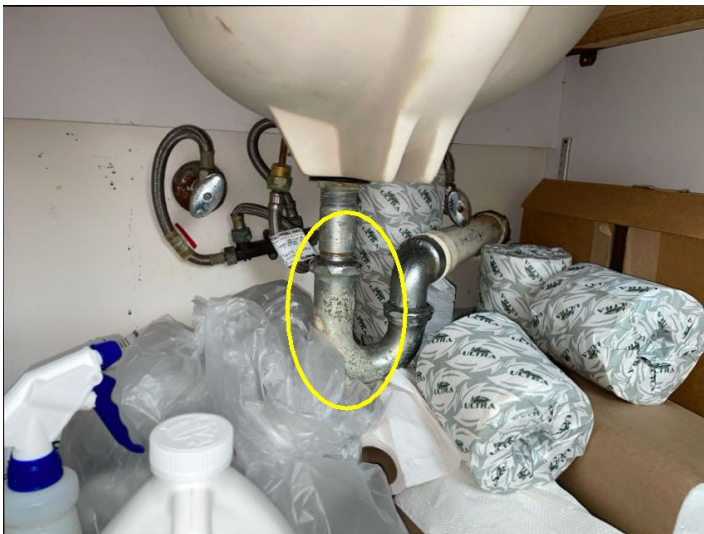
- Corrosion noted on galvanized pipes. No active leaks observed.
- Supply shut off valve was missing on the third floor toilet. Recommend repair.

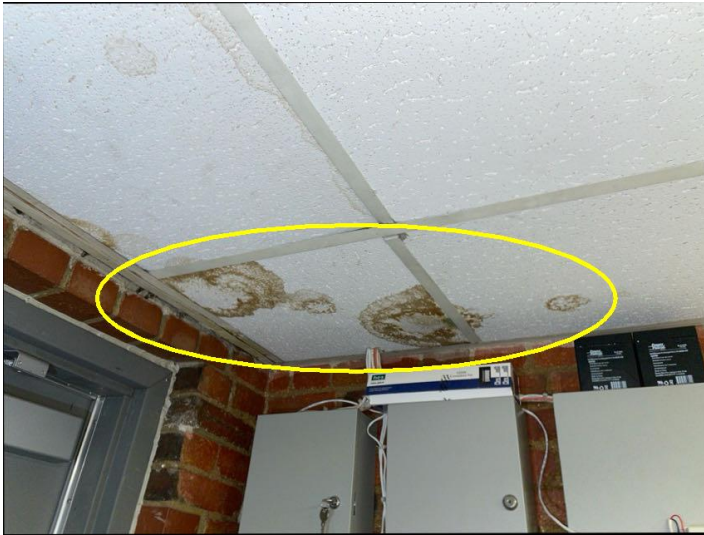
- Several ceiling tiles in the basement were stained. AC refrigerant line noted above tiles. No active leak noted at the time of the inspection. Recommend review refrigerant line for defects and replacing tiles.
- Loose ceiling tiles noted in the basement. Secure or replace as needed.
- Peeling wallpaper noted on fourth floor. Areas tested dry. Repair or replace wallpaper as needed.
- Stains noted on the fourth floor ceiling. Areas tested dry. Paint or repair as needed.
- Cracked and peeling drywall tape noted in several areas on third floor. Recommend repair.
- Peeling paint and cracks noted in several areas. Recommend repair.

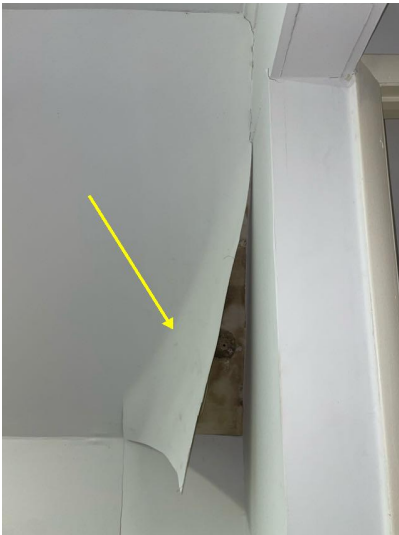
Peeling wall paper - fourth level

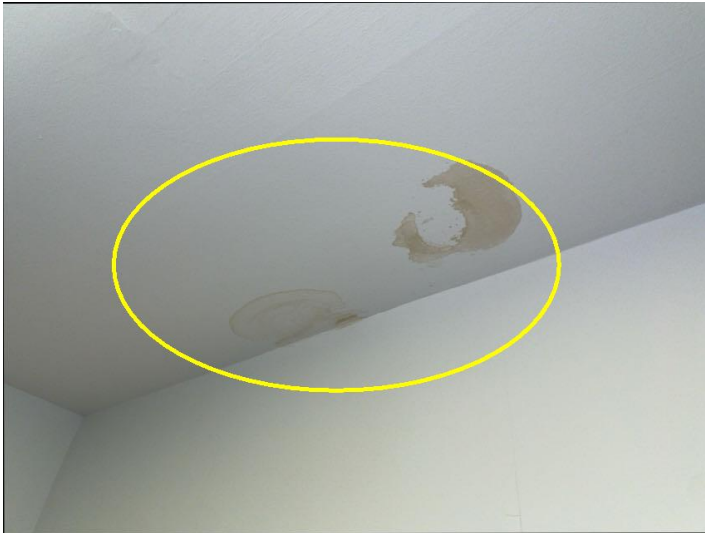
Stains - fourth floor

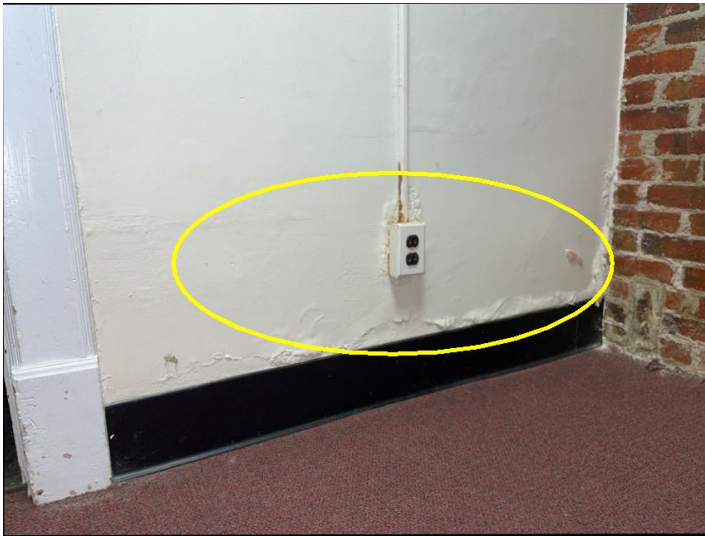
- Mold-like stains noted on the fourth floor walls. Areas tested dry.
- Efflorescence noted on interior basement wall. Moisture indicated when tested. Recommend review and repair as needed.
- Cracks and peeling paint noted in several areas. Recommend repair.

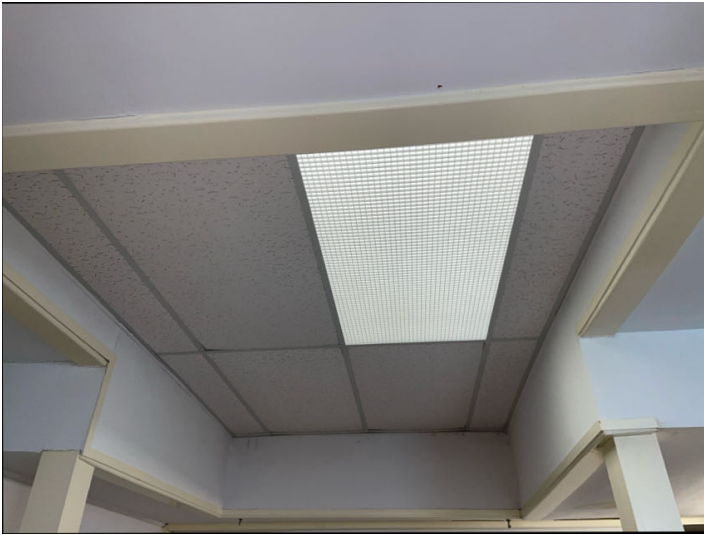
- Large skylight on fourth floor was covered. Unable to inspect.
- Mold-like stains noted around small skylights. Areas tested dry.
- Plexiglass observed on the interior of the curved windows. Unable to operate.
- Peeling paint and deteriorated caulk noted on all windows. Paint or seal as needed.
- Several windows did not open when tested. Review and repair as needed.

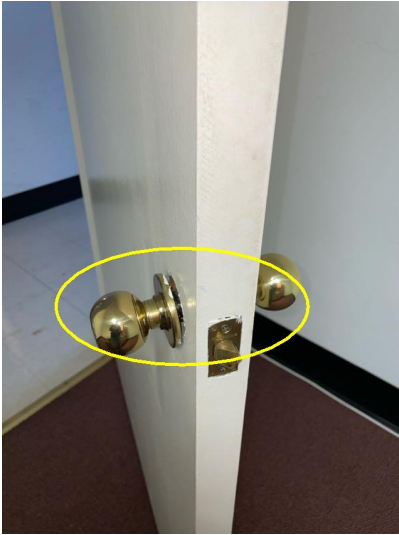
- Door was not accessible due to furniture placement. Unable to access closet or room.
- Several door knobs were loose. Recommend repair.
- Metal doors with weatherstripping dragged across the flooring. Recommend adjust or repair as needed.
- One or more doors were misaligned and did not latch. Adjust or repair as needed.

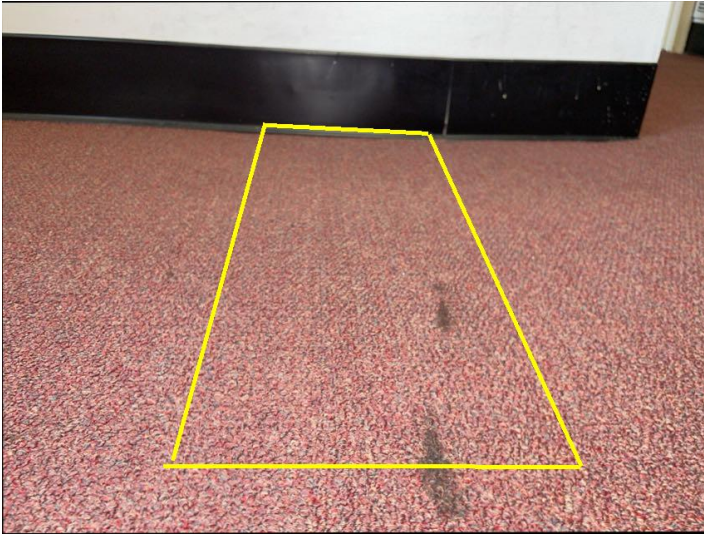
- Fourth floor sub floor was not level. Recommend review and repair as needed.
- Damage noted on the hardwood in several areas. Recommend repair or replace affected areas as needed.

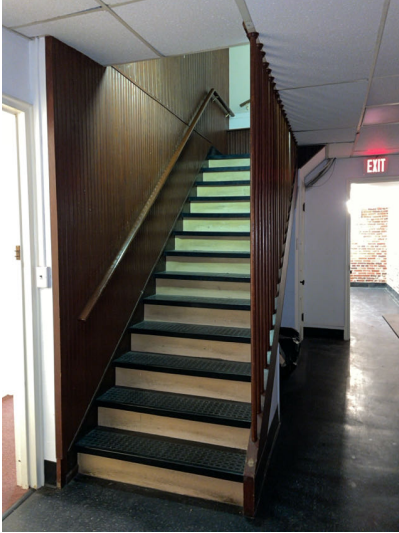
- Loose spindles noted at basement level stairs. Recommend repair.
- Hand and guardrail heights did not meet current standard of 34" - 38".

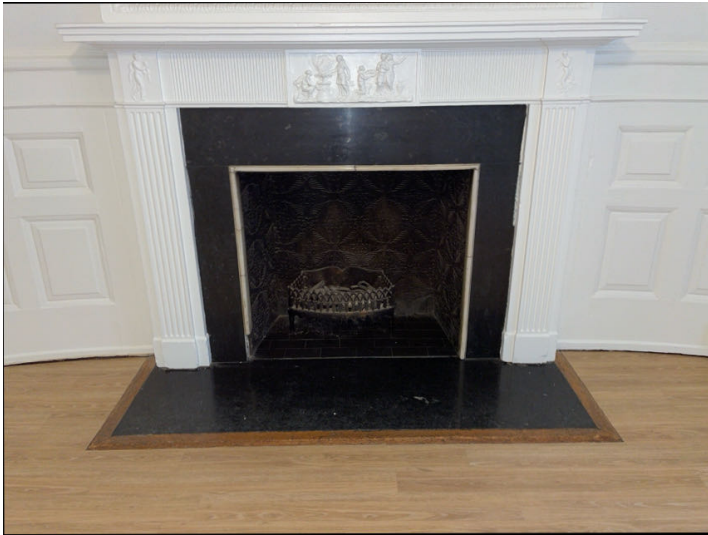
Location: Main floor • Second floor
Observations:
• Some repairs needed.
