INSPECTION REPORT

18218 Rolling Meadow Way #45, Olney, MD 20832

Date of Inspection: 1/15/2022 Time: 9:00 AM

Age of Home: 1987 Size: 1192

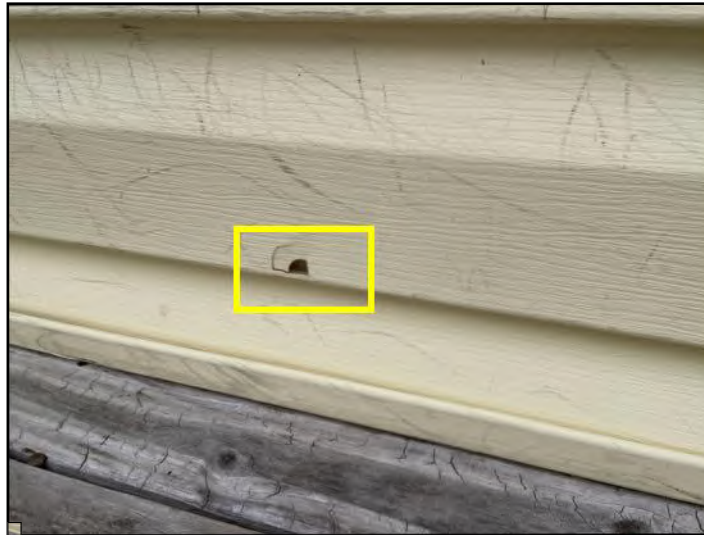
2. Cladding Condition

- Vinyl siding damage observed. Recommend repair or replacement of damaged section to keep moisture and insect intrusion.

Hole

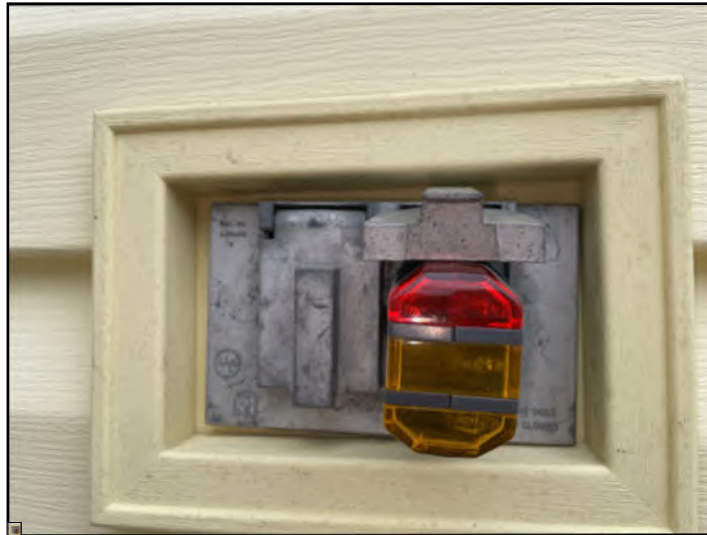
- Exterior outlet was not operational. Recommend repair or replace by a licensed electrician.

No power

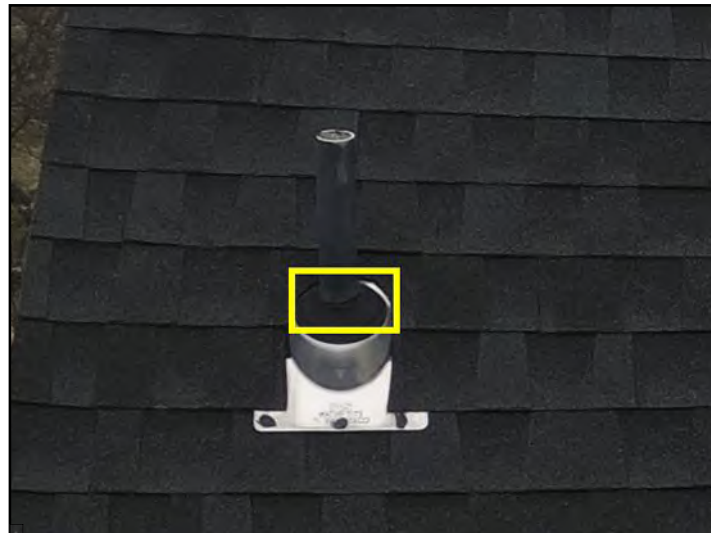
2. Vent Stack

- Deteriorated vent stack collar observed. Recommend repair or replace as needed.

Deteriorated collar

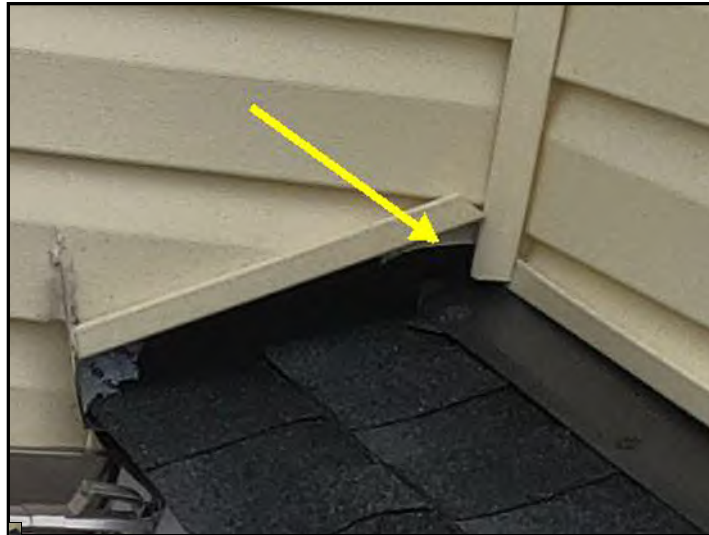
3. Flashing

- Sidewall flashing appeared to be installed incorrectly. Recommend review and repair by a qualified contractor or roofing specialist.

Not under siding

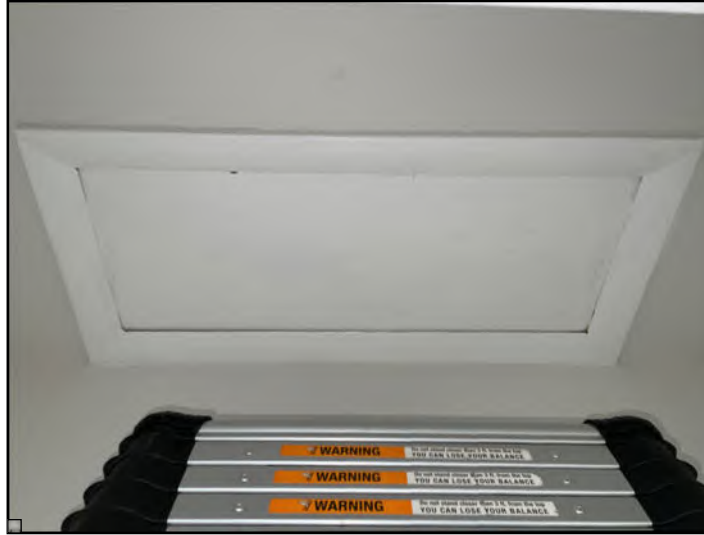
1. Access

- Bedroom closet.
- Attic access was difficult to reach due to shelving placement. Hatches must be readily accessible. Recommend exploring ways to create unobstructed access.

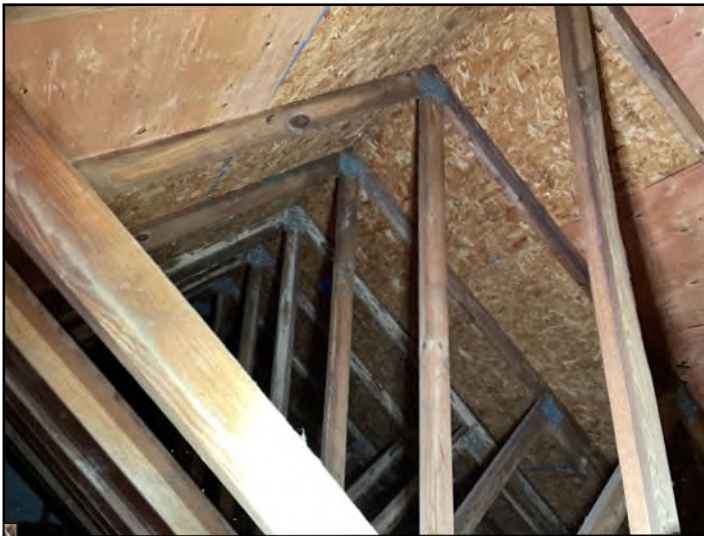
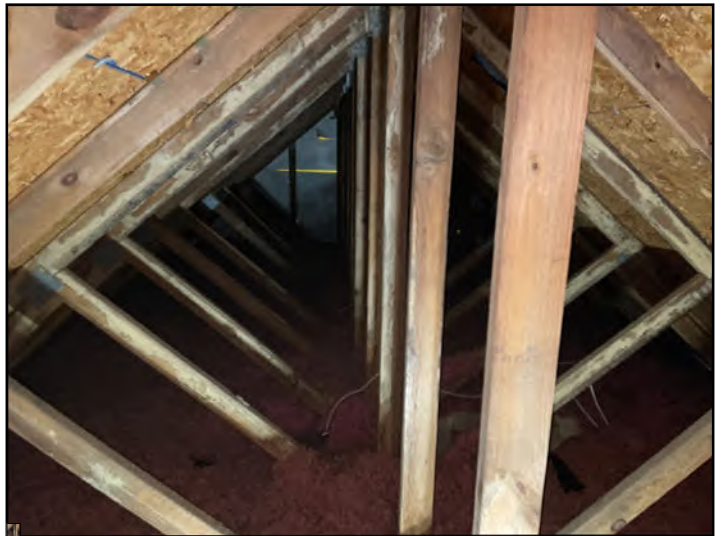
2. Structure

- Large holes and/or gaps in firewall observed. Recommend repair for safety.

Gaps in firewall

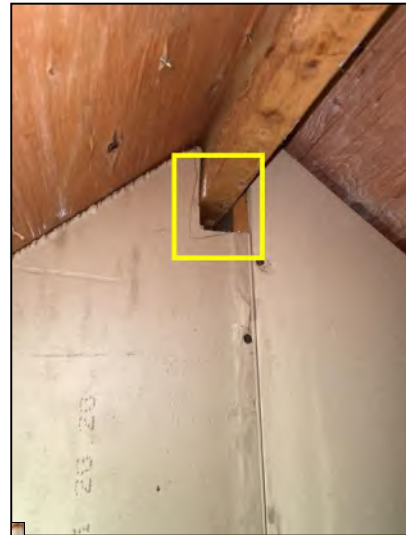
Gap in firewall

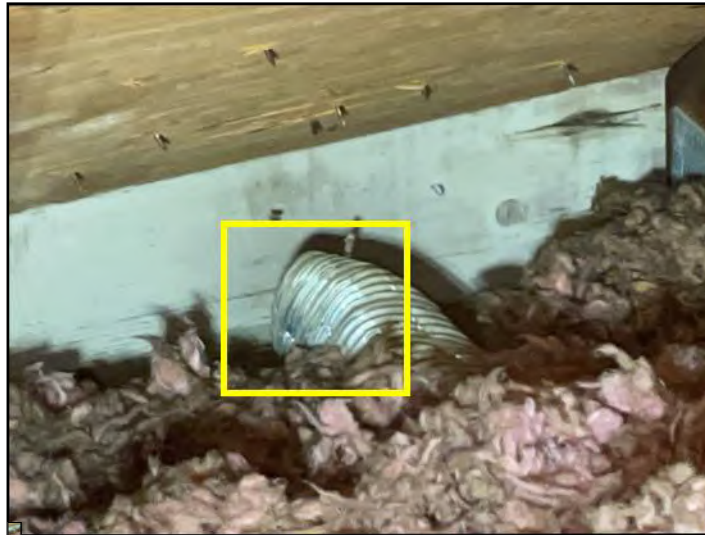
- Exhaust fan duct appeared to be terminating in attic. Have duct routed to exterior to minimize moisture and possible development of mold.

Not exterior vented

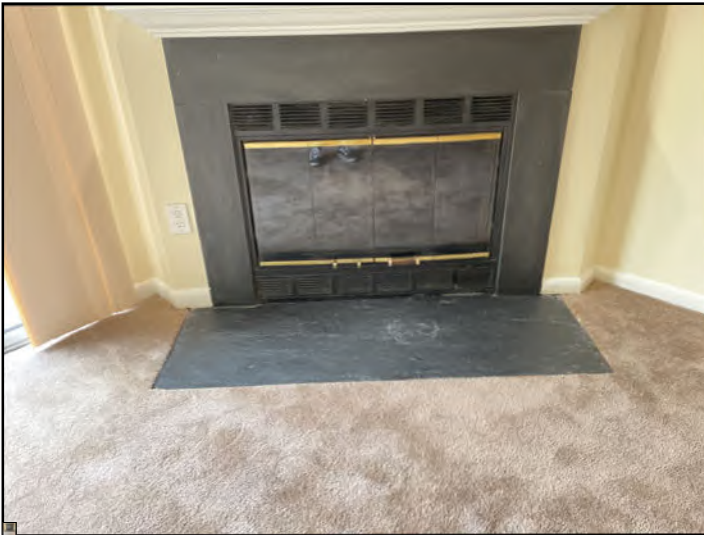
- Level II inspection—The National Fire Protection Association (www.nfpa.org) advises that each chimney receive a Level II inspection each time a residence is sold. Inspection levels are explained at www.csia.org/pressroom/press-inspection-levels-explained.htm. It is also advised that this inspection be conducted by a chimney sweep certified by the Chimney Safety Institute of America (www.csia.org).
- The flue was dirty; soot buildup noted. Recommend clean and sweep the chimney by a certified professional.

Damper closed

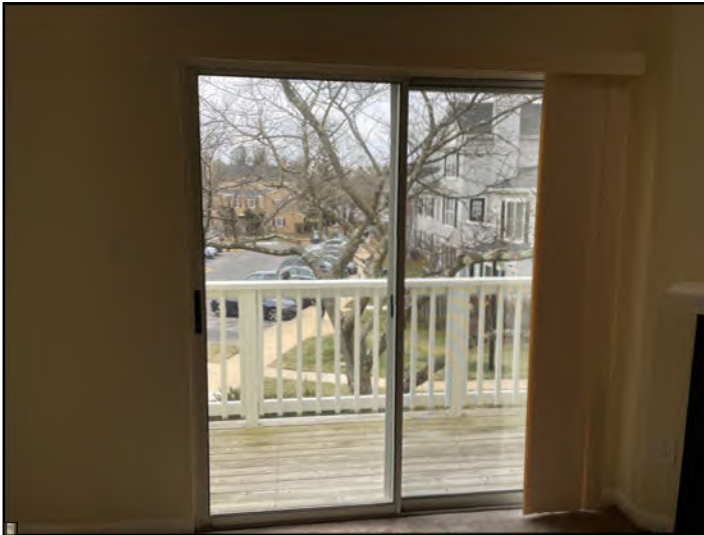
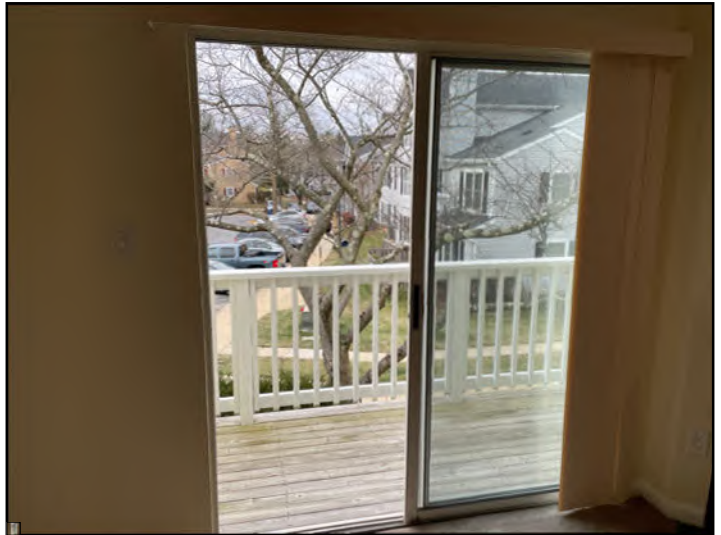
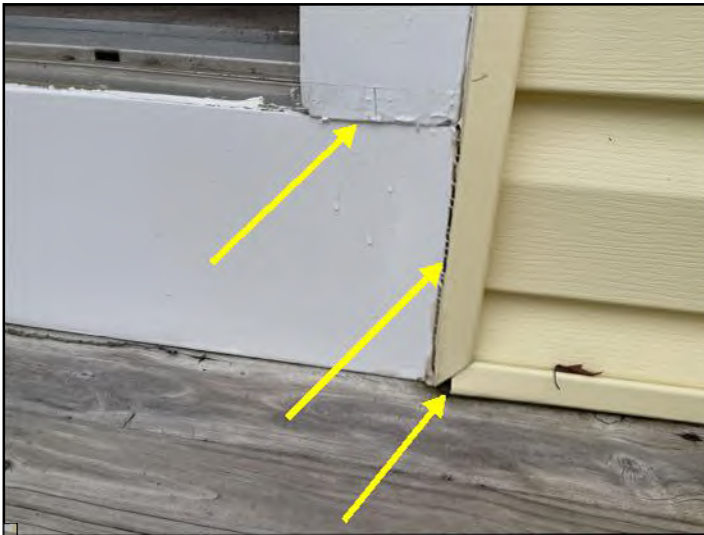
- Gaps and cracks noted around the door frame. Recommend caulk or seal as needed.

Gaps

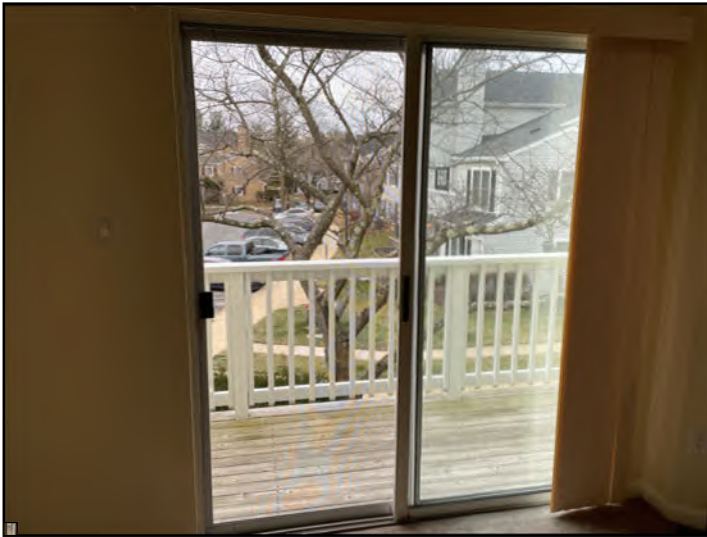
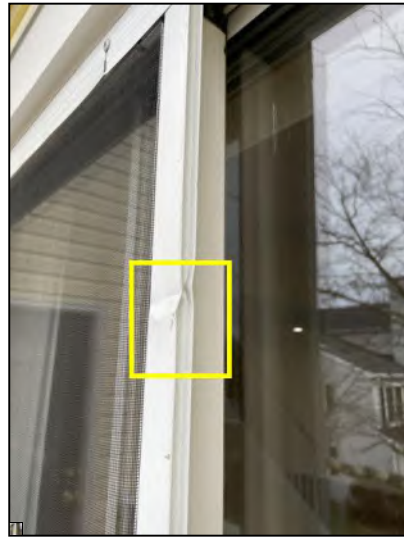
- Sliding screen door was bent but still functional. Repair or replace as needed.

Dented

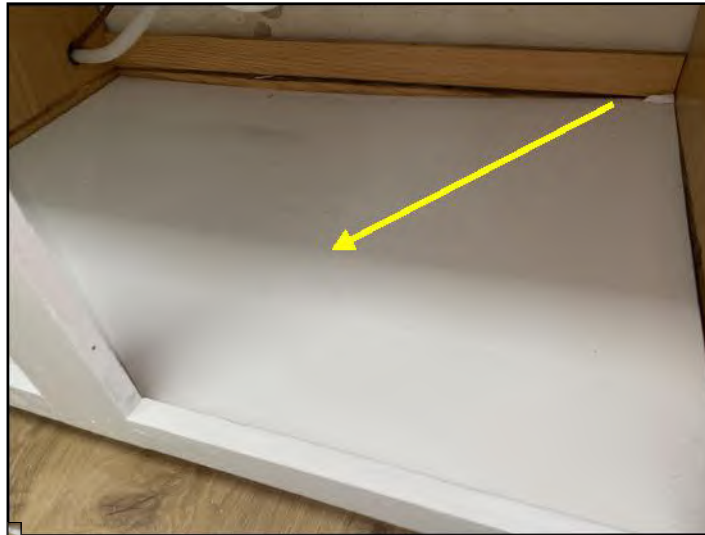
- Warped cabinet base noted under sink. No moisture indicated on moisture meter. Recommend repair or replace as needed.

Warped base

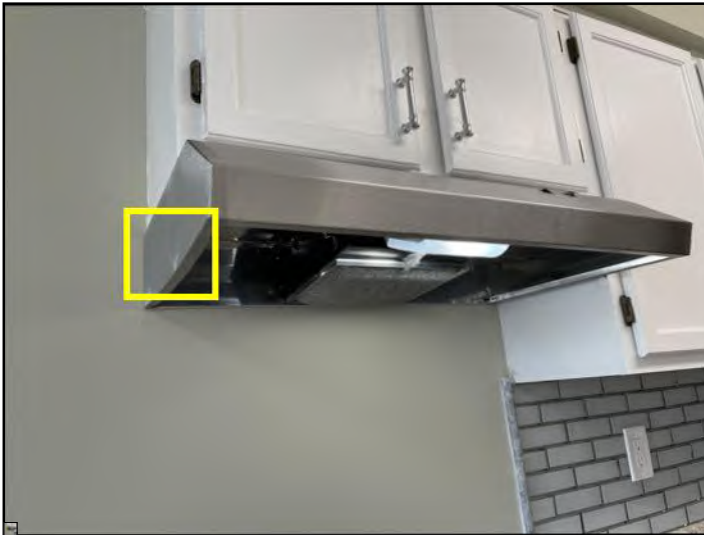
14. Vent Condition

- Vent hood appeared to be dented. Recommend replacing as needed.
- Vent louvers were covered at time of inspection. Recommend removing cover to allow vent to operate properly.

Dent

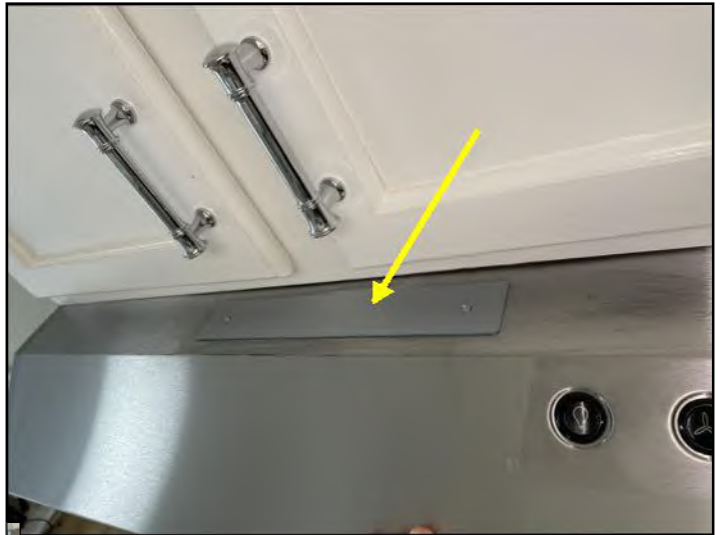
Vent covered

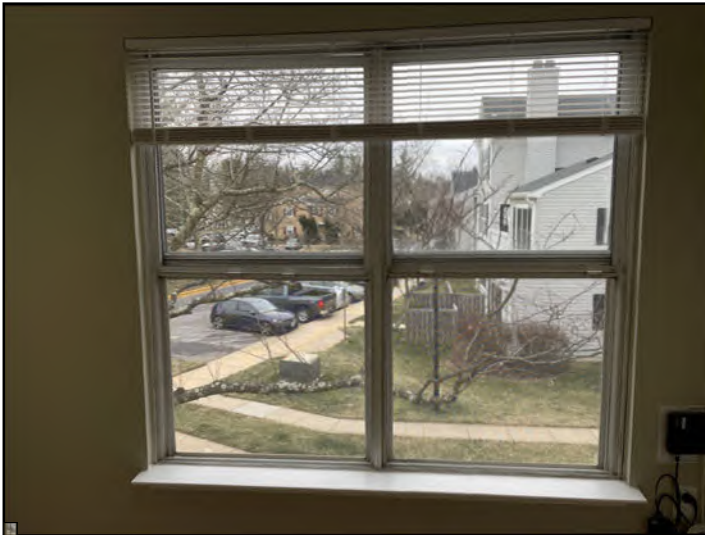
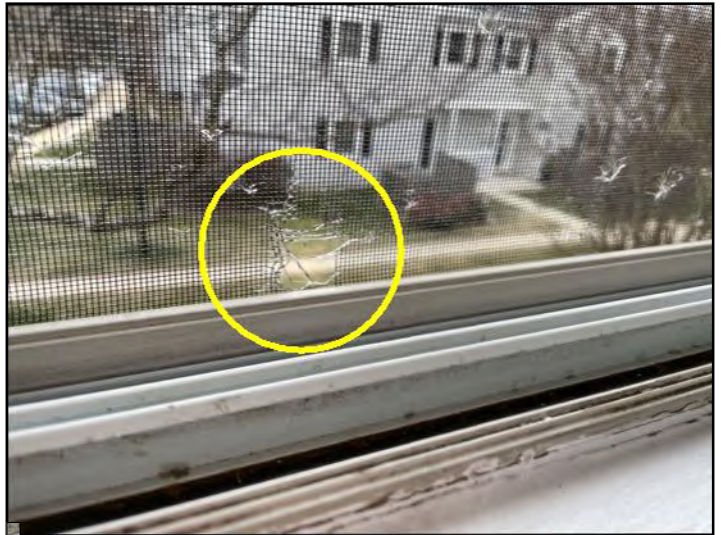
5. Window Condition

- **Improve:** Windows were original, older type. Consider upgrading to double pane, thermally insulated, newer efficient type.
- **Windows didn't latch due to misalignment or improper installation. Recommend repair or replace as needed.**
- **Deteriorated caulk noted. Recommend sealing or repair as needed.**
- **Damaged screens observed. Repair or replace as needed.**

Torn screen

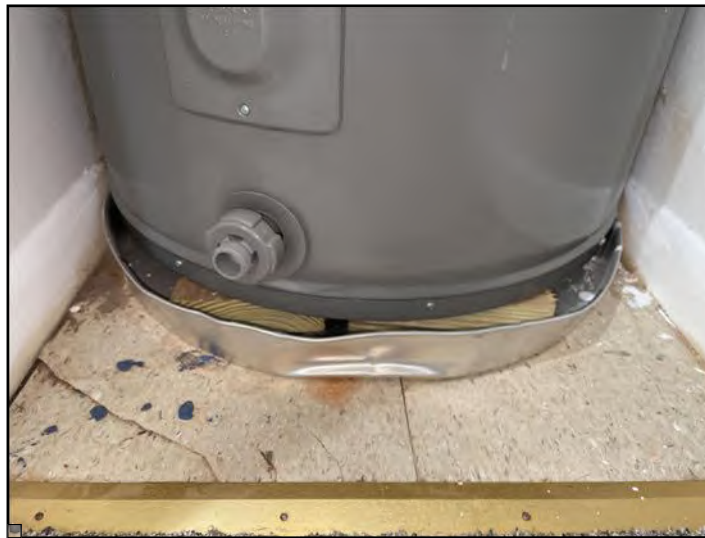
- Unable to view entire overflow pan. Drain not visible. Recommend ensuring overflow pan has drain. Repair or replace pan as needed.

No visible drain on pan

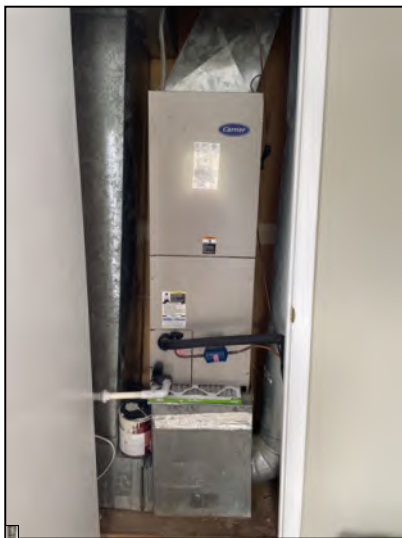
- Manufacture date: 2011. Life expectancy around 20 years.
- Unit appeared to operate properly using normal operating controls at the time of inspection.
- HVAC system service date was over 12 months ago or unable to be determined. Recommend the HVAC system be serviced and cleaned by a licensed HVAC specialist.

Missing shut off switch

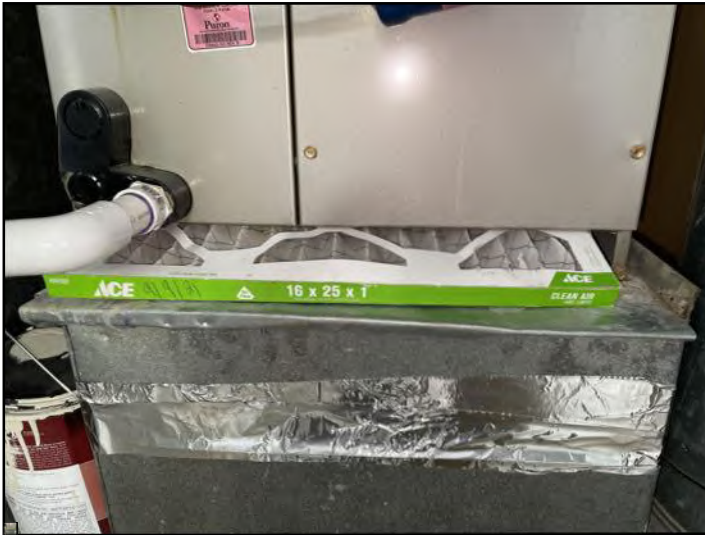
- **Maintenance:** The air filter should be inspected at least monthly and cleaned or replaced as required. Remember that dirty filters are the most common cause of inadequate heating or cooling performance.
- The filter was dirty and oversized. Recommend replacement.

Filter location

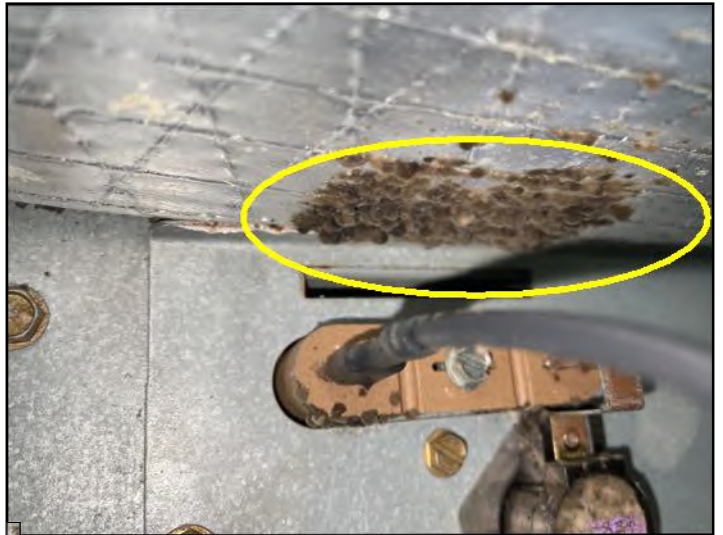
- Some grime was noted inside the enclosure. Recommend cleaning by a HVAC specialist.

Dirty

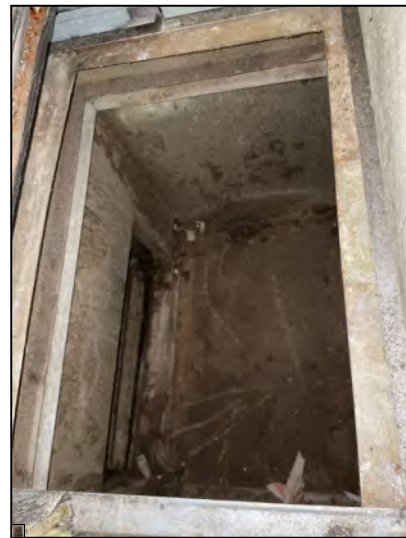
7. Enclosure Base

- Dust and corrosion noted in unit. Service by HVAC specialist is recommended.

Dusty

Corrosion

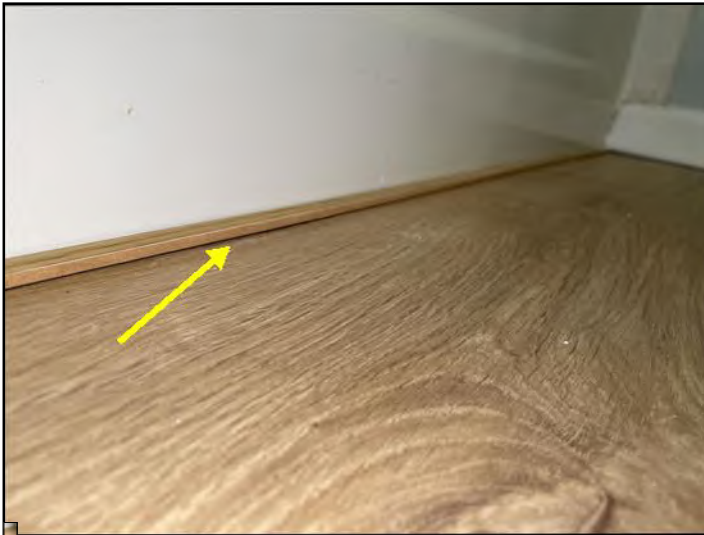
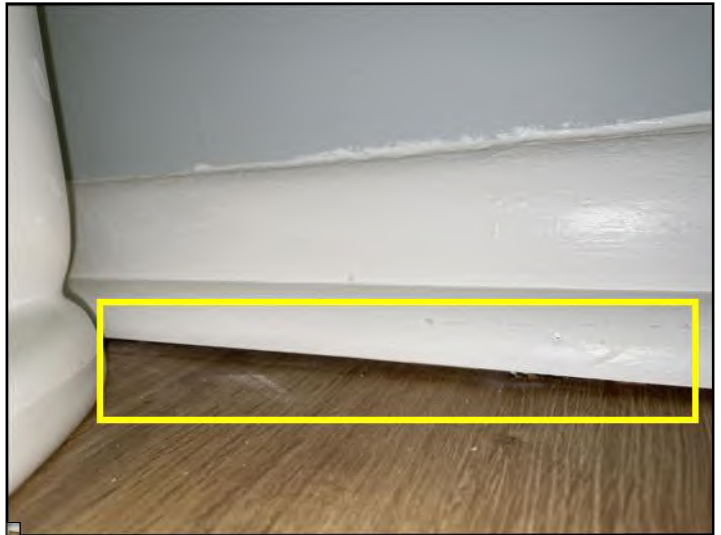
4. Floor Condition

- Gaps observed around floor perimeter. Recommend sealing voids to prevent water intrusion to subfloor.

Gap

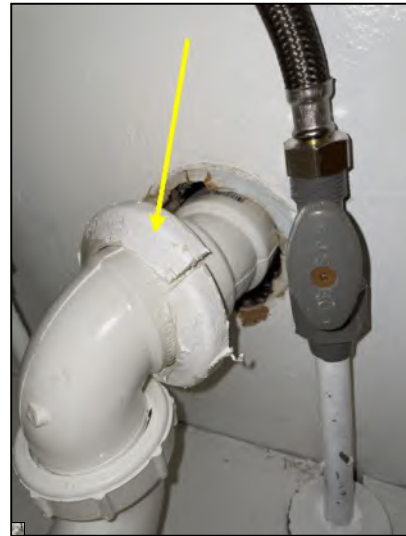
13. Plumbing

- Loose and broken escutcheon observed. Recommend repair and seal with caulk.

Loose and broken escutcheon

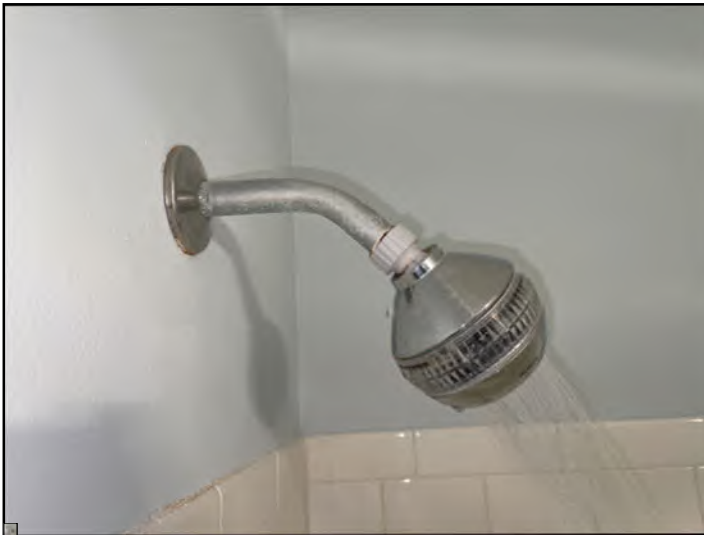
- Shower head leaked. Recommend repair.
- Shower diverter did not engage completely. Repair or replace as needed.

Leaked

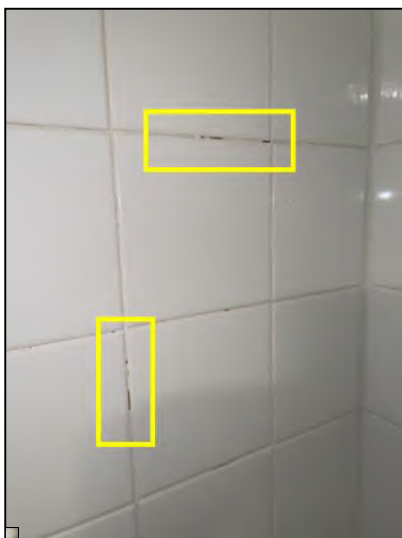
- Ceramic tile.
- Missing or damaged grout observed. Recommend grout or seal as necessary.
- Deteriorated caulk observed. Recommend sealing gaps.

Missing grout

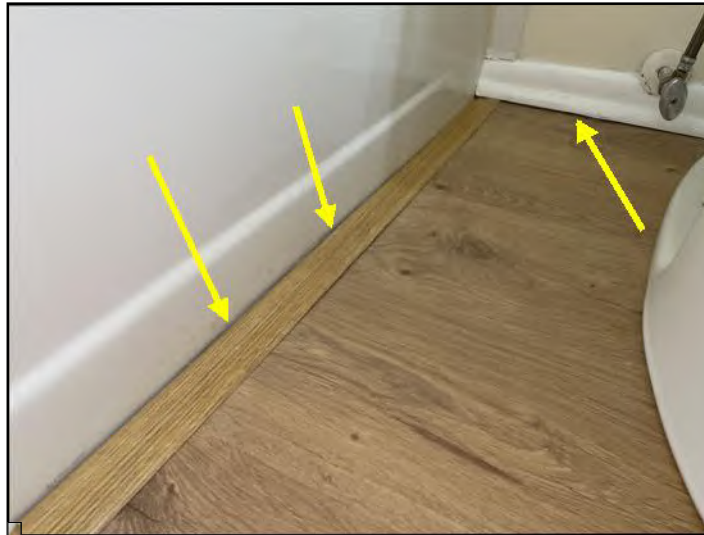
- Gaps observed around the floor perimeter. Recommend sealing all gaps to prevent water intrusion to subfloor.

Gaps

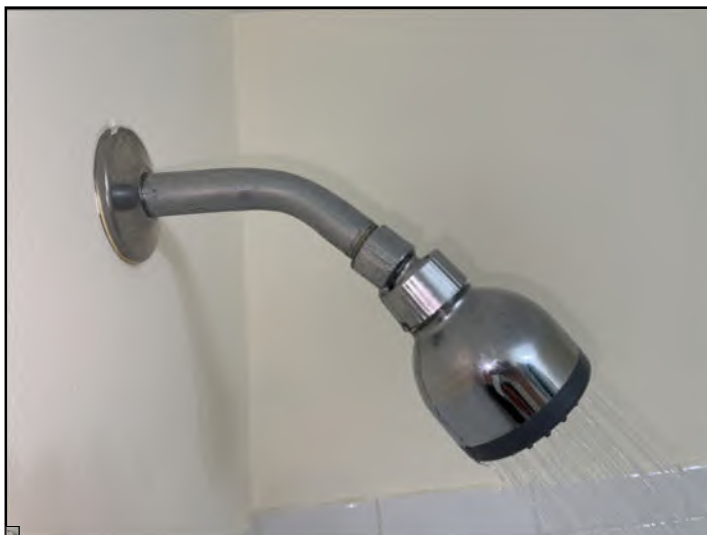
- Shower head leaked. Recommend repair.
- Shower diverter did not engage completely. Repair or replace as needed.

Leaked

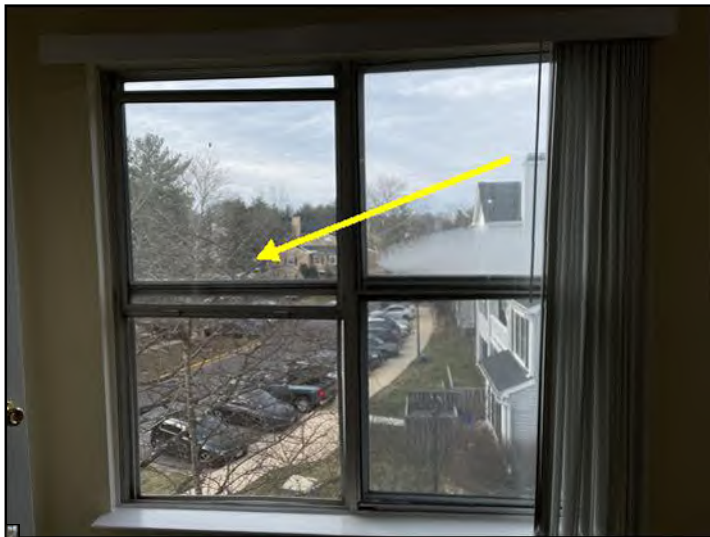
- Some windows were difficult to open. Repair as needed.
- Broken or cracked glass pane noted. Repair or replace as needed.
- Damaged screens observed. Repair or replace as needed.

Difficult to open

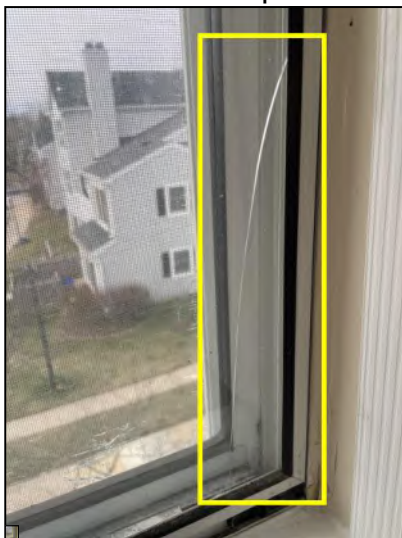
Cracked pane

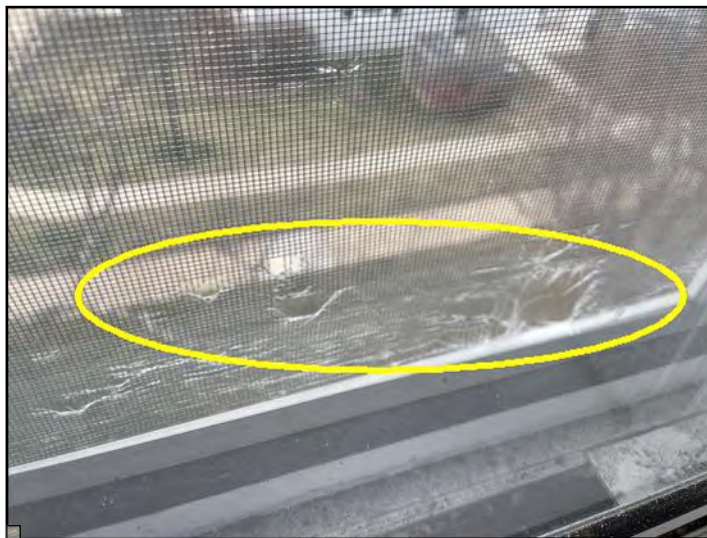
Torn screen

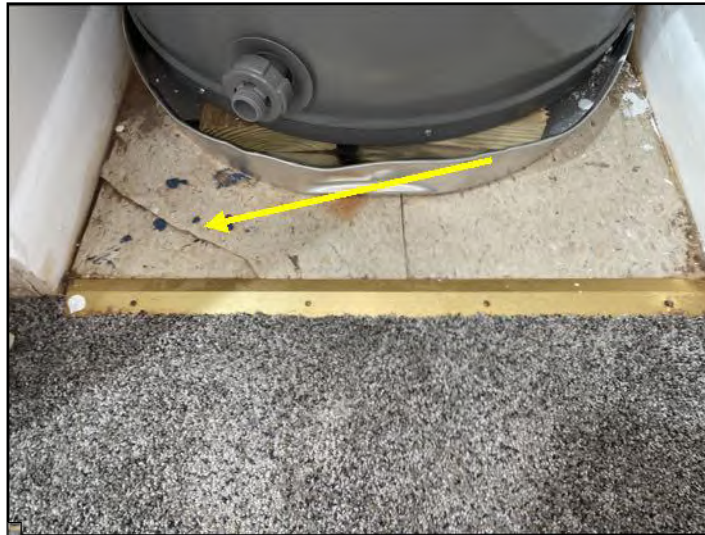
- Broken tile observed in water heater closet. Recommend repair or replace as needed.

Cracked tile

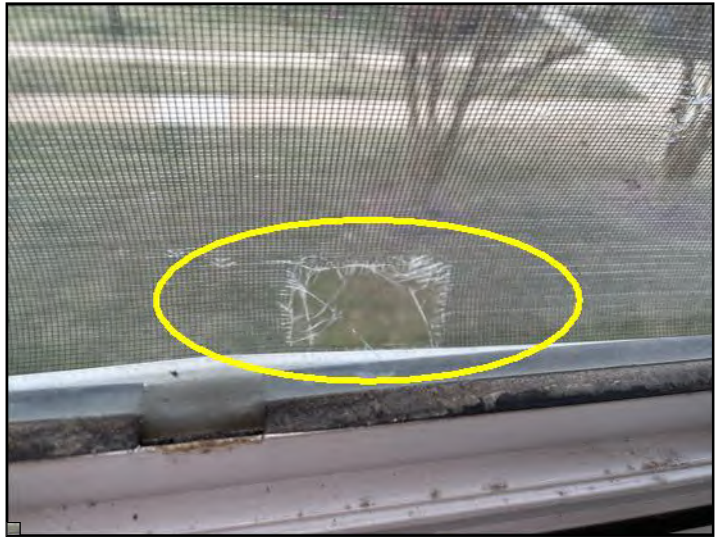
- Damaged screens observed. Repair or replace as needed.
- Deteriorated glazing bead observed. Recommend repair or replace as needed.

Damaged screen

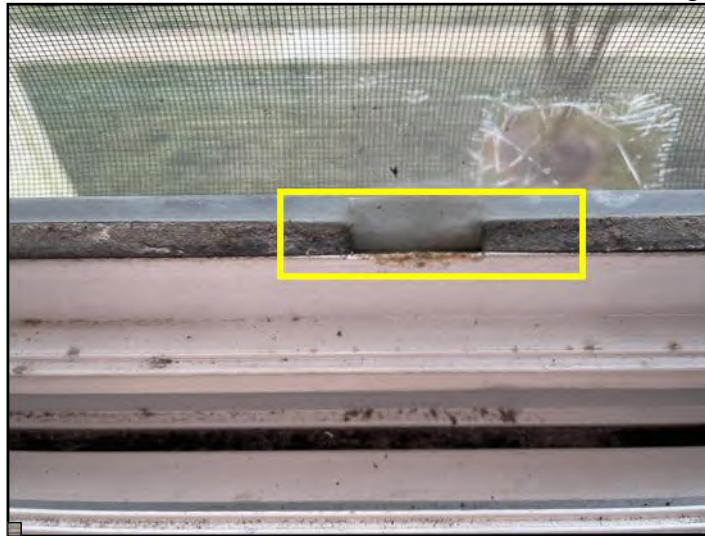
Deteriorated glazing bead
