INSPECTION REPORT

1111 Sample Ave, Sample, VA Sample
Inspection prepared for: Sample Sample
Date of Inspection: 7/24/2025 Time: 2:00 PM
Year Built: 2021 Size (Sqft): 1522 sqft
Weather: Sunny 90 degrees F

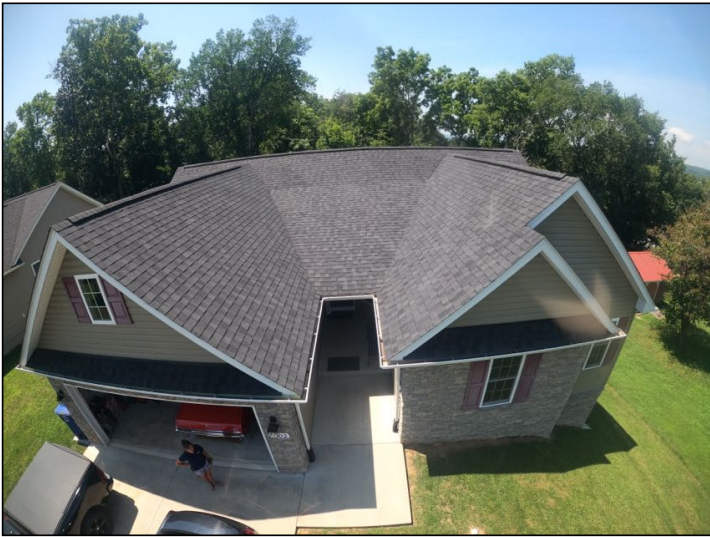
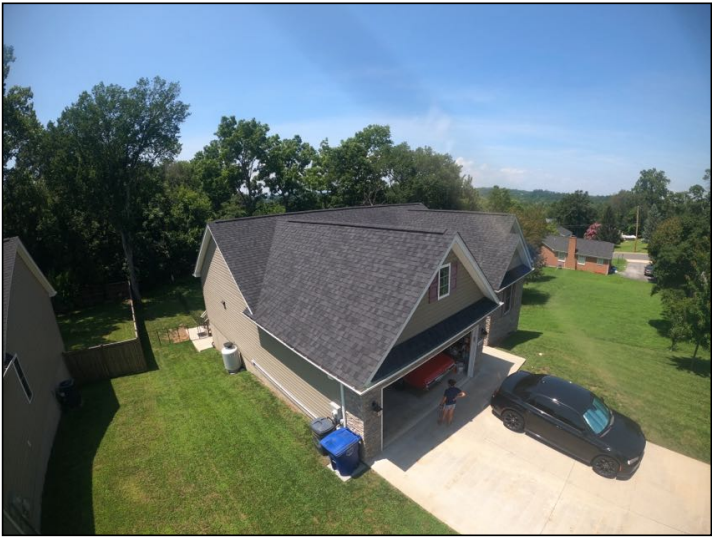
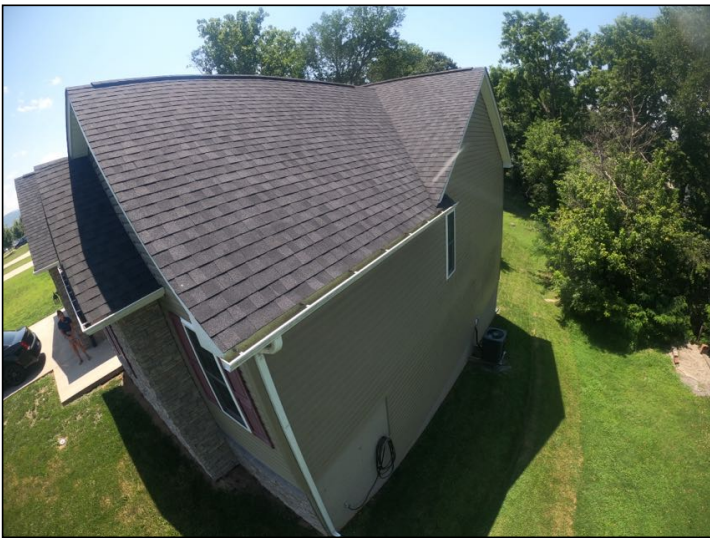
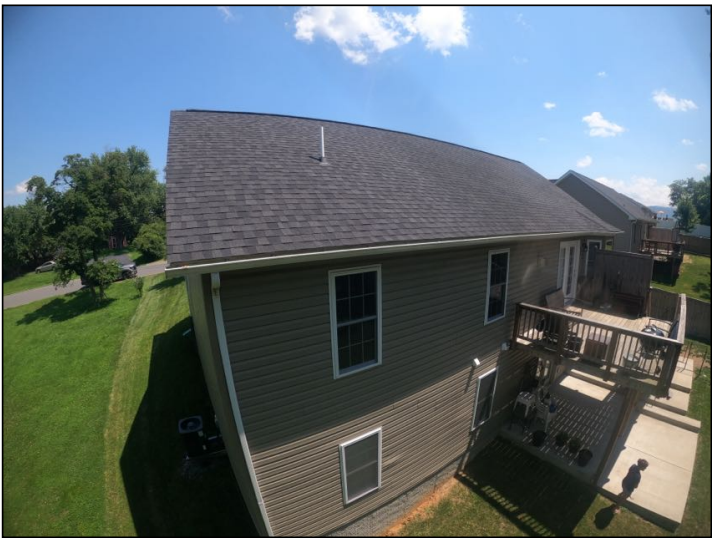
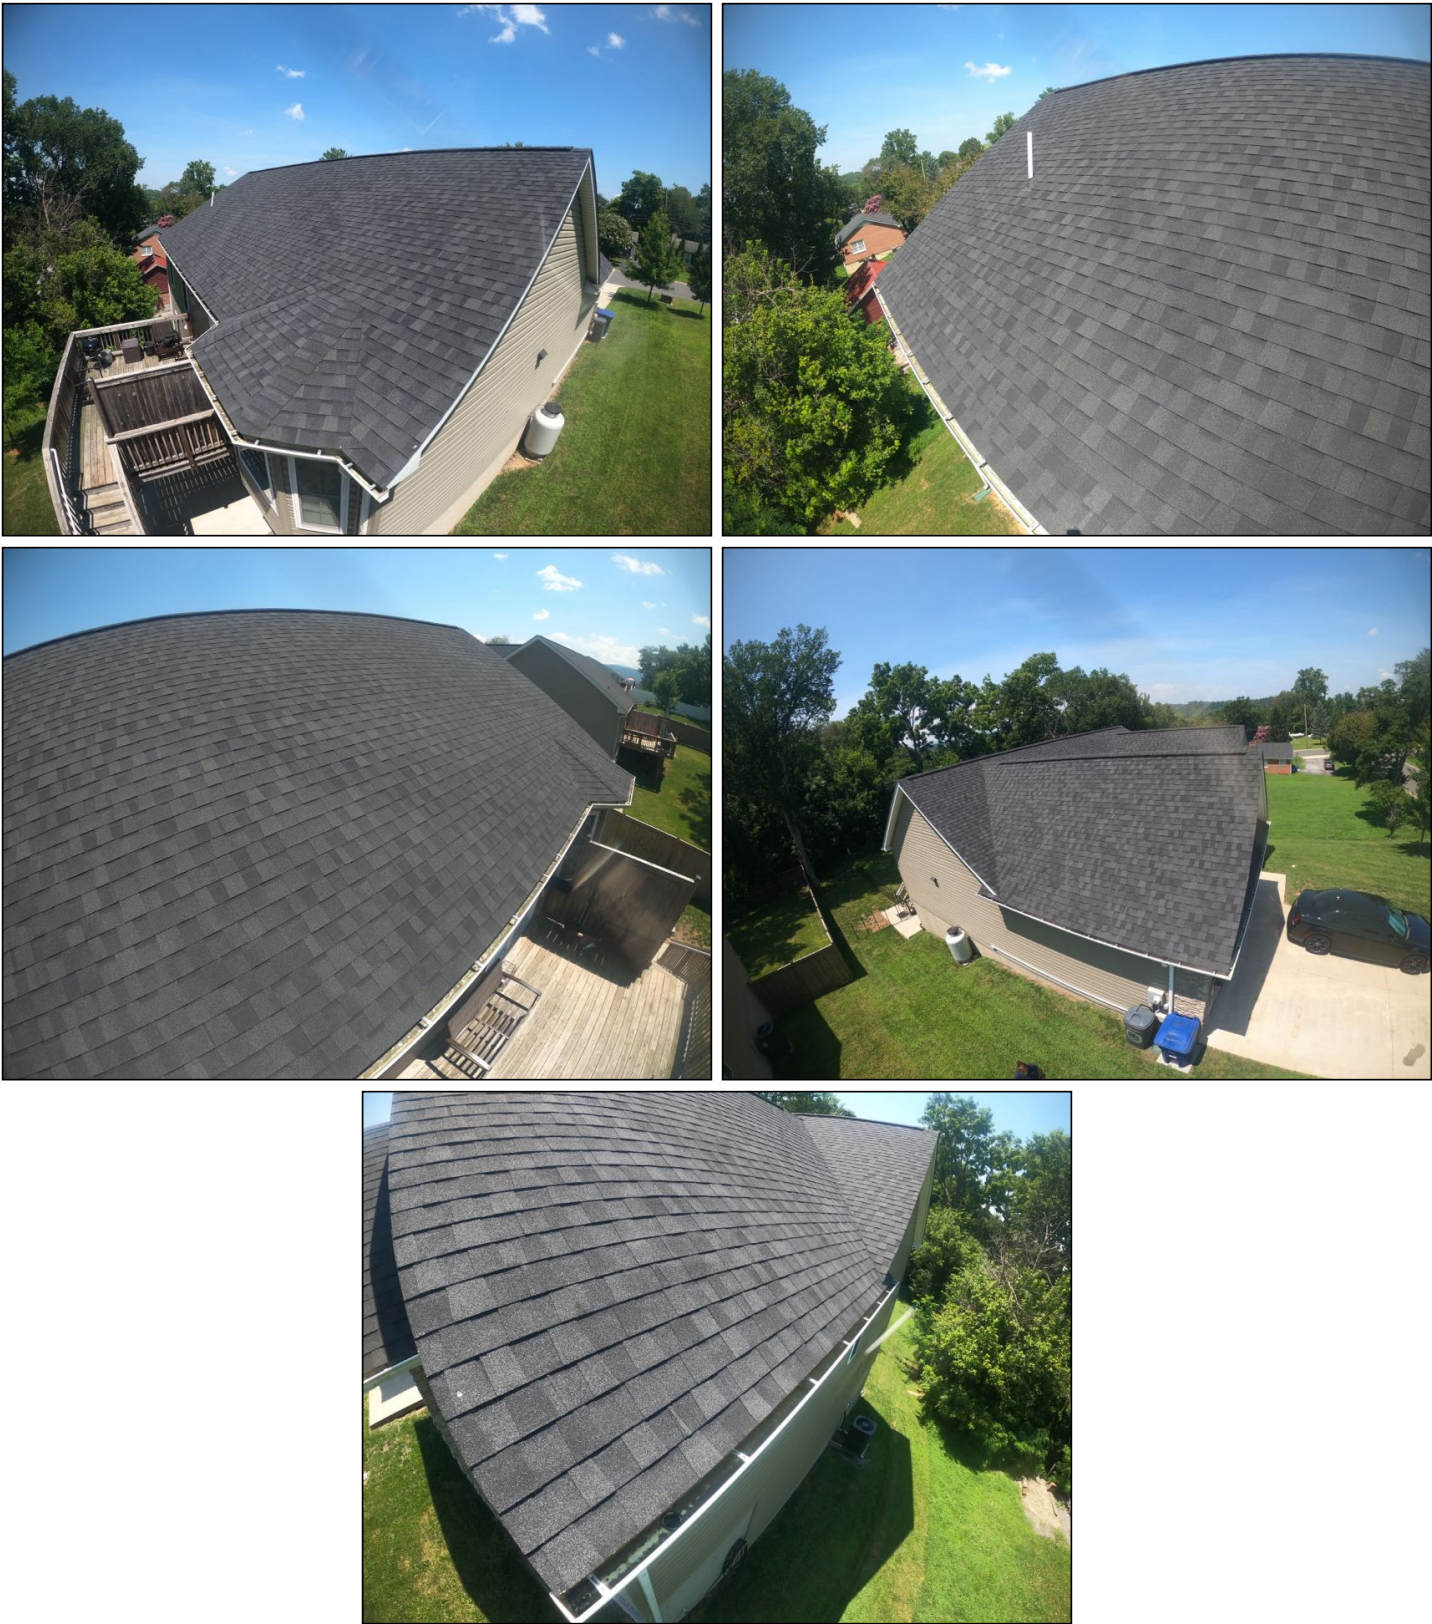
Materials: Inspected from ground level with extended "Eyestick" and camera.
Some areas of the roof may be visually restricted from inspection.
Materials: Asphalt shingles.
Observations:
• No major system safety or function concerns noted at the time of inspection.

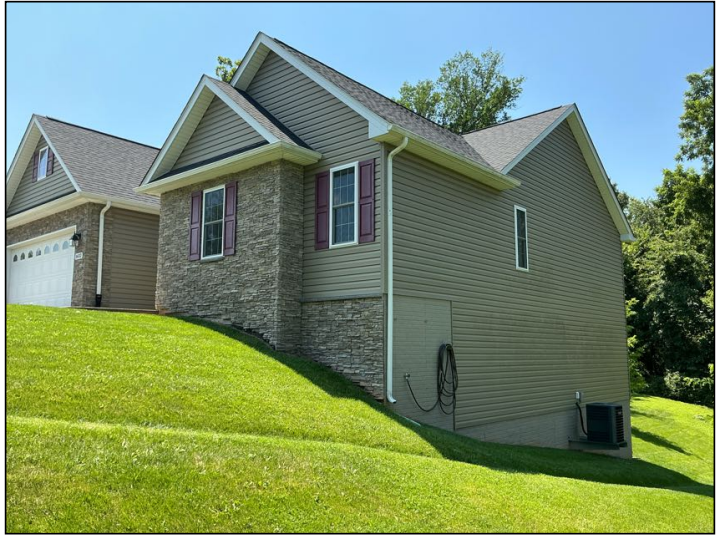
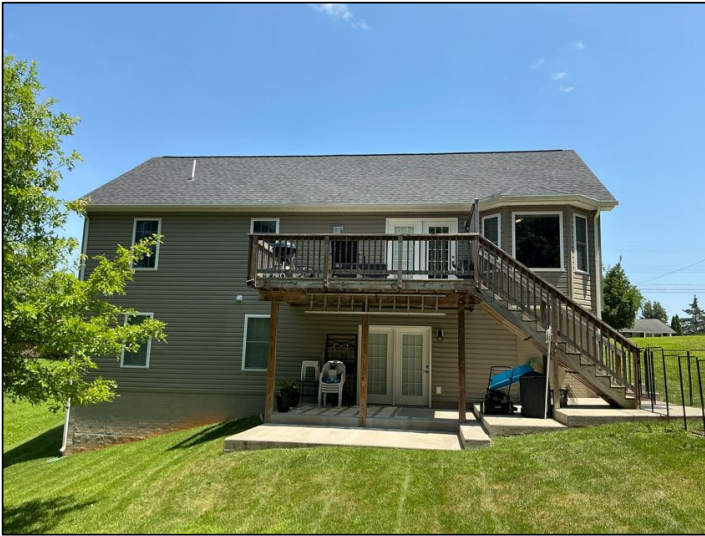
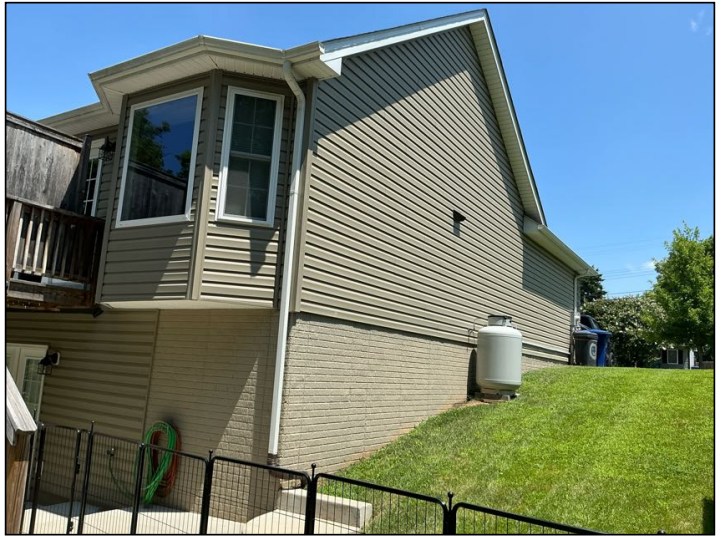
- No major system or safety concerns noted.
- Monitor: Maintain all exterior finishes, caulking, and other sealants at any dissimilar material abutments and all penetrations to the walls and roof. This inexpensive task aids in the prevention of moisture intrusion and saves on costly repairs.

| Page 17 Item: 8 | Cladding Condition | <ul style="list-style-type: none"> • Monitor: Maintain all exterior finishes, caulking, and other sealants at any dissimilar material abutments and all penetrations to the walls and roof. This inexpensive task aids in the prevention of moisture intrusion and saves on costly repairs. |

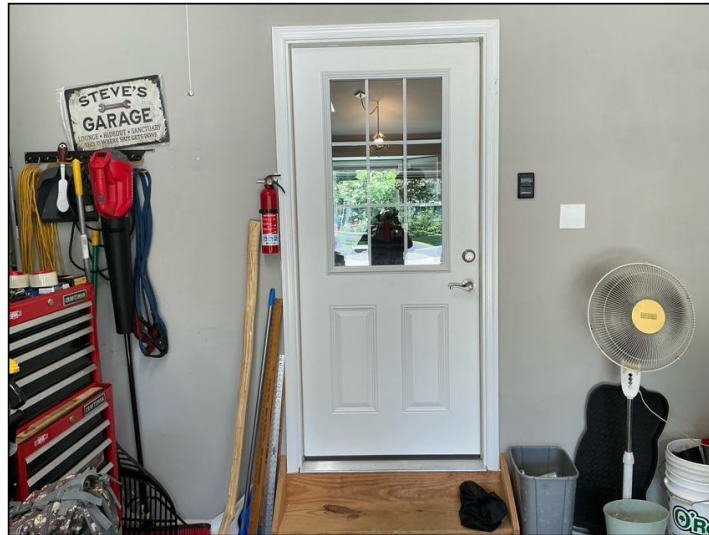
- No auto closure present. Recommend installing an auto closure for safety. Fire doors and auto closure are fundamental to the integrity of fire barriers which provide resistance to the spread of fire, smoke, and toxic gasses.
- No auto closure present. Recommend installing an auto closure for safety.

| Page 22 Item: 5 | Fire Door | • No auto closure present. Recommend installing an auto closure for safety. |

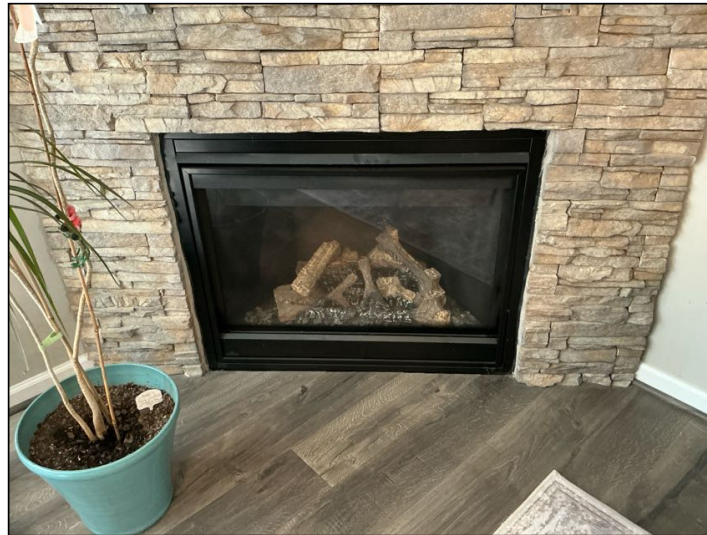
- The fireplace appears to be in fair visual condition. Was not operated because the gas pilot was turned off.
- Have a gas fireplace professional service/evaluate fireplace before operating.

| Page 25 Item: 6 | Fireplace | <ul style="list-style-type: none"> • Have a gas fireplace professional service/evaluate fireplace before operating. |

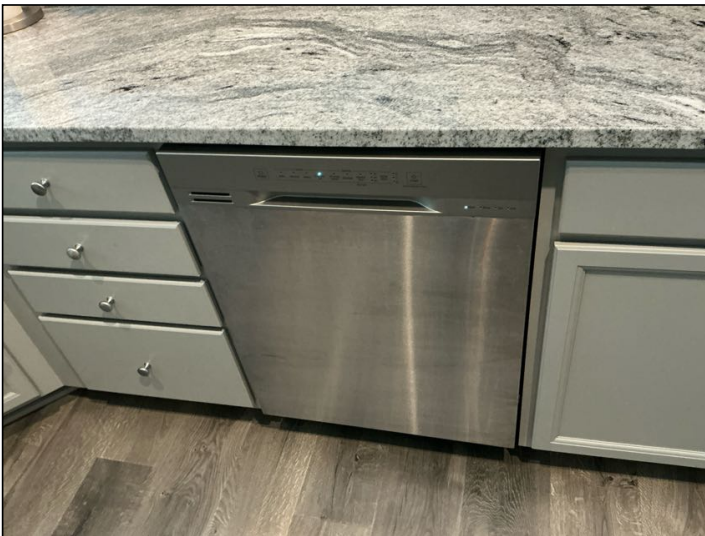
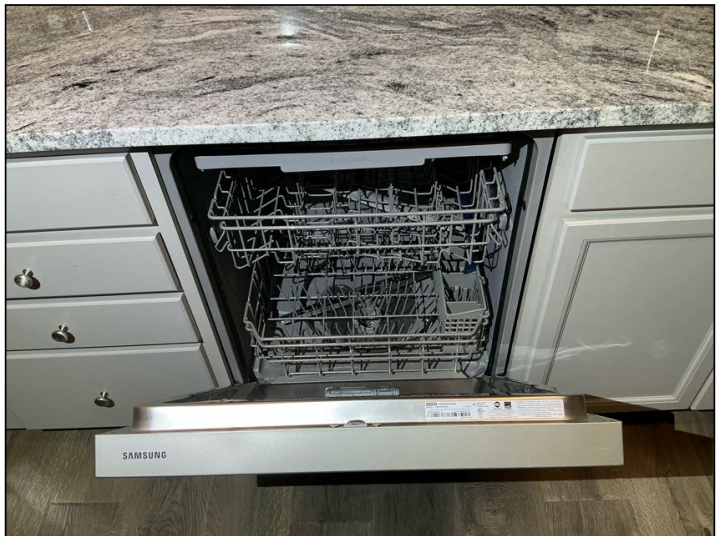
- Operated normally at the time of inspection.
- No high drain loop noted. Dishwasher high drain loop is to prevent back flow of water into the dishwasher.

| Page 28 Item: 7 | Dishwasher | <ul style="list-style-type: none"> • No high drain loop noted. Dishwasher high drain loop is to prevent back flow of water into the dishwasher. |

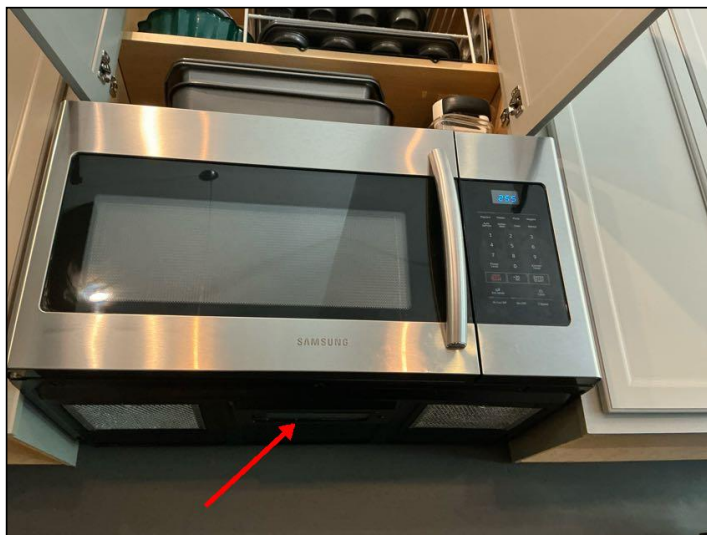
- Tested exhaust fan was operational at the time of inspection.
- Light bulb not working or missing.

| Page 30 Item: 14 | Vent Condition | <ul style="list-style-type: none"> • Light bulb not working or missing. |

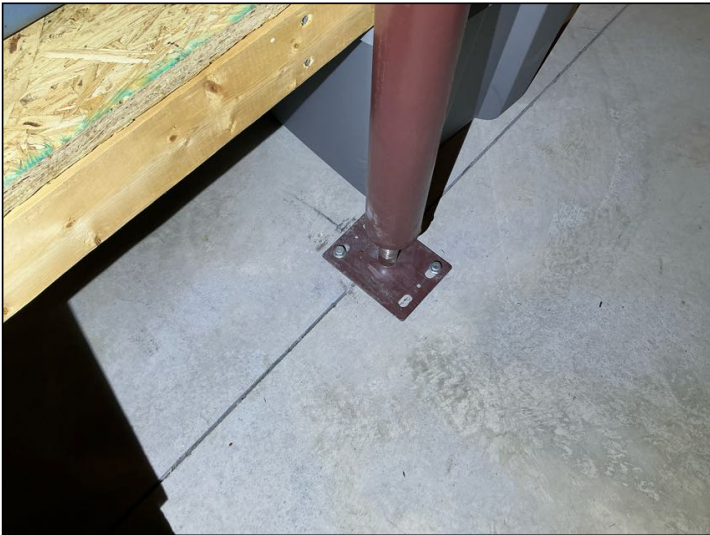
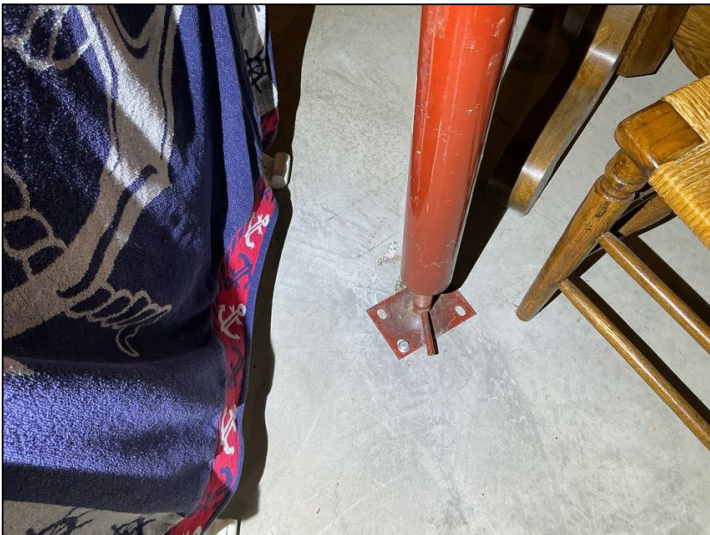
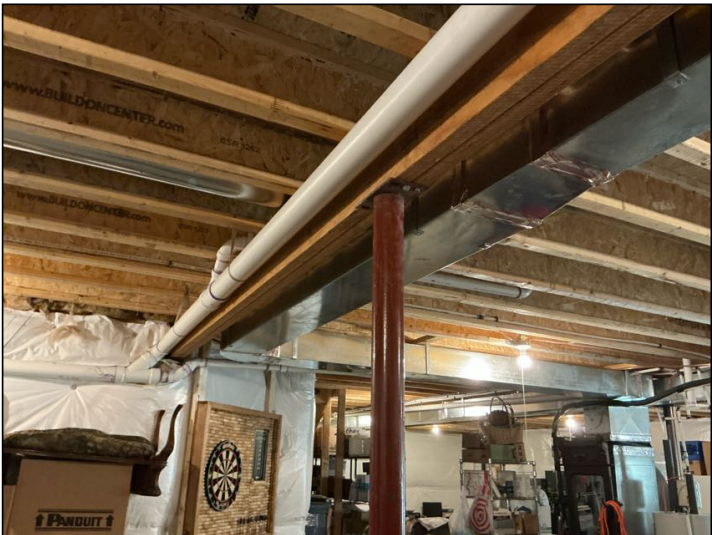
- Screw jacks are usually intended as temporary supports. Support posts may lack proper footings to disperse load bearing weight imposed at noted area. Recommend review of post and support structure by a qualified contractor.

| Page 36 Item: 3 | Columns | <ul style="list-style-type: none"> • Screw jacks are usually intended as temporary supports. Support posts may lack proper footings to disperse load bearing weight imposed at noted area. Recommend review of post and support structure by a qualified contractor. |

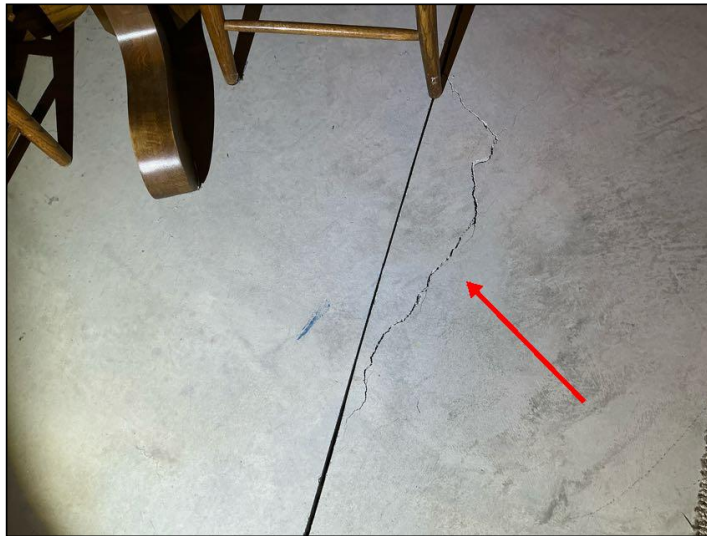
- Common cracks noted. All concrete floor slabs experience some degree of cracking due to shrinkage in the drying process, Recommend sealing all cracks.

| Page 37 Item: 4 | Slab Floor | <ul style="list-style-type: none"> • Common cracks noted. All concrete floor slabs experience some degree of cracking due to shrinkage in the drying process, Recommend sealing all cracks. |

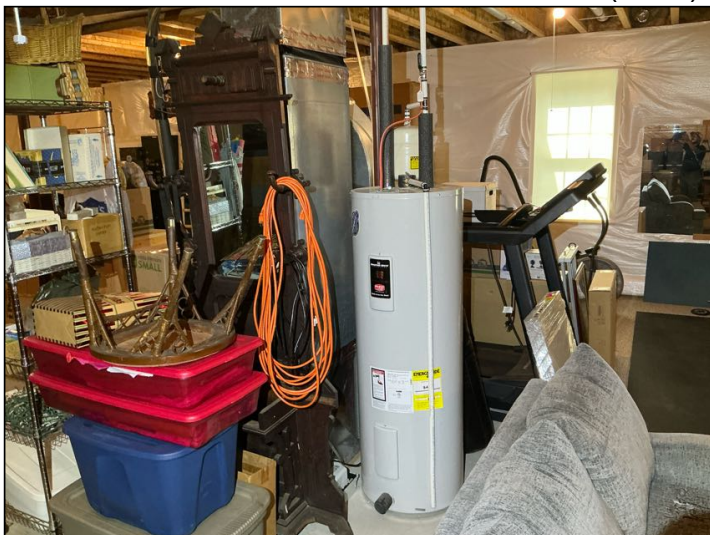
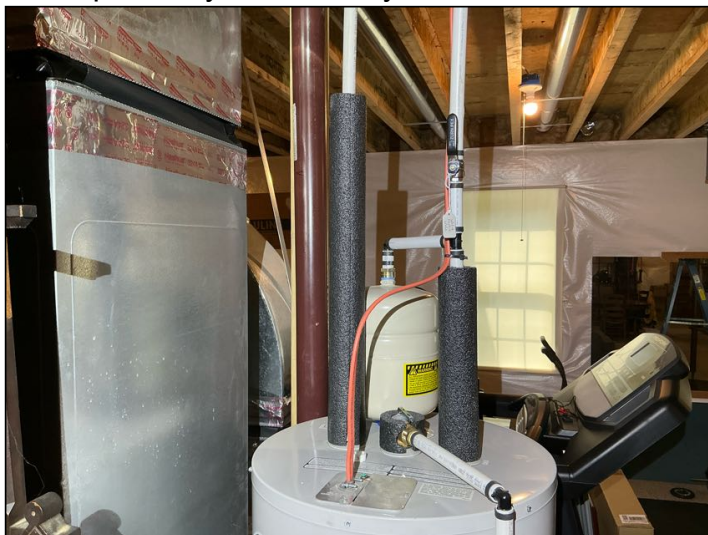
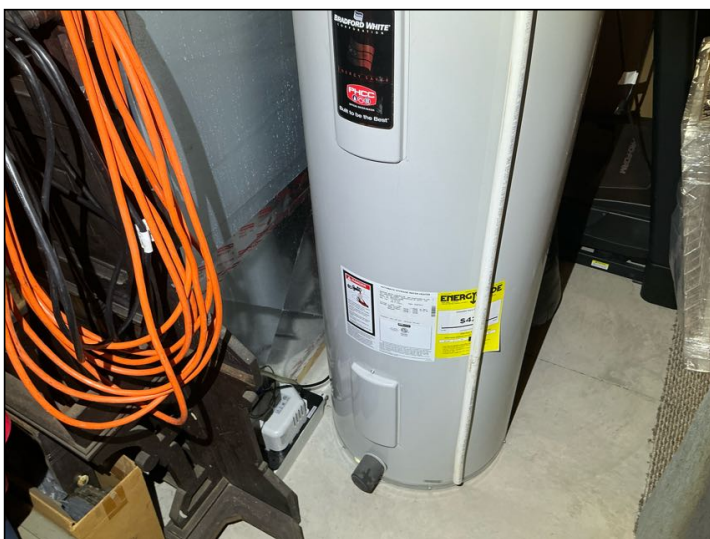
- Tank appears to be in satisfactory condition.
- Manufacture date:(2019). Life expectancy around 12 years.

MFD 2019—50 gallons

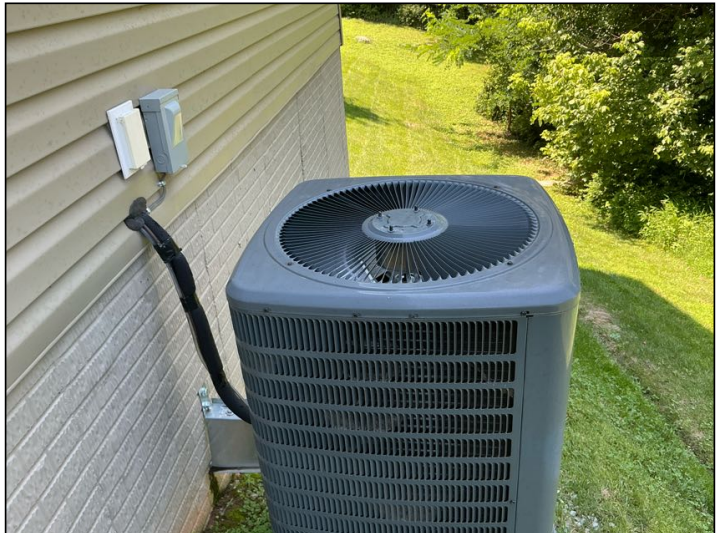
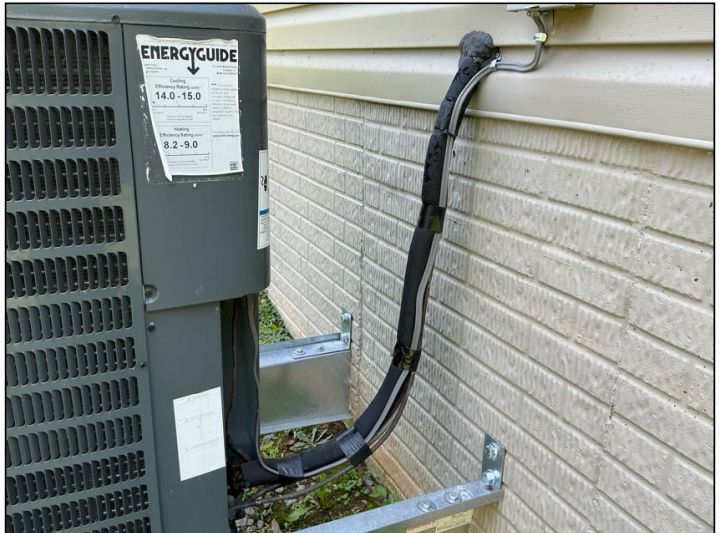
- Appeared functional at the time of inspection.
- Manufacture date:(2019). Life expectancy around 20 years.
- **Recommend cleaning and servicing the HVAC system by a licensed HVAC specialist.**

MFD 2019—R410A

| Page 46 Item: 1 | AC Compress Condition | <ul style="list-style-type: none"> • Recommend cleaning and servicing the HVAC system by a licensed HVAC specialist. |

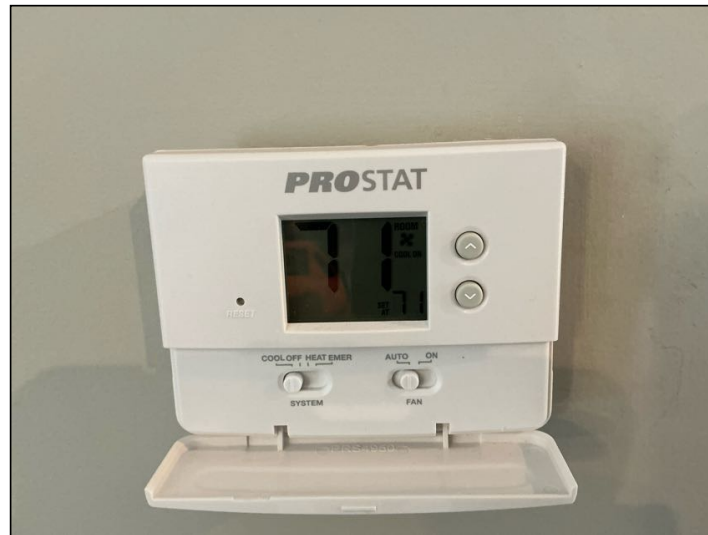
- Located in the family room
- Digital - programmable type.
- Functional at the time of inspection.

Set to cool 71F

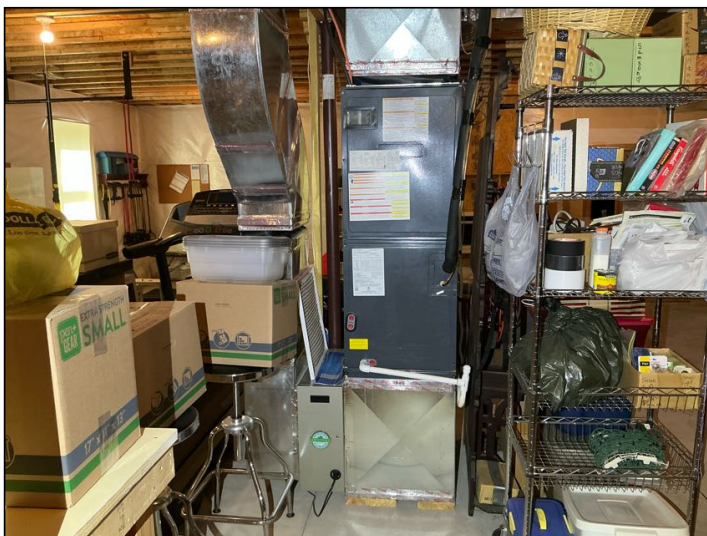
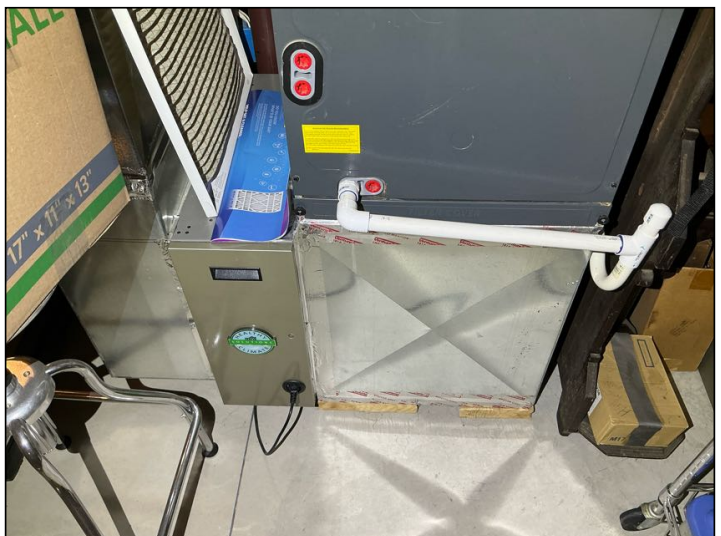
Type: Heat pump noted.

- Heat pump was tested using normal operating controls. Unit appeared to operate properly at time of inspection. As with all mechanical equipment, the unit may fail at anytime without warning. Inspectors cannot determine future failures. A heat pump is basically a compressor-cycle air conditioning system that can operate in reverse. As long as the unit is functioning properly in either the heating or cooling mode, it is an indication that the major components (compressor, fans, and coils) are operational. Adequate air flow is important to the efficiency of these units; the filter should be kept clean as with air conditioners. If a detailed evaluation of the heating or cooling capacity of these units is desired, a licensed HVAC contractor should be consulted prior to closing.

- Manufacture date:(2019). Life expectancy around 20 years.
- HVAC system service date was over 12 months or not being able to be determined. We recommend the HVAC system be serviced and cleaned by a licensed HVAC specialist.

| Page 47 Item: 4 | Heater Condition | <ul style="list-style-type: none"> • Recommend the unit to be serviced by a qualified HVAC specialist. |

- Recommend the unit to be serviced by a qualified HVAC specialist.
