NextDay Inspect

Commercial Inspection Report

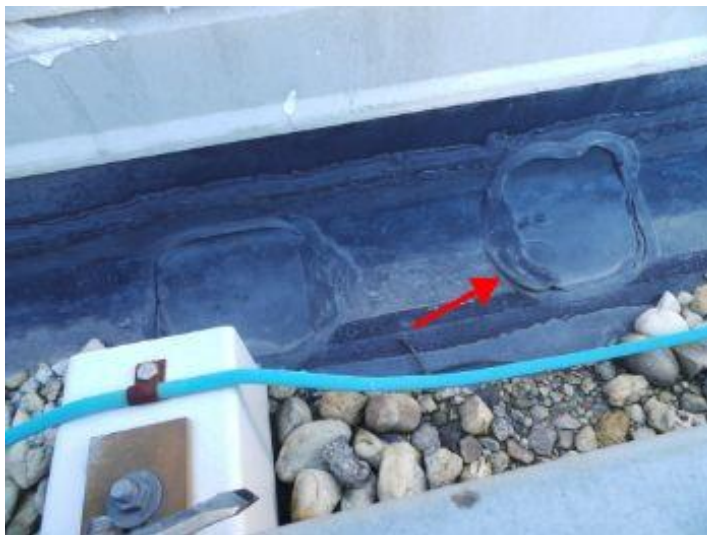
2. Presence of Exposed Membrane

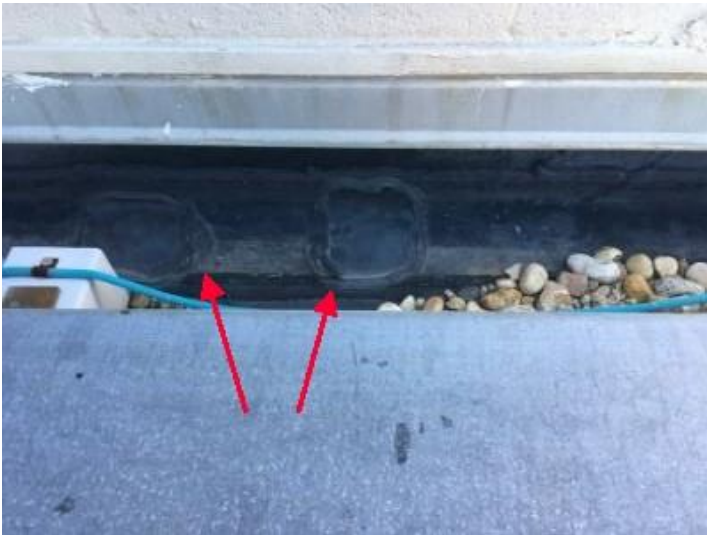
• Sections of the built-up roofing have delaminated leaving some of the lower membrane exposed. This will eventually cause a leak due to the breakdown of the lower layers. Recommend contacting a licensed roofing contractor for evaluation and repair options.

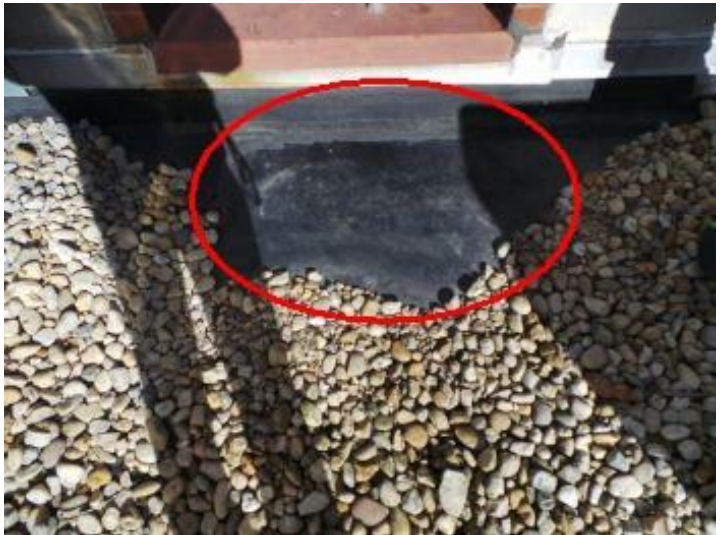
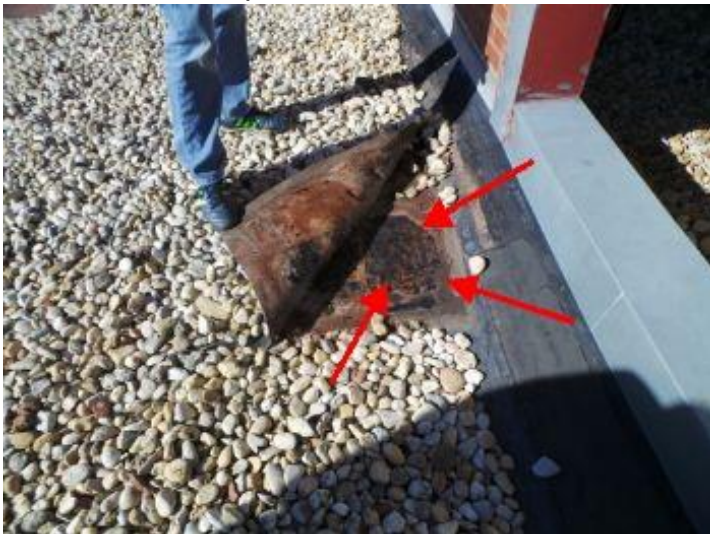
3. Evidence of Ponding

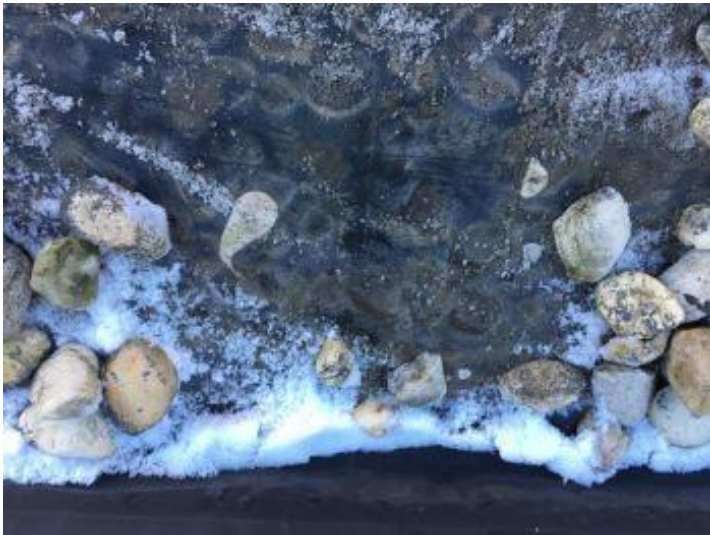
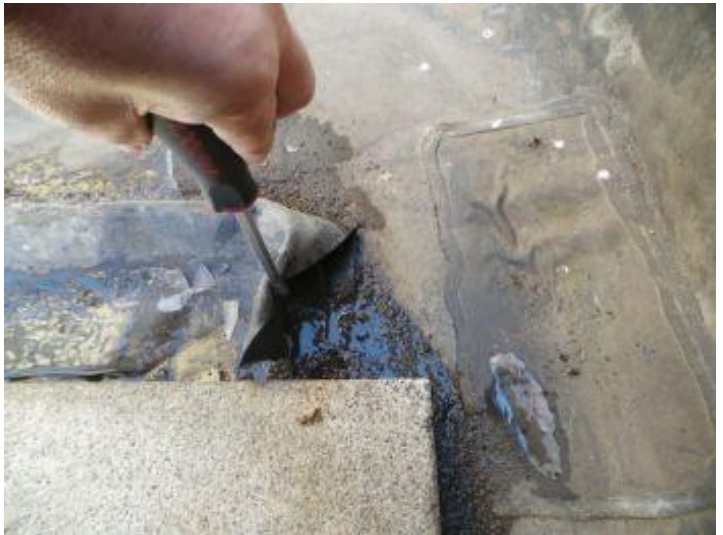
- ponding is evident in areas on the roof. This is normally caused by improper pitch or slope of the roofing materials or the roof deck. Recommend contacting a licensed roofing contractor to review repair options.

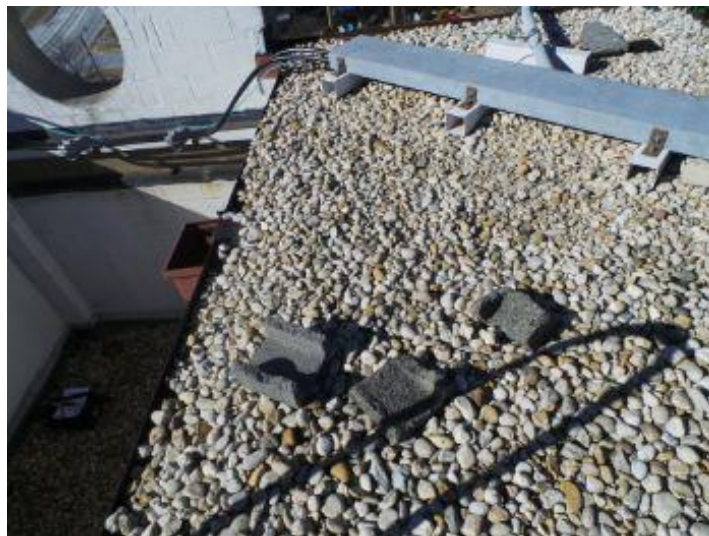
- The structures above the elevator and stairwell have flat roof with no slope or gutter system to direct rain water to the downspout, we recommend installing gutters on the additional structures and direct the water to downspout and roof drainage.

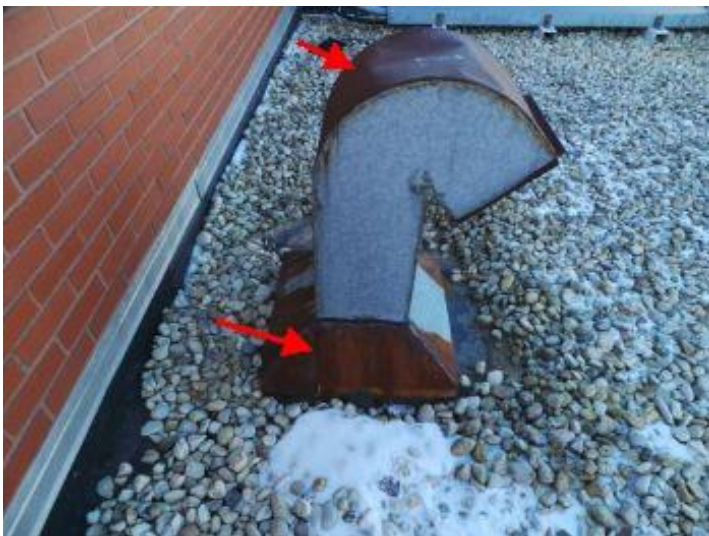
- Several breather vents are too short which can lead to the accumulation of ice, snow, and debris inside the vent, therefore the vents get clogged. Minimum vent penetration height above the roof for Northern Virginia is 6 inches and the average 18 inches.
- Several roof penetrating vents have excessive rust. We recommend replacing and/or sanding and painting the rusty vents
- Several nails securing the flashing are popping out.

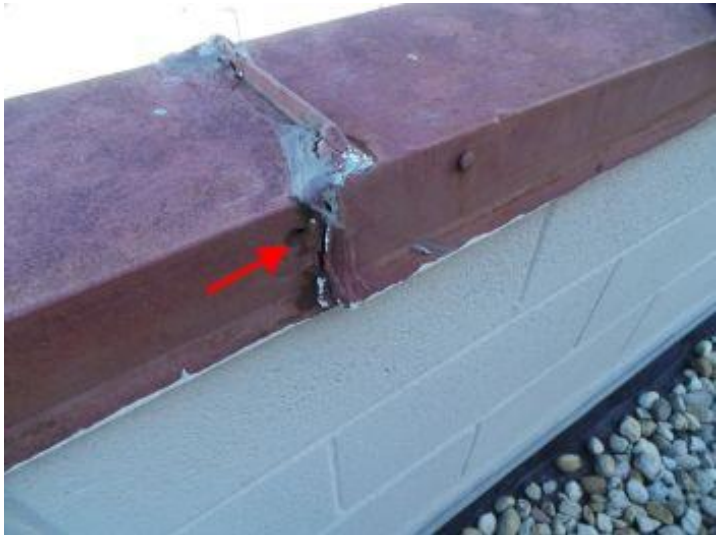
Nail pop out on roof flashing

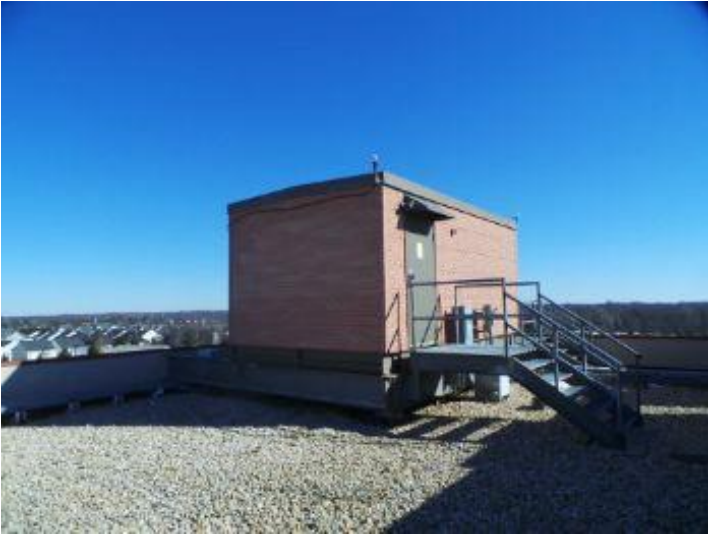
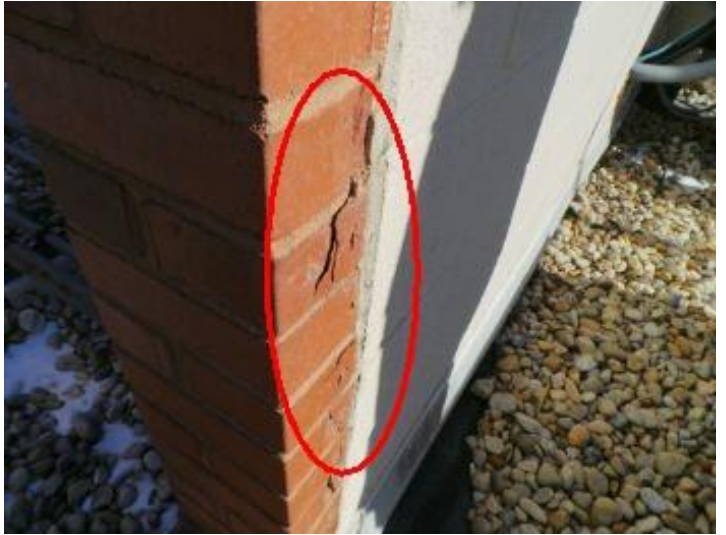
- Brick spalling noted at the time of the inspection
- noted broken leg covers on the Sprint cables track container.

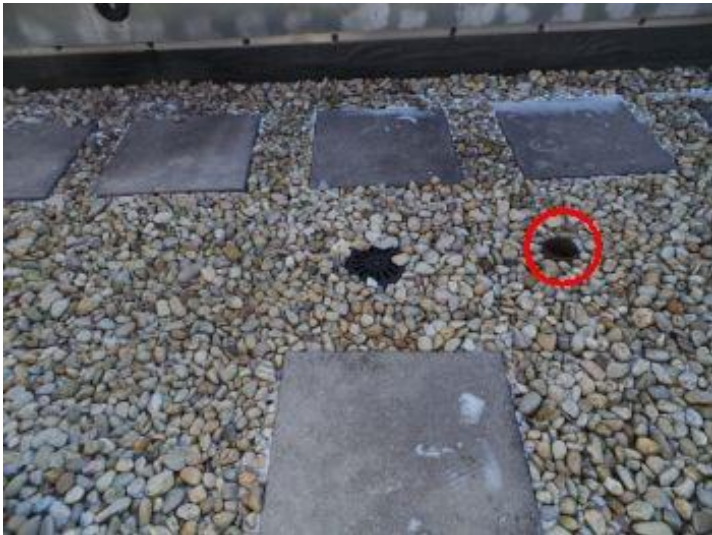
Breather vent too short

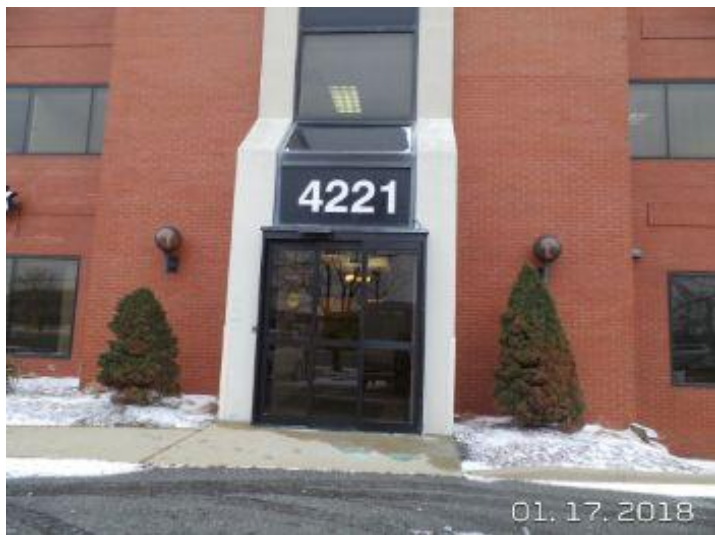
- Main Entry door is made of aluminum I with tempered glass
- one or more door stopper worn out or broken
- one or more doors have worn out weather strip and or insulation
- Flooring Store main entrance floor transition noted missing screws at the time of the inspection

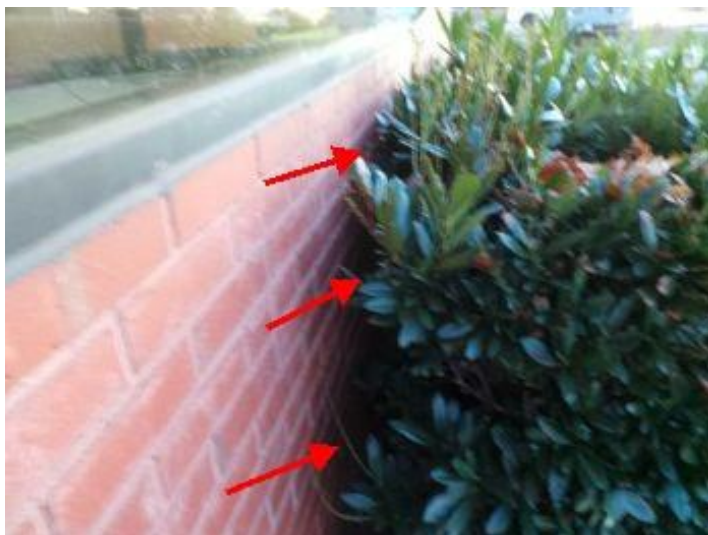
- noted plants and shrubs touching the building, recommend pruning and cutting at least one foot from the building walls

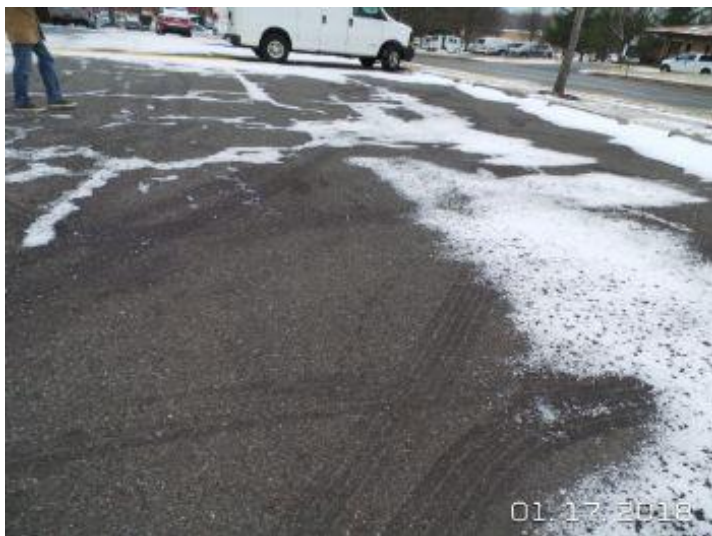
- Parking seems to be adequate with Handicap parking. Estimated about 100 parking stalls
- The markings for parking stall and handicap parking are worn out and in some areas the making is not visible. We recommend painting the parking areas with the proper paint and markings.

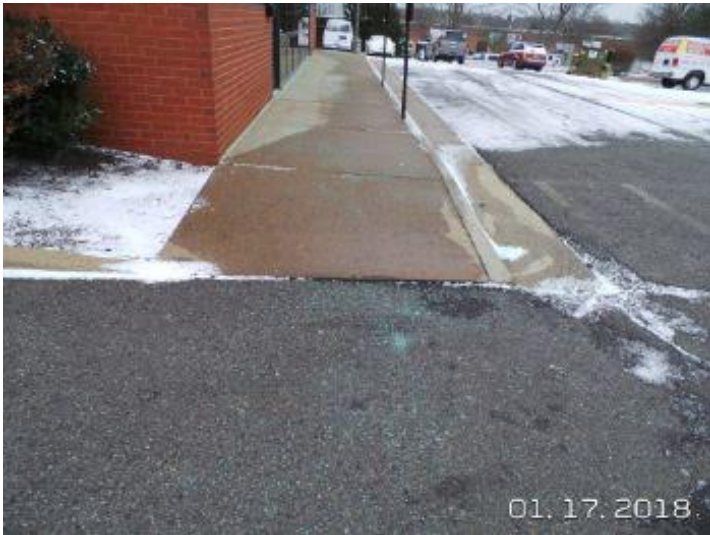
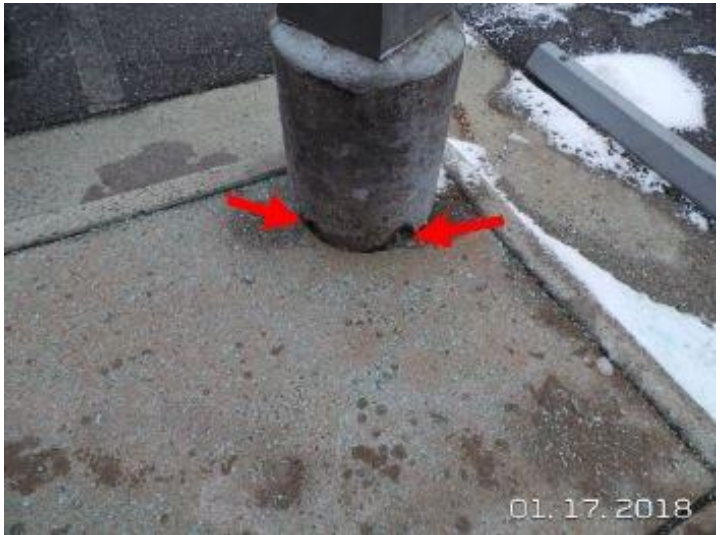
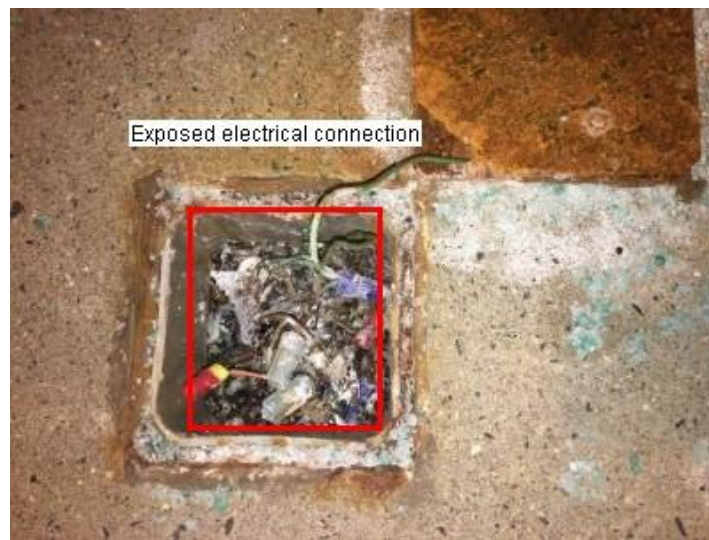
- Concrete sidewalk noted
- noted chipped concrete base for parking light holder
- Noted missing cover for in ground electric junction box

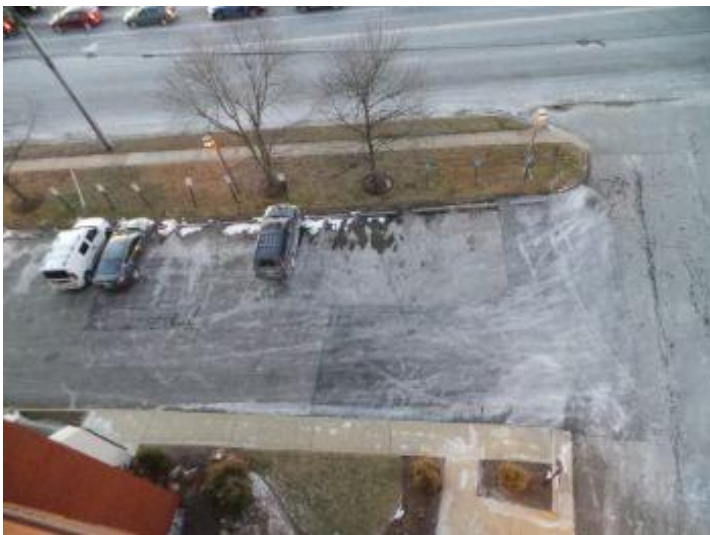
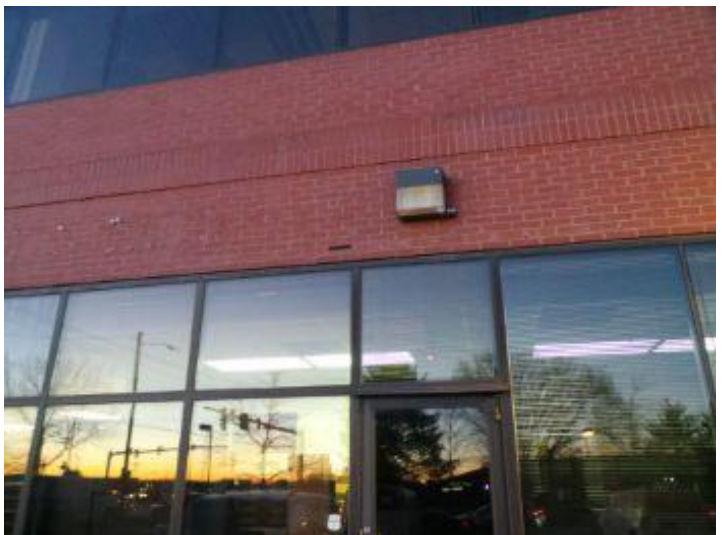
- one or more parking area lights are missing cover

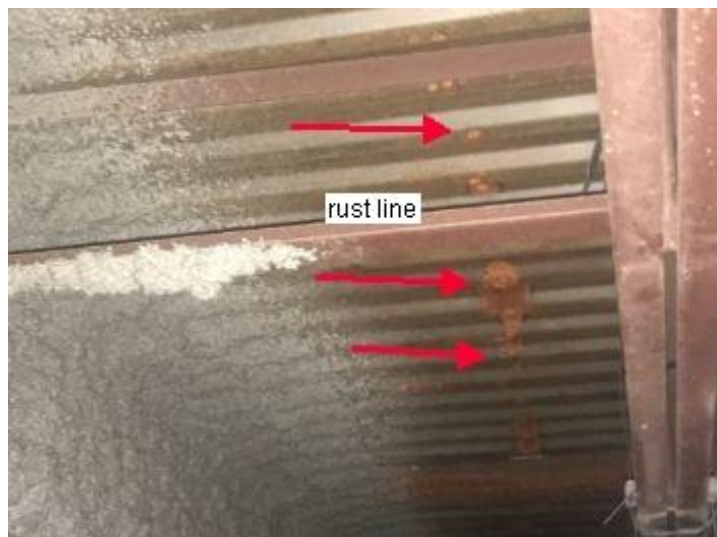
• Steel beams for roof structures and system racks have excessive rust and flaking paint

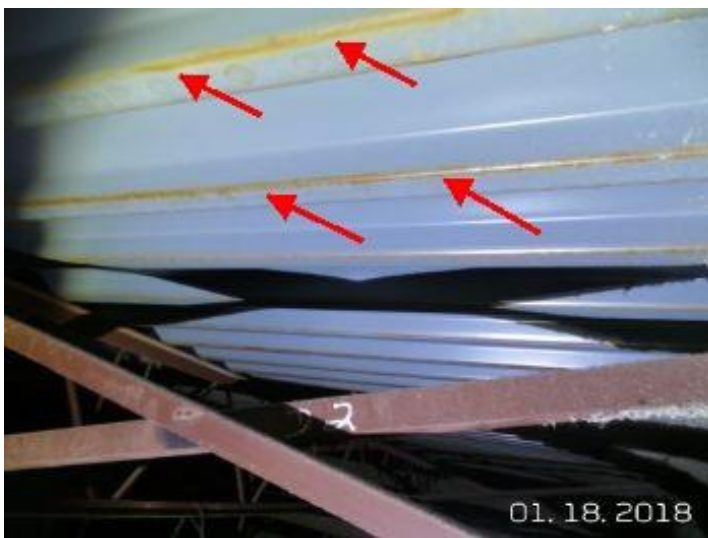
5th Floor Ceiling - Visible Rust

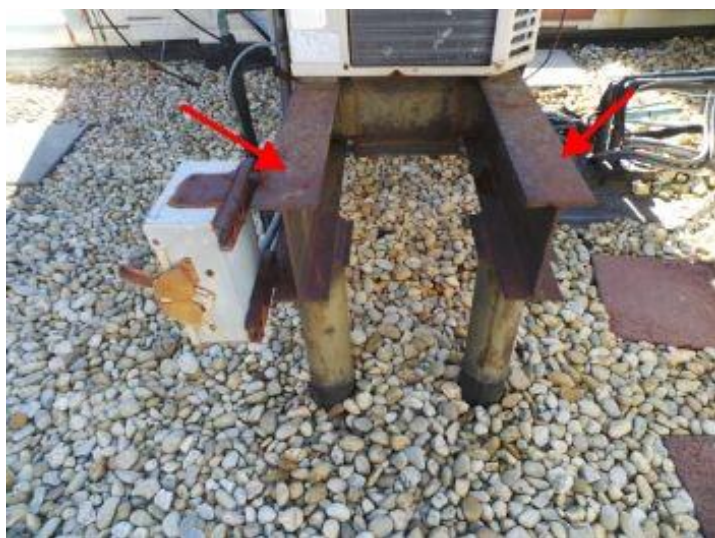
Rooftop Racks - Excessive Rust

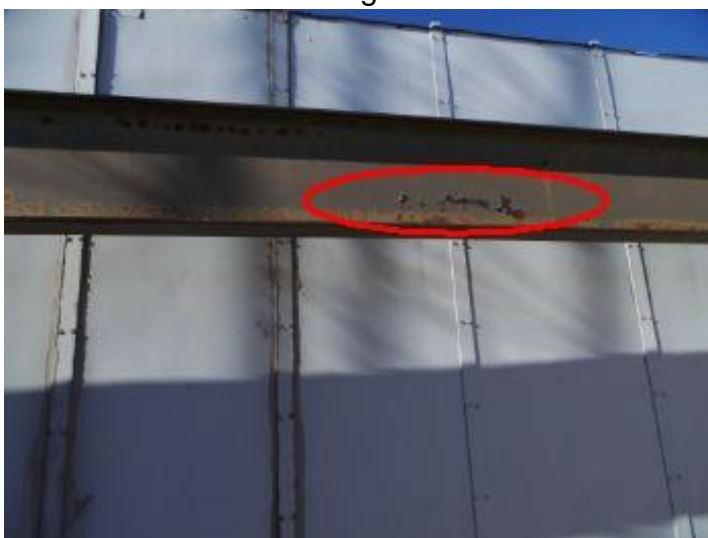
Rooftop Tracks peeling paint

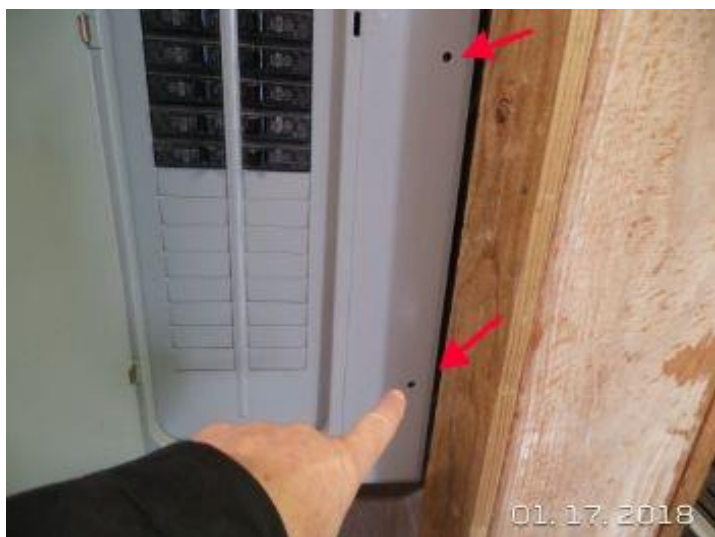
1st Floor - behind the building

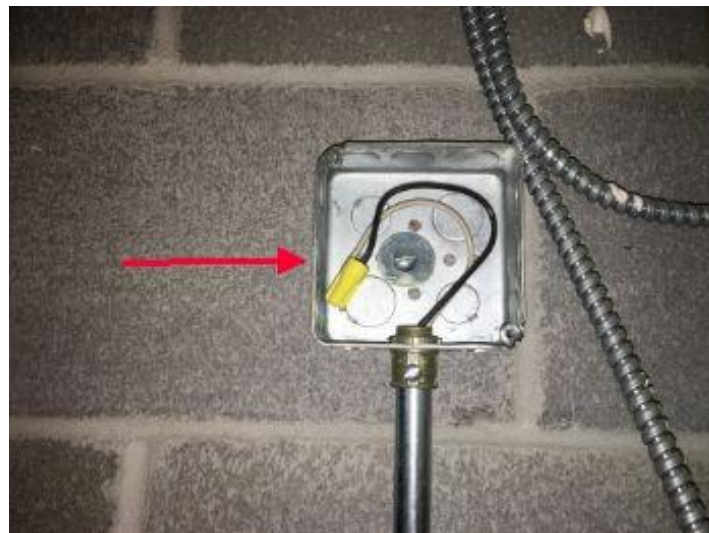
1st Floor Main utility room

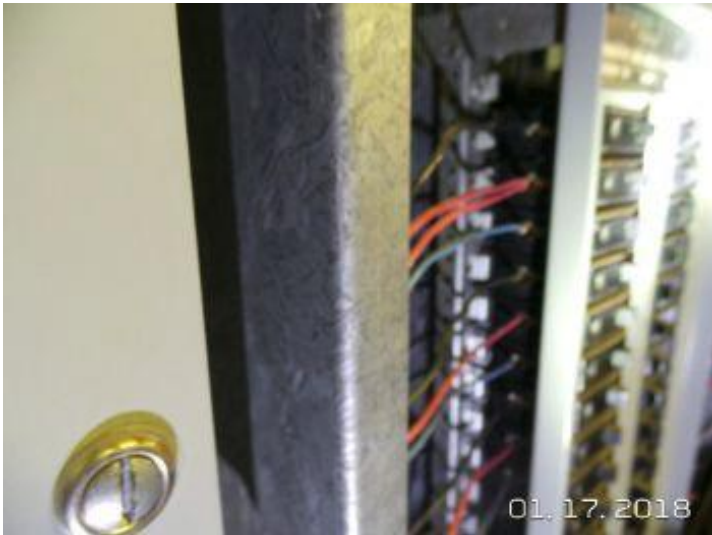
- Noted one or more double tapping to a circuit breaker in the main utility room, this should be corrected by a licensed electrician
- Noted one or more wires in the ceilings not properly terminated

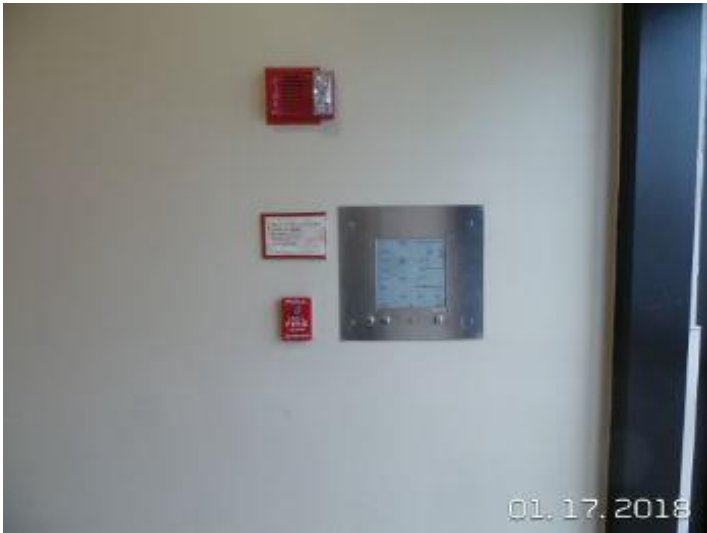
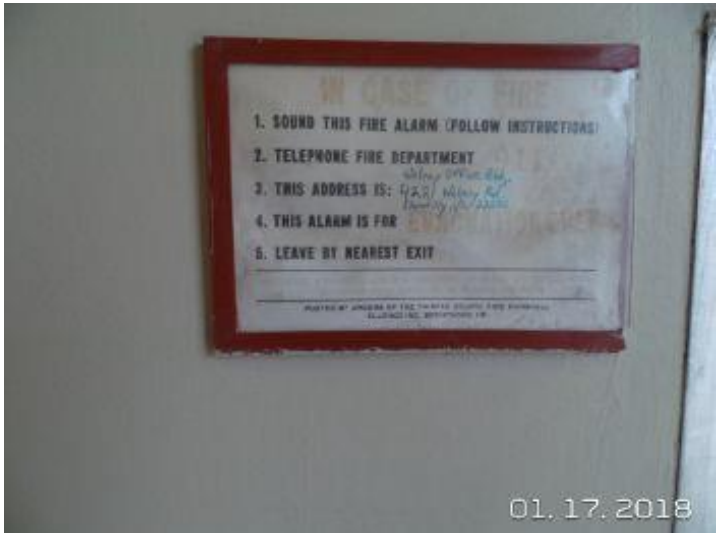
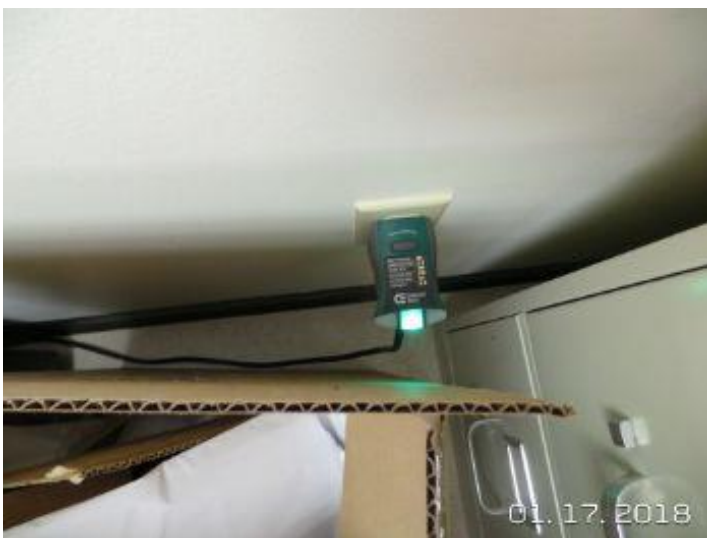
- Fire Alarm System: it is present and in proper areas, testing the fire alarm system is beyond the scope of this inspection. We recommend contacting the Fire Marshal for testing the system.
- Fire alarm on the 5th floor ceiling is broken

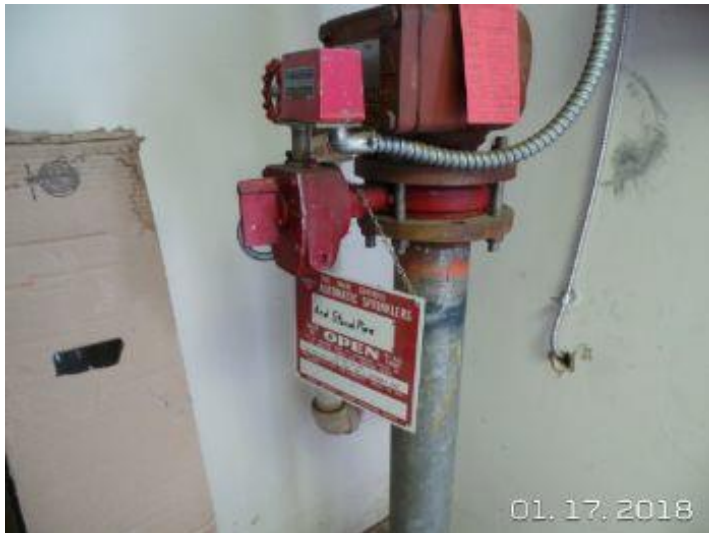
1st Floor Main Utility Room

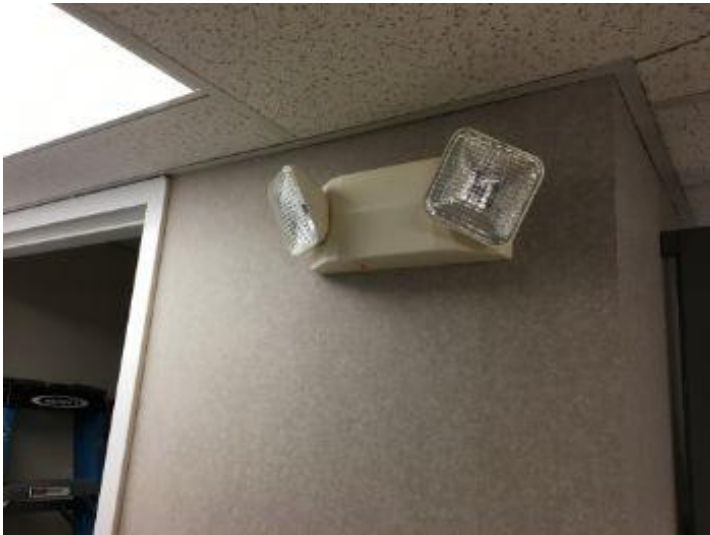
- Emergency lighting systems: adequacy or performance questionable.
- Several emergency lights did not respond to test. Several emergency lights are broken or not functional

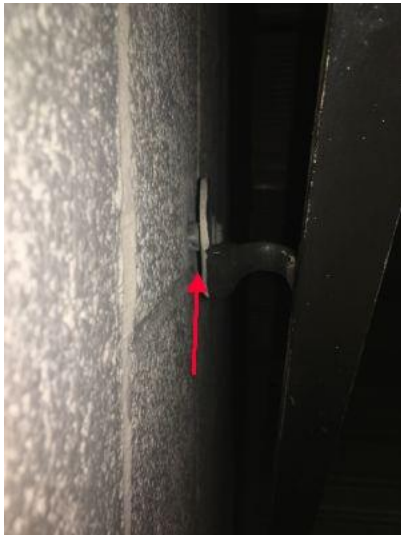
- Several stairwell handrail are loose or unstable.

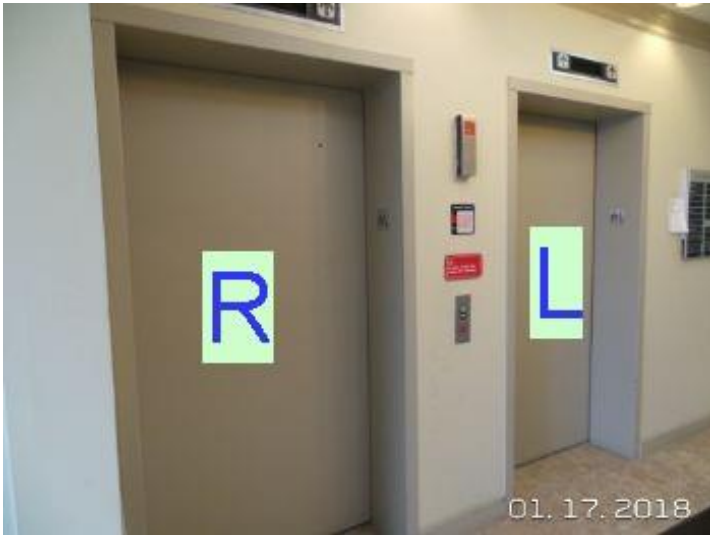
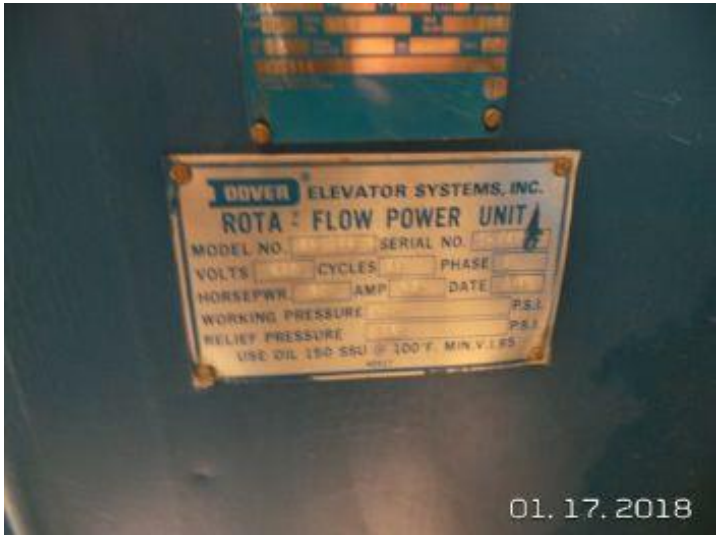
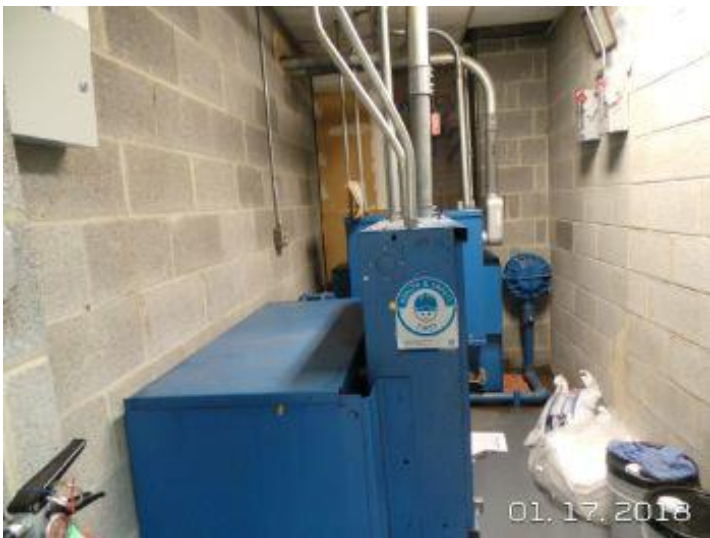
Mechanical room - 1st Floor

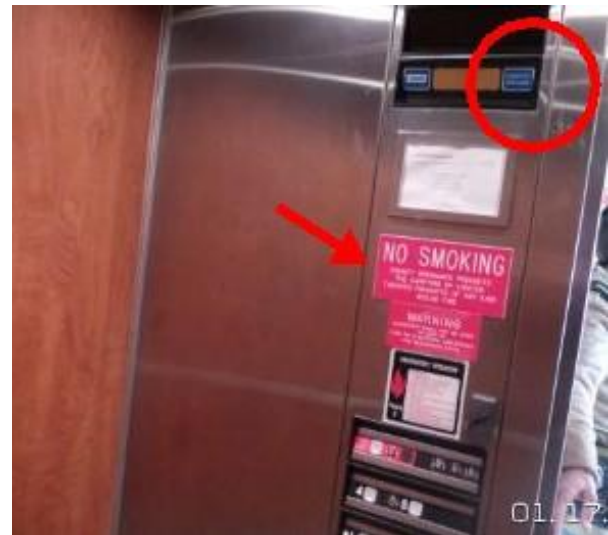
Mechanical room - 1st Floor

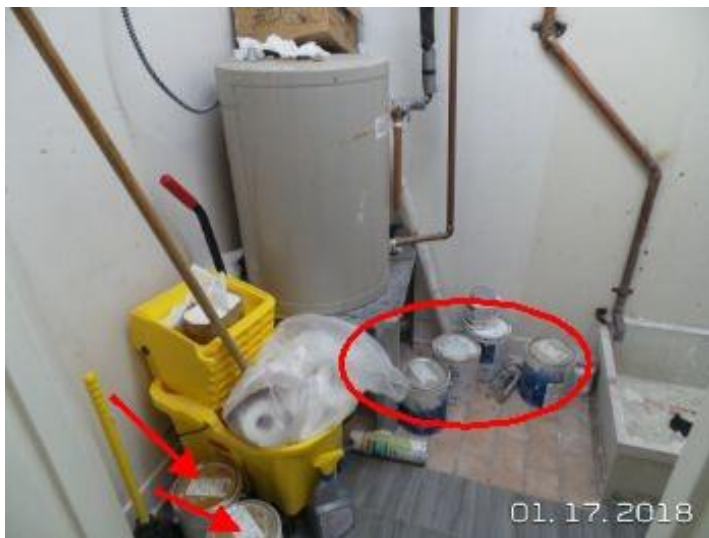
2nd Floor - Bathroom

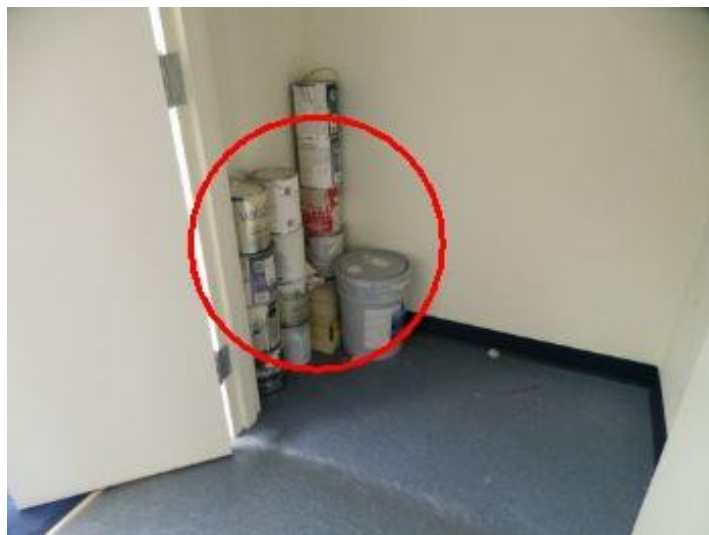
4th Floor - Hazard Material

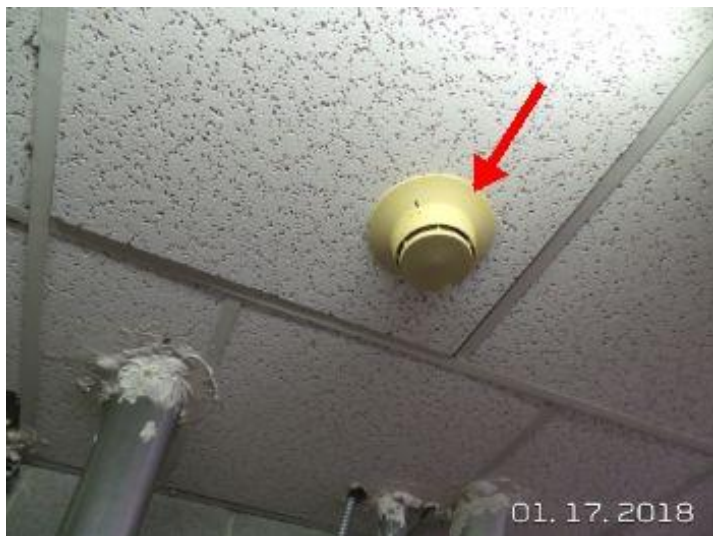
1st Floor Main Utility Room

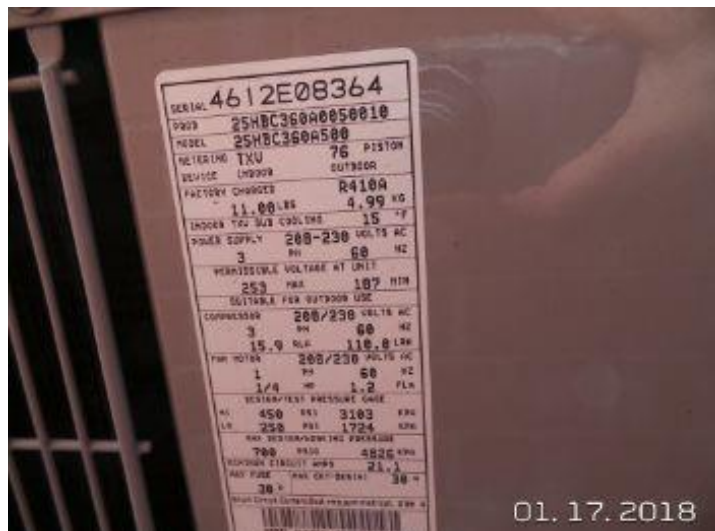
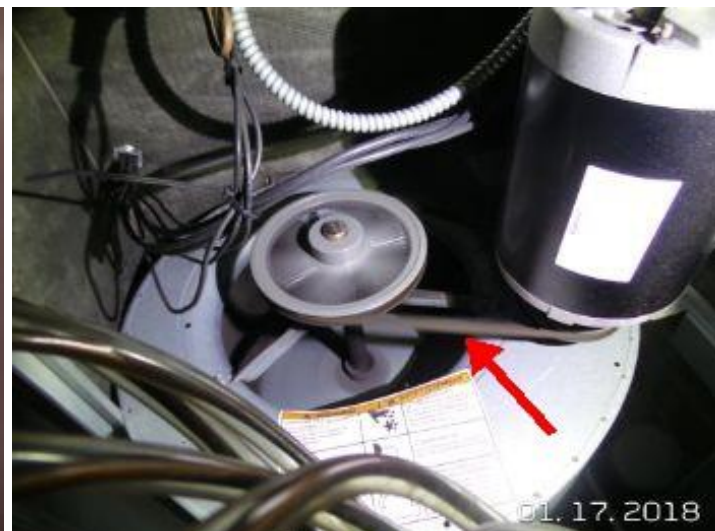
1st Floor - behind the building

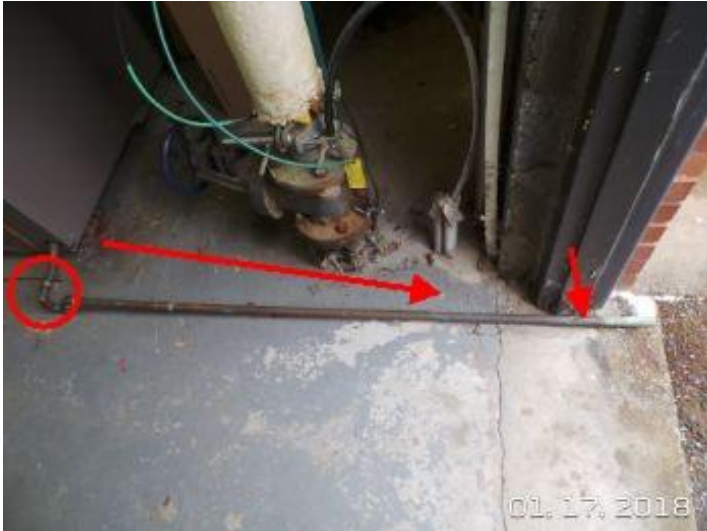
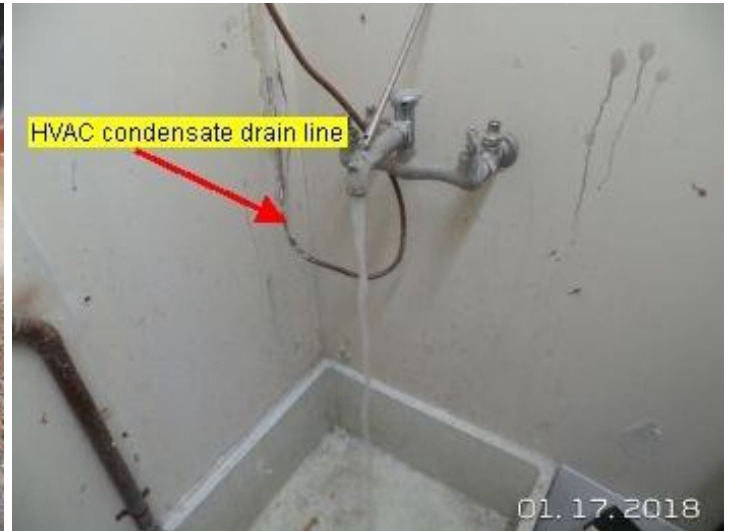
- The condensation line in the main utility room is crimped by the door and negatively slopped
- One or more condensate lines were loose and not properly directed for drainage

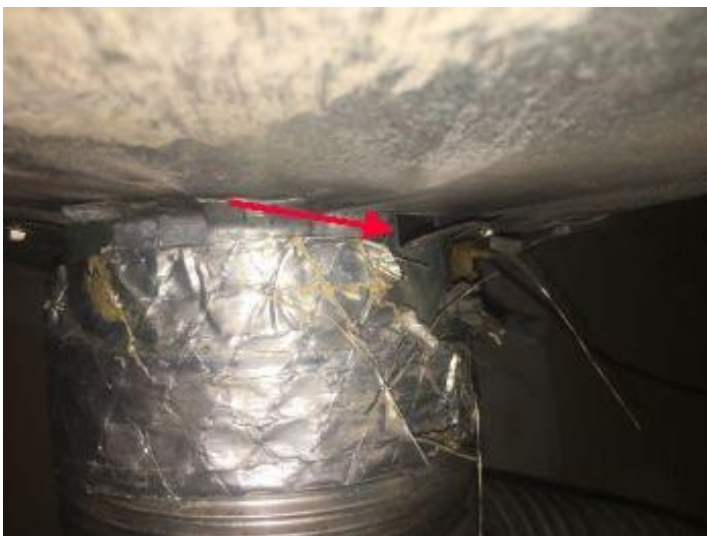
- Several ductwork are broken, bended, or damaged which leads to energy loss by leaking hot and cold air.
- Most of the ductwork between the different floors above the ceilings are not insulated and there is evidence of moisture/condensation accumulation.

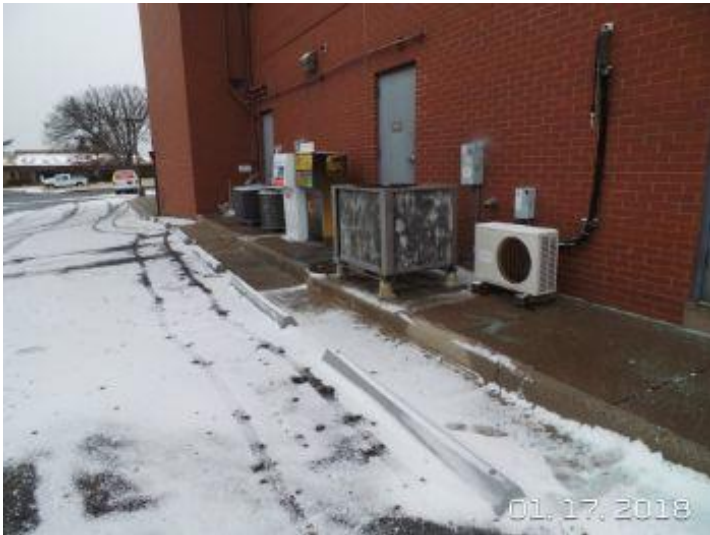
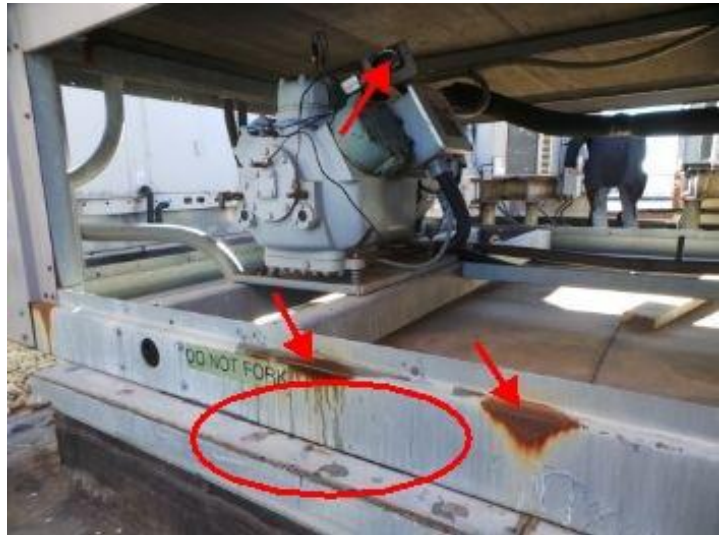
- The condensers are on the roof and the back of the building on the 1st floor
- Maintenance Tip: Recommend that HVAC professional seasonally check the air conditioning unit, and ensure the unit is level. This can be accomplished at the same time as the annual furnace inspection.
- Some data plates on the exterior units were weathered and not legible at the time of the inspection.
- Air Conditioning line set has missing or damaged insulation; we recommend repair by a licensed HVAC specialist.
- Rust/Stained at exterior condensers, we recommend further evaluation and service by a licensed HVAC professional.

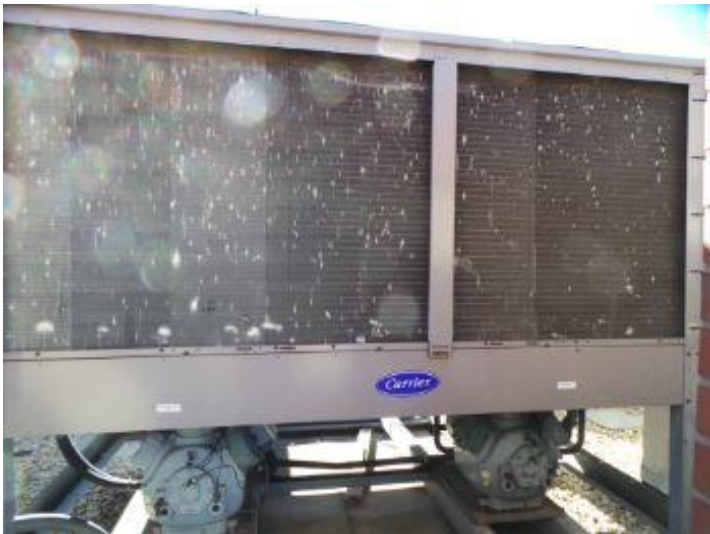
HVAC Stack missing condensation channel

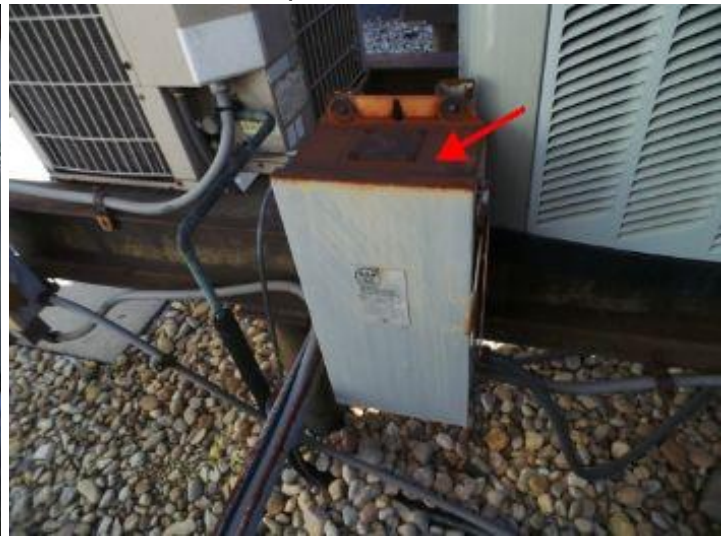
Rooftop Unit - Excessive Rust

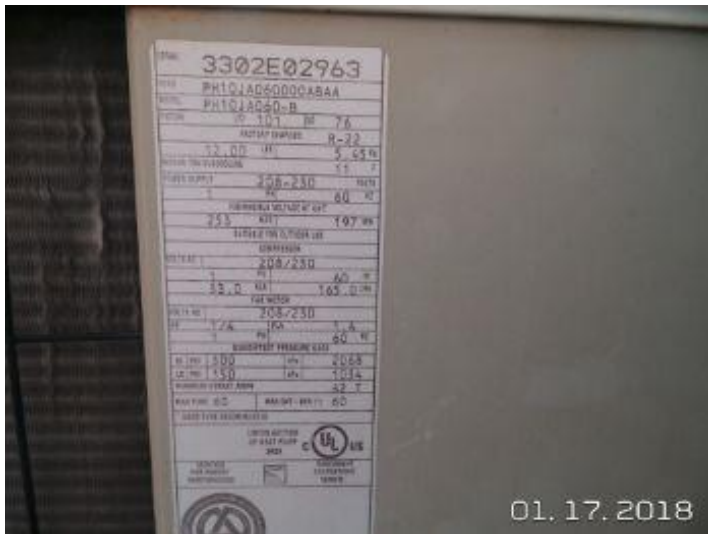
1st Floor - behind the building

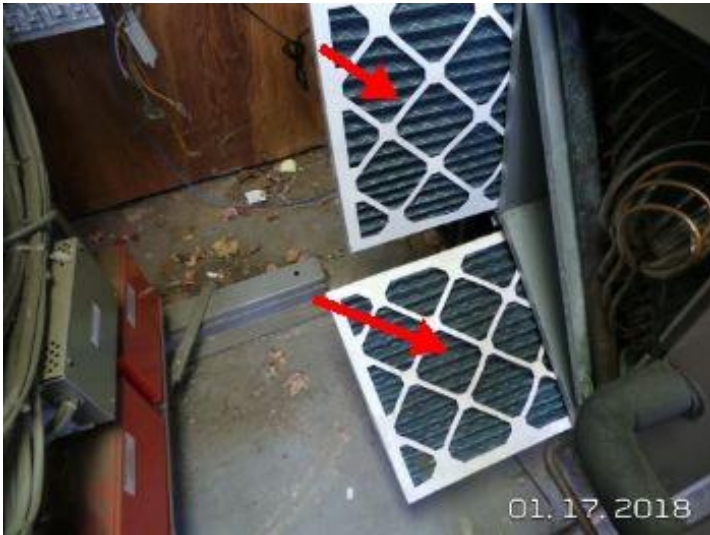
1st Floor Main Utility Room - Access Bank

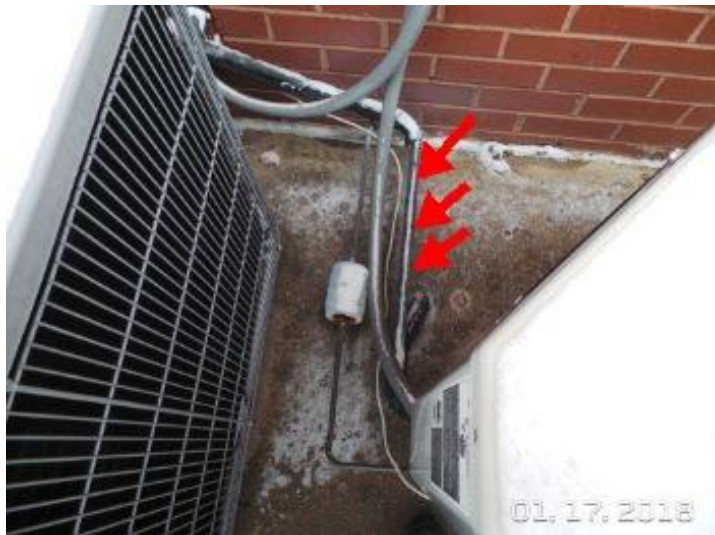
1st Floor - behind the building

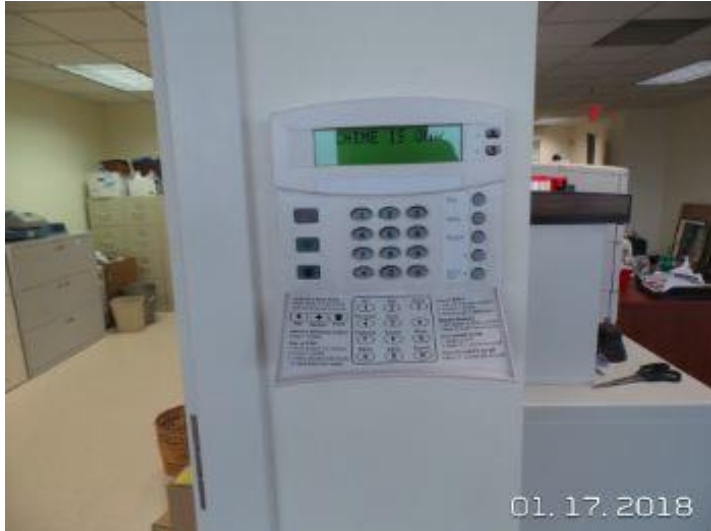
- IMPROVE: Non-programmable thermostats have no energy saving capabilities as do digital setback-type thermostats. Recommend an upgrade to a modern, digital programmable thermostat.

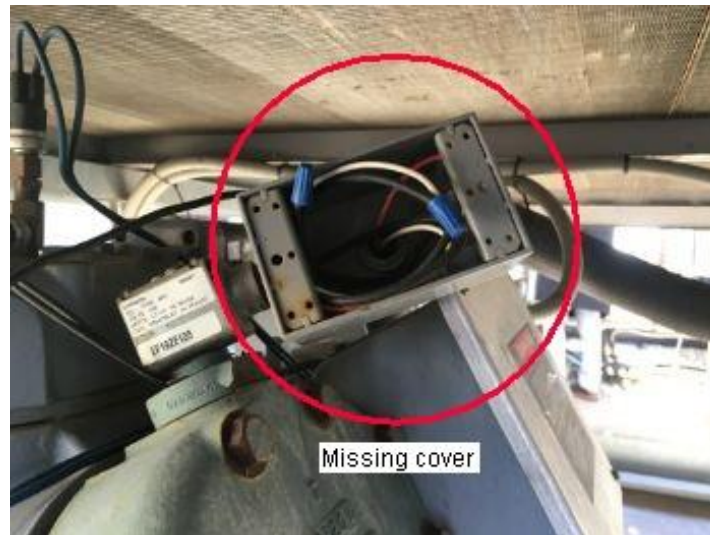
- Missing Junction box cover next to the motor of the HVAC stack compressors on the roof

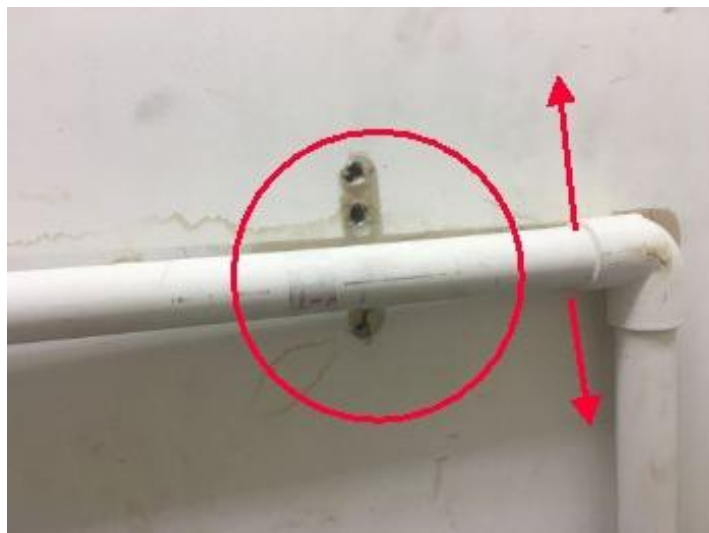
- one or more drainage pipes were loose at the time of the inspection

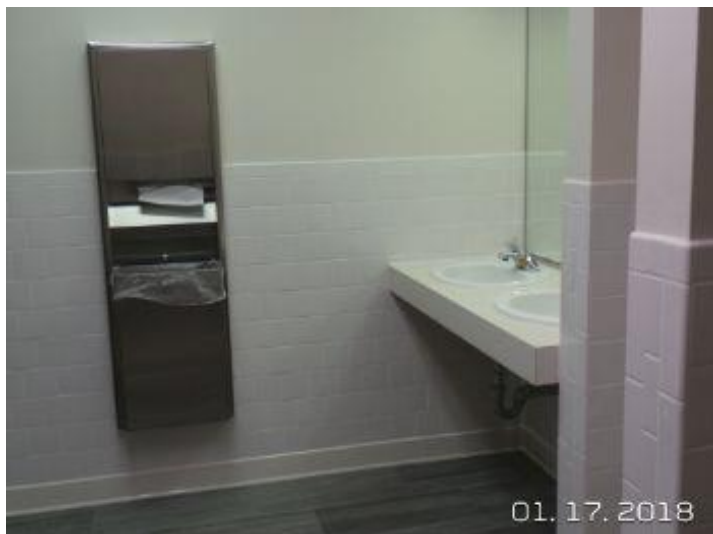
2nd Floor next to the elevators

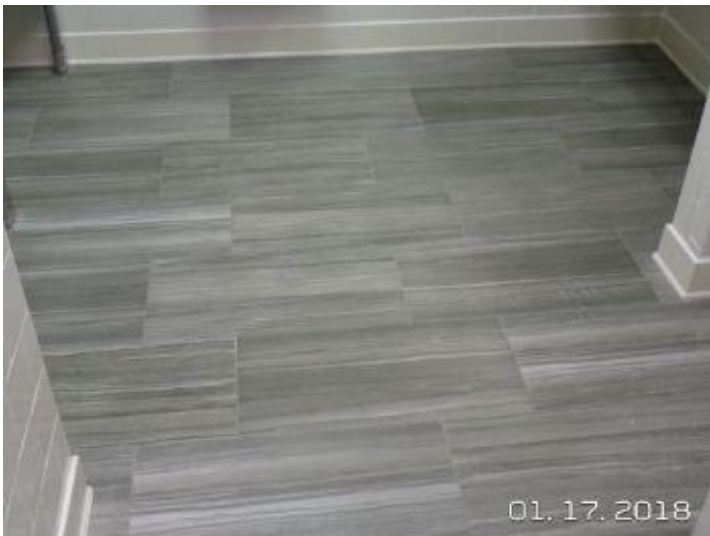
- Several bathrooms have broken or missing tiles
