NextDay Inspect

Commercial Inspection Report

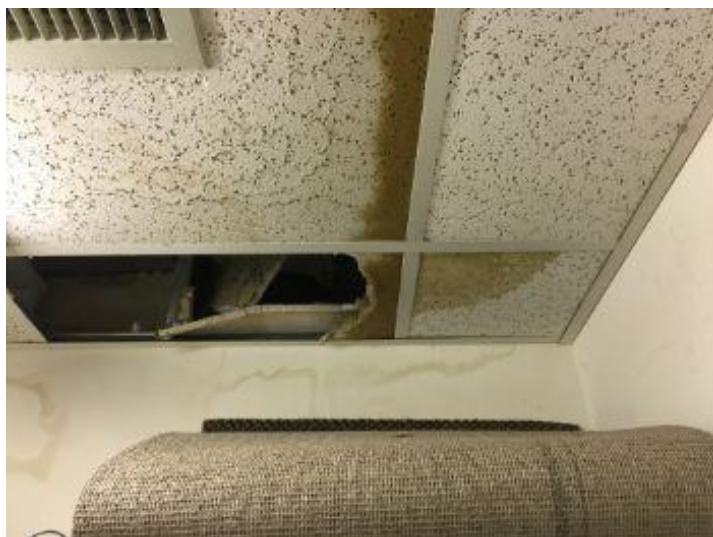
- Several bathrooms have stained ceiling tiles, this is evidence of past leak or moisture, but there was no active leak at the time of the inspection in any of the bathroom ceilings
- Some ceiling tiles are missing, broken, or misplaced

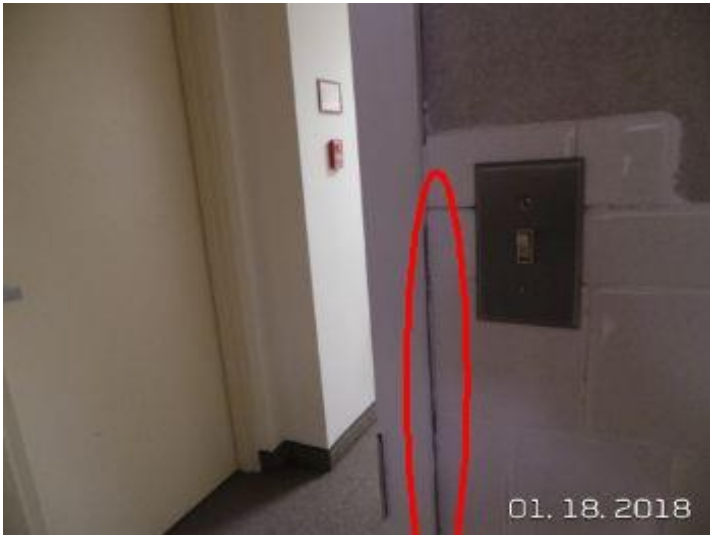
3rd Floor - Men Bathroom

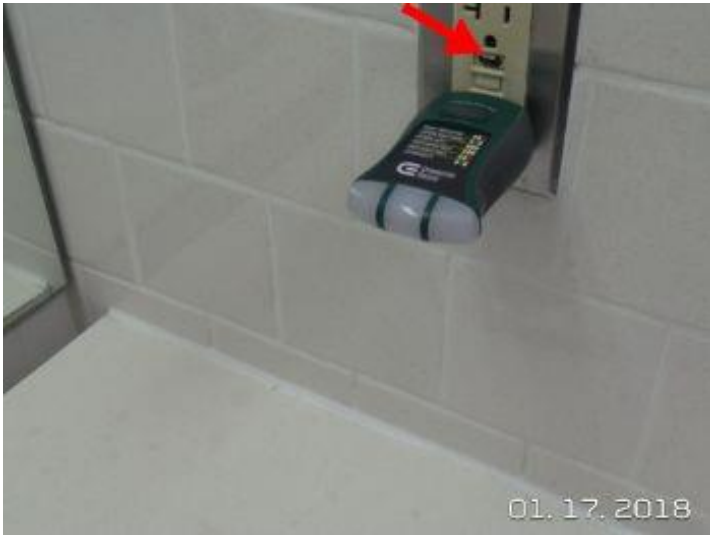
- Some bathrooms have non **GFCI** outlet next to the sink, some GFCI outlets are not functional or broken, repair as needed

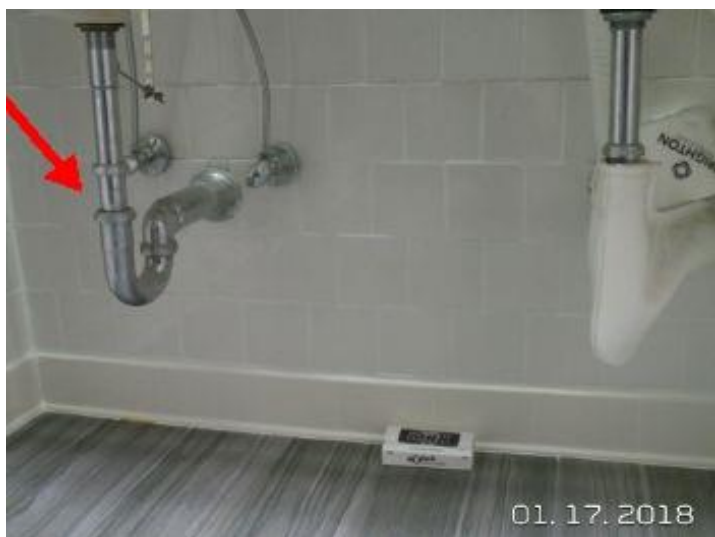
- Recommendation: replace metal drain pipes with **PVC** pipes, as metal pipes tend to corrode, rust and deteriorate on the inside, therefore they are prone to leak at anytime
- There is evidence of previous leak under the sink in the Men Bathroom on the 5th floor

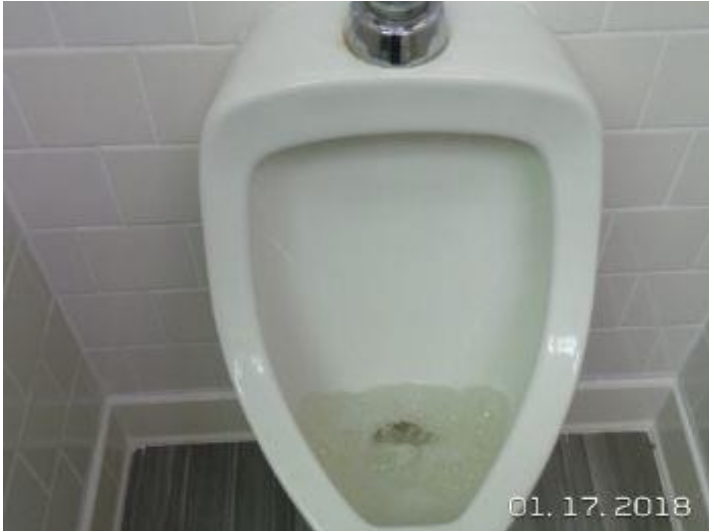
- All urinal stalls were tested and they were functional at the time of the inspection
- Some stalls have gaps and/or deteriorated grout, we recommend Caulking all cracks and gaps with silicon or other sealants.

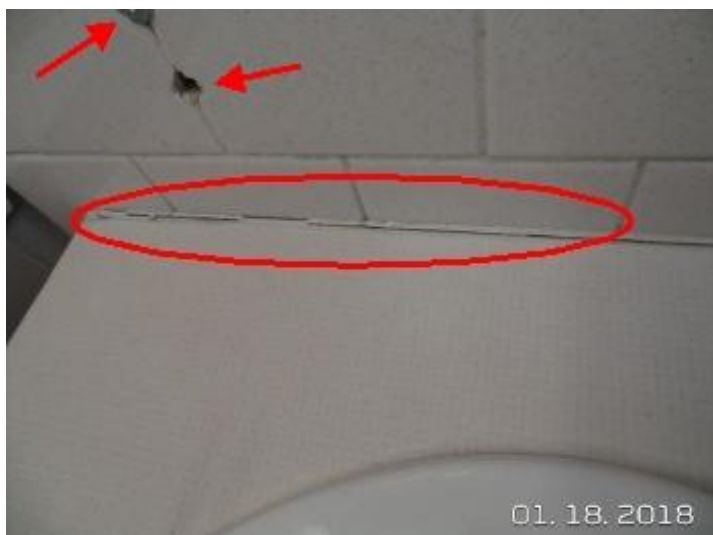
3rd Floor - Men Bathroom

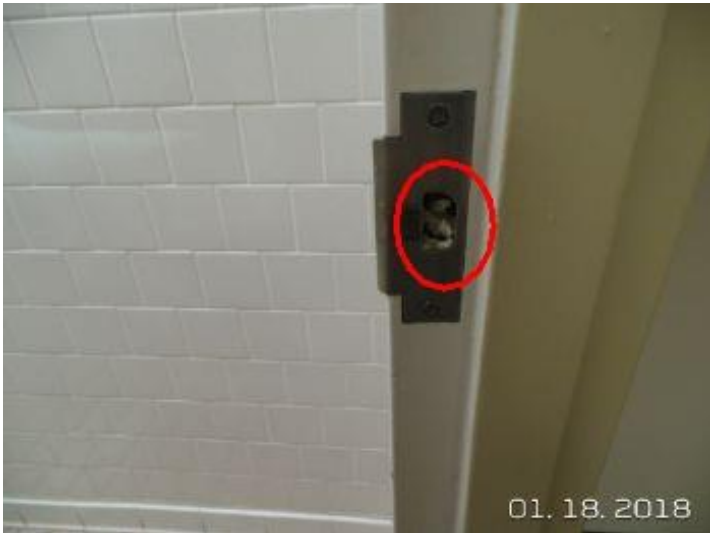
3rd Floor - Women Bathroom

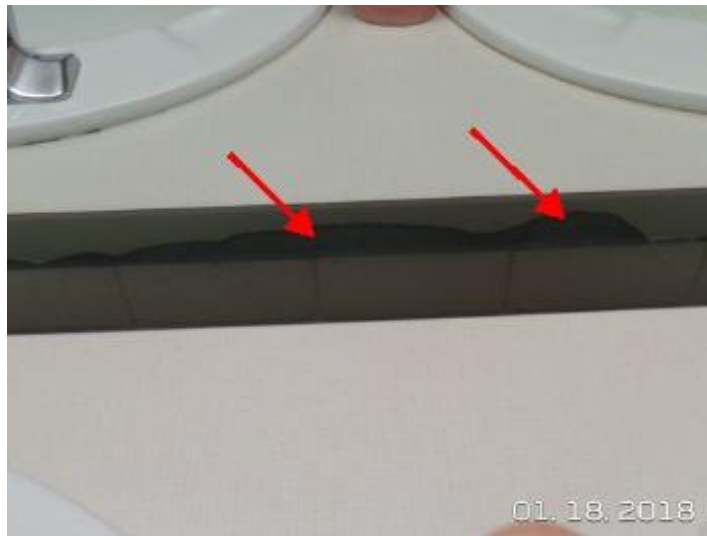
4th Floor - Men Bathroom

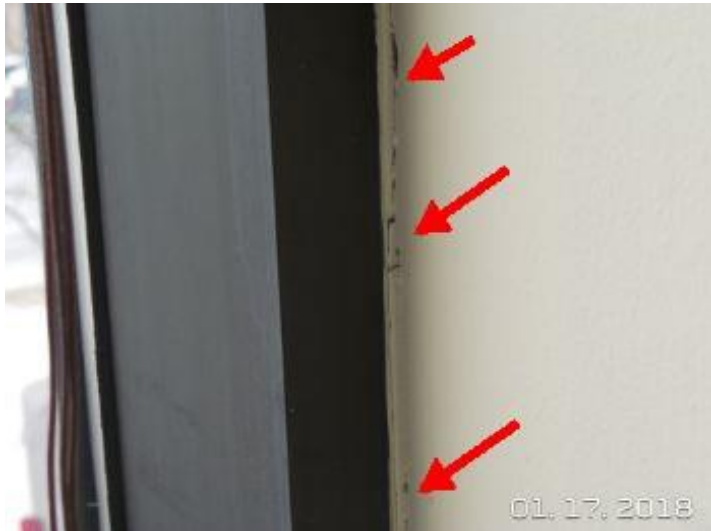
2nd Floor next to the elevators

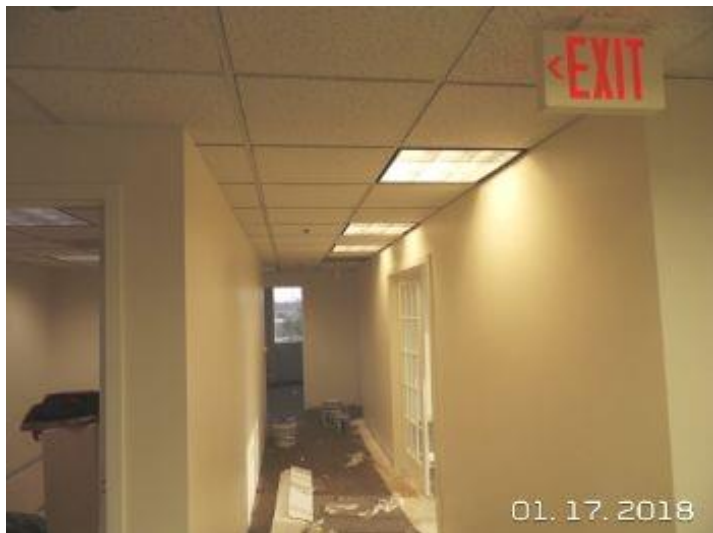
- Except for the areas under repair, the floors are in a fair condition for their age
- **Noted wet carpet floor on the 5th floor reception area which carried on to the floor on the 4th floor**

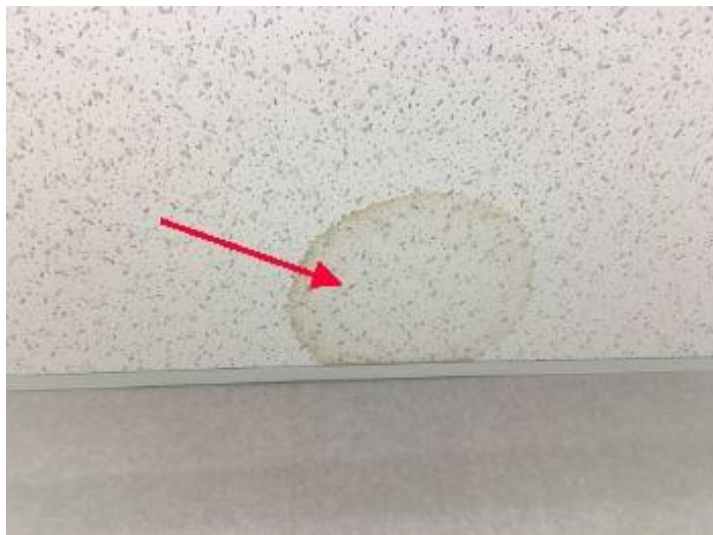
- Several ceiling tiles are missing and/or misplaced. Repair and install ceiling tiles as needed
- Several ceiling tiles are stained, this evidence of previous leak or accumulation of moisture. These tiles were dry at the time of the inspection. No active leak at the ceilings was noted at the time of the inspection

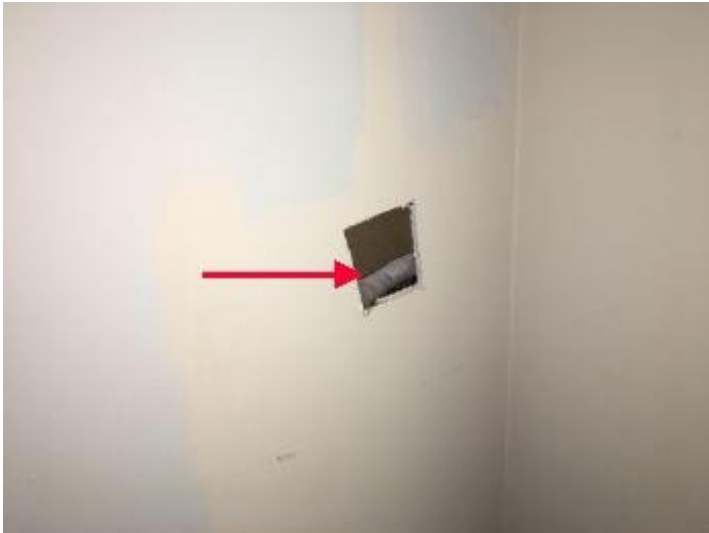
1st Floor Main Flooring Store

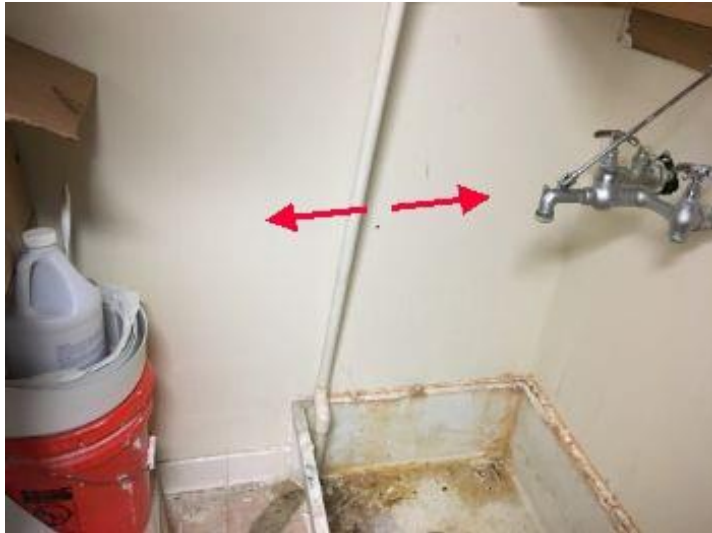
- Noted excessive corrosion on some water supply pipes
- One or more water heater drain pipe are unstable

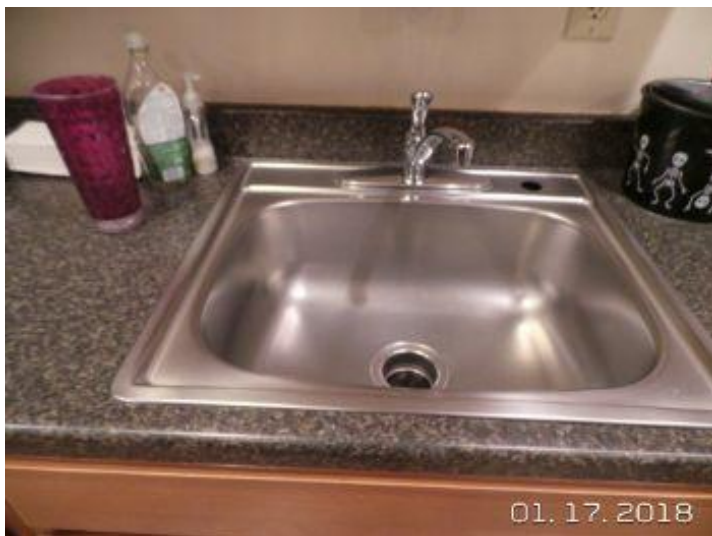
1st Floor - Access Bank

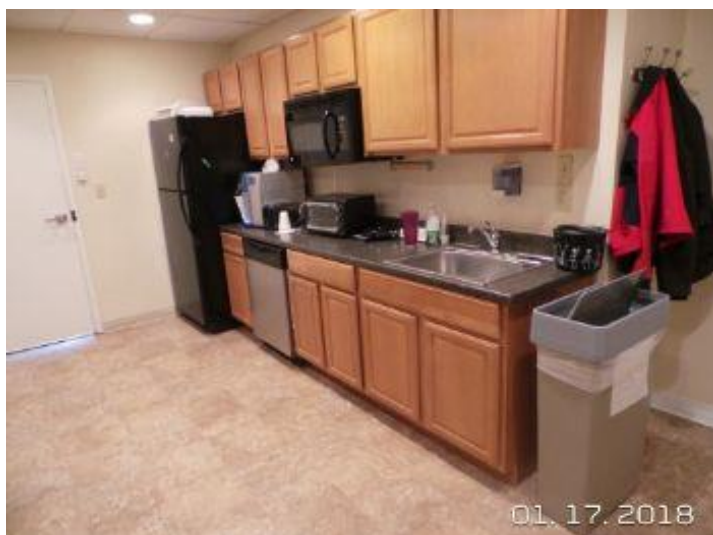
1st Floor - Access Bank

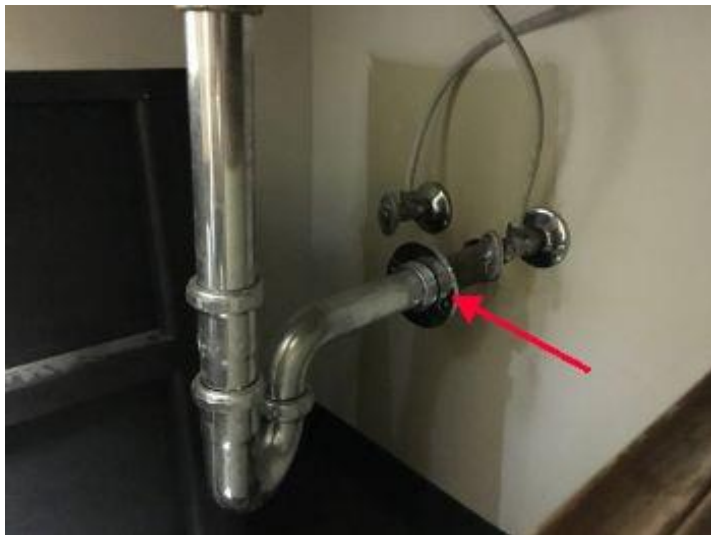
1st Floor Main Flooring Store

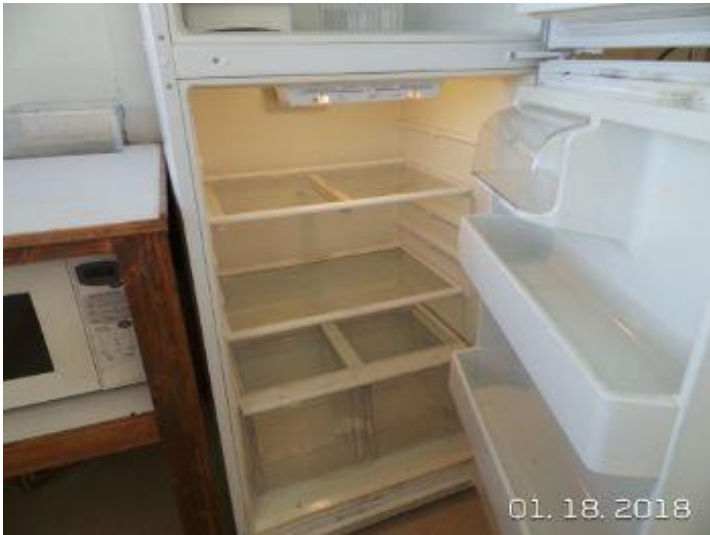
- Several refrigerators are dirty and some are missing the ice collector pans

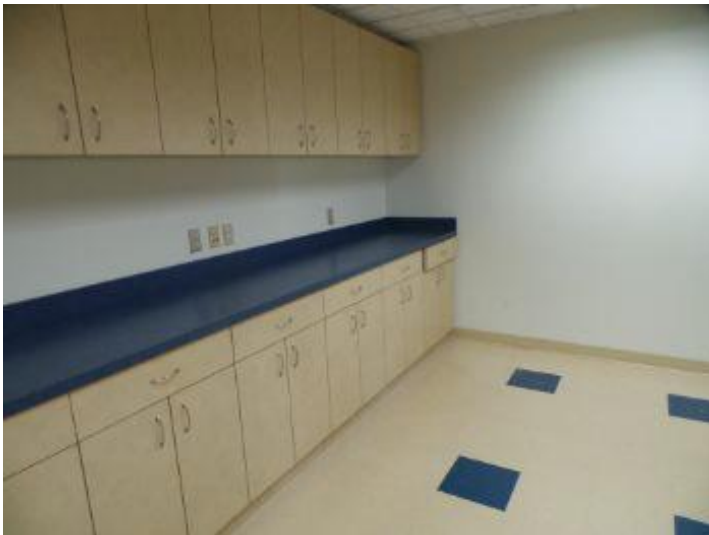
- Functional, no deficiencies were noted at the time of the inspection, except for the sink cabinet on the 4th floor
- The sink cabinet in the open area on the 4th floor has irregular cut in the back and the drawers are not aligned which obstruct their normal operation, also, the counter of this cabinet needs caulking with silicon or other sealant to prevent water penetration.

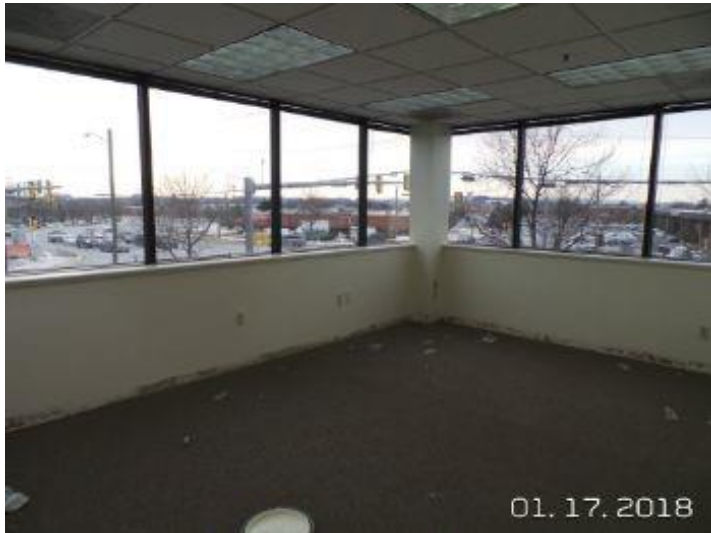
- Several ceiling tiles are stained, but dry, this is an indication of previous leak or moisture accumulation.
- Several ceiling tiles are missing, chipped, broken, or misplaced
- Several sprinkler heads on the ceilings are missing the head covers

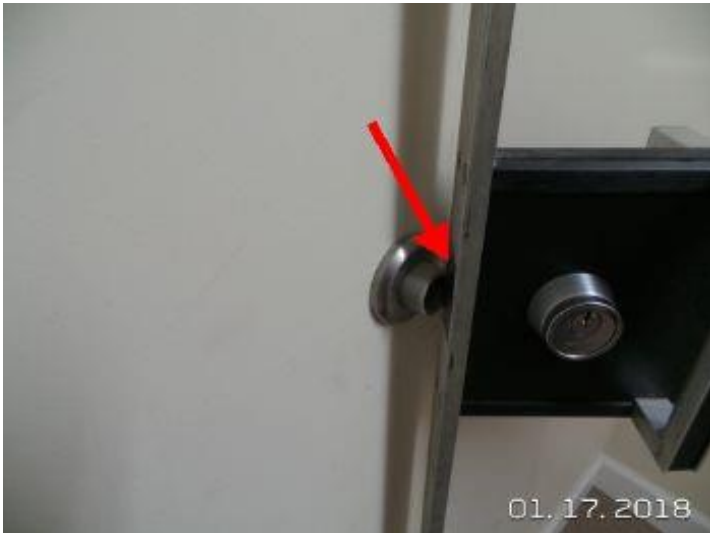
1st Floor - Access Bank vault area - door stopper

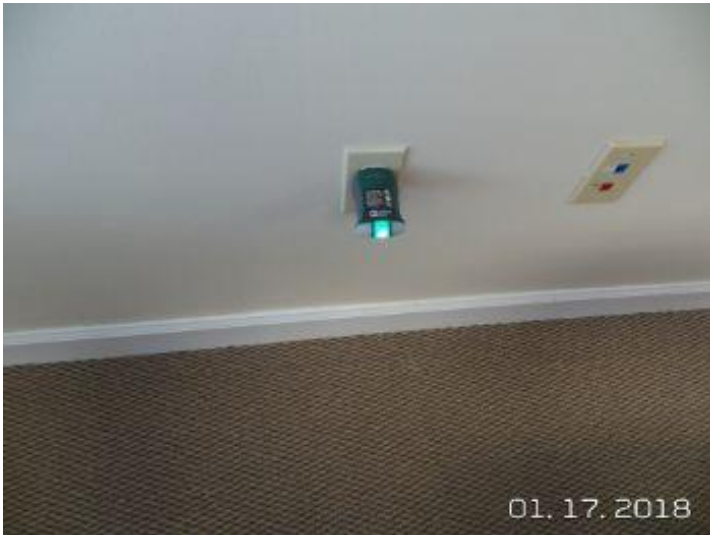
1st Floor - Access Bank

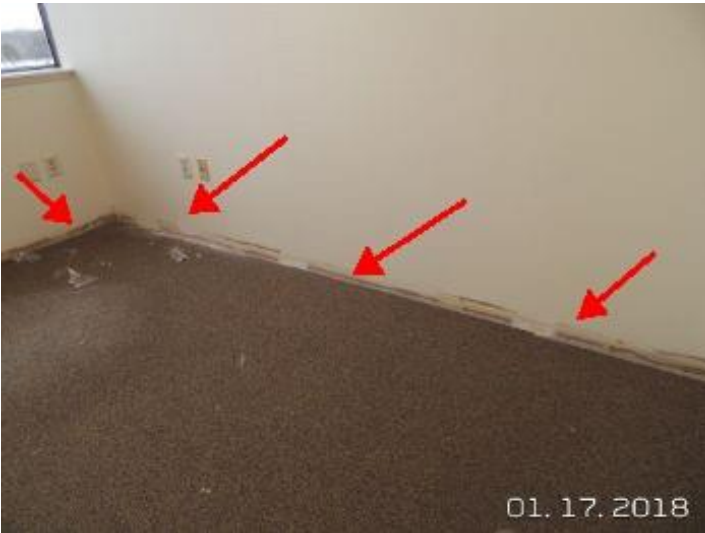
- Several areas show excessive wear

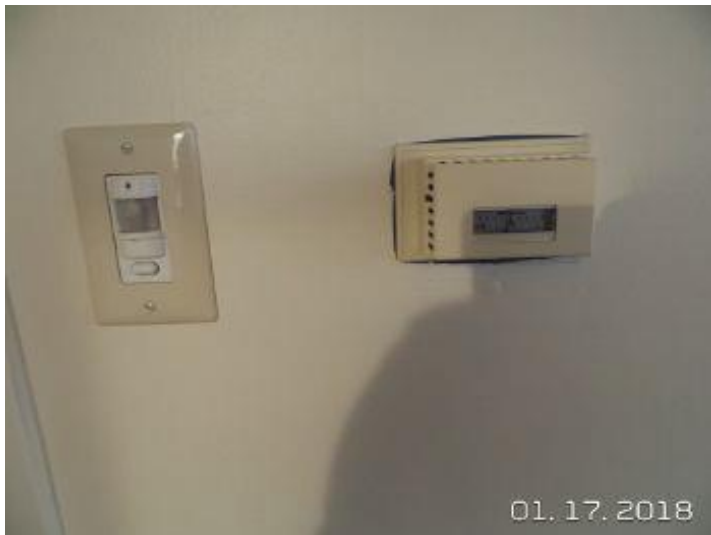
- Several local office analog thermostats were broken or not functional.

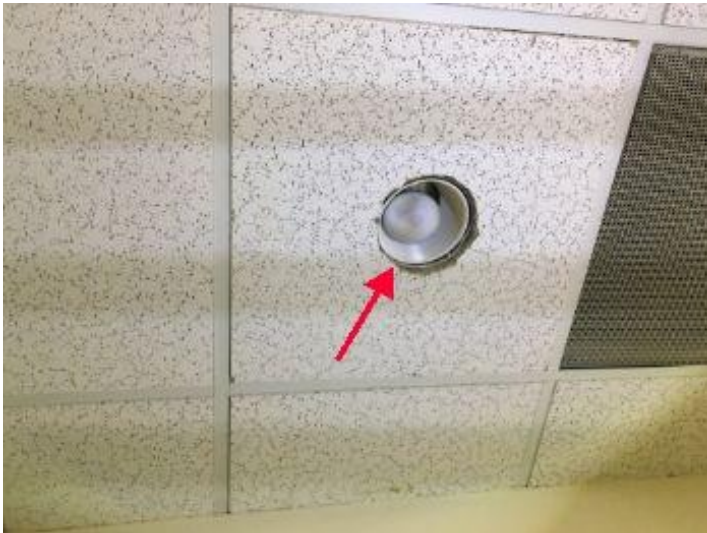
1st Floor Main Flooring Store

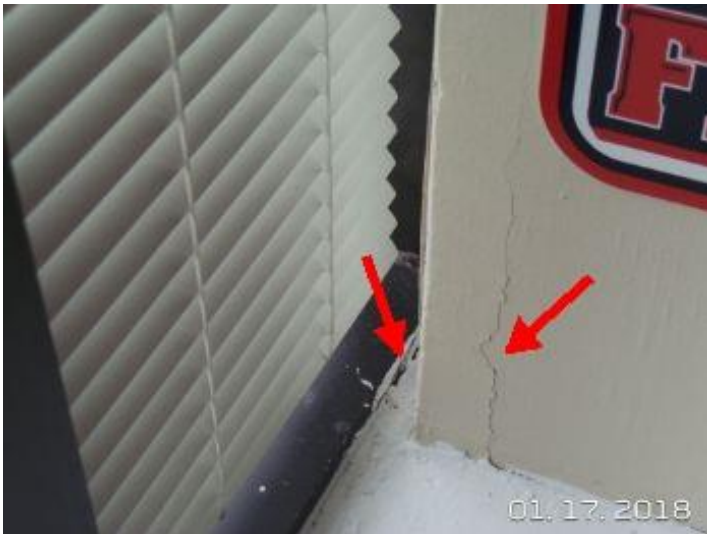
1st Floor - Access Bank
