# INSPECTION REPORT

10010 Sample St, Sample, VA 01010

Age of Home: 66 yrs (1959) Size: 697 sqft

Home Type: Condominium one level

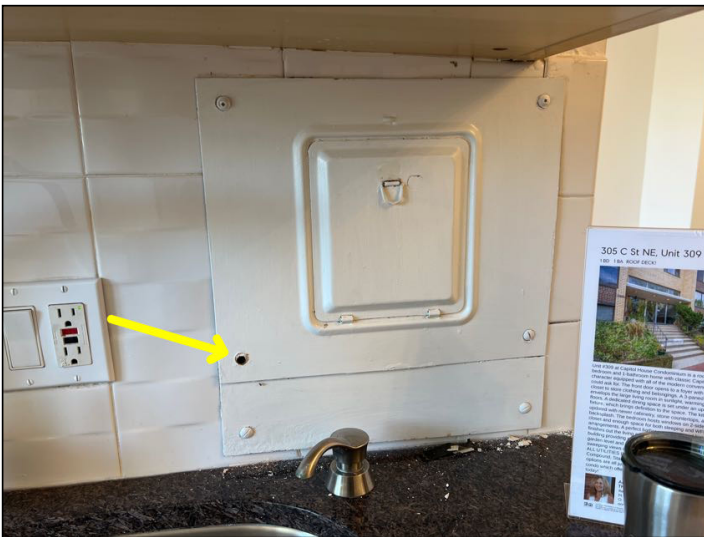
- Sharp-pointed metal screws hold panel cover in place. These are a potential hazard as they may puncture wire insulation and electrify panel box, becoming a shock or electrocution hazard. These screws should be replaced with approved, flat-tipped screws.
- **Recommend replacing sharp screws with approved flat tipped screws at the electrical panel for safety**
- **Panel cover screws missing. Recommend replacement of missing screws with flat tipped machine screws.**
- **The breakers were not labeled at the panels circuit directory. Recommend labeling each breaker (circuit) to properly identify**

Missing screw

| Page 11 Item: 1 | Electrical Panel | <ul style="list-style-type: none"> <li>Panel cover screws missing. Recommend replacement of missing screws with flat tipped machine screws.</li> </ul> |

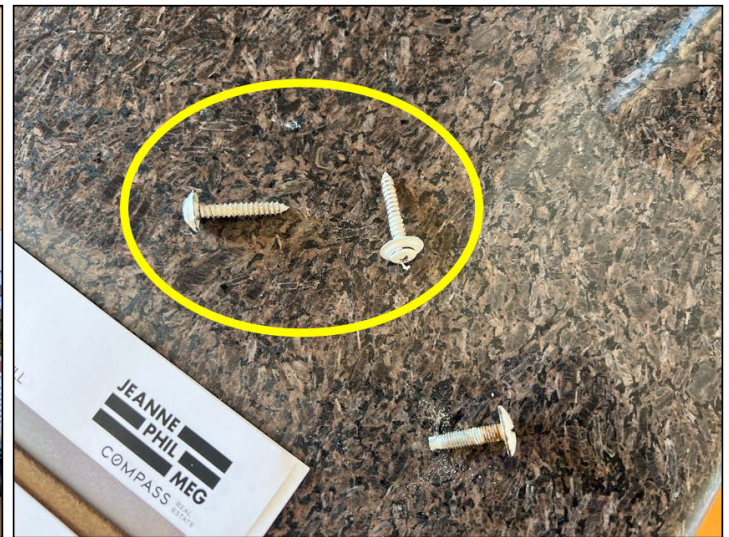
Sharp screws

| Page 11 Item: 1 | Electrical Panel | • Recommend replacing sharp screws with approved flat tipped screws at the electrical panel for safety |

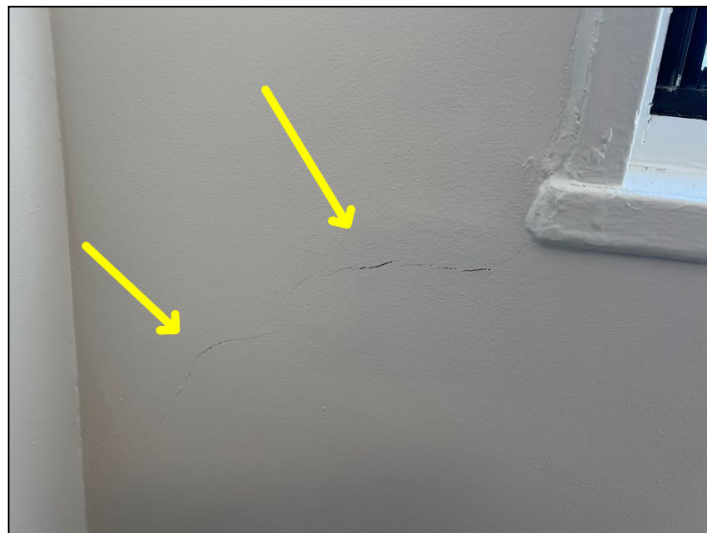
- Gaps/cracks noted in one or more locations. Recommend repair/refinish as needed

Cracks

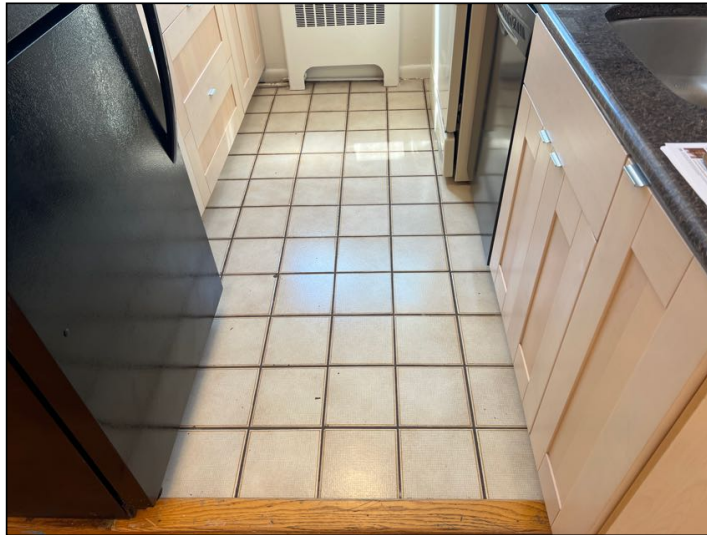
- Worn flooring and stains noted throughout. Recommend repair/replace as needed by a qualified contractor

Worn/stains

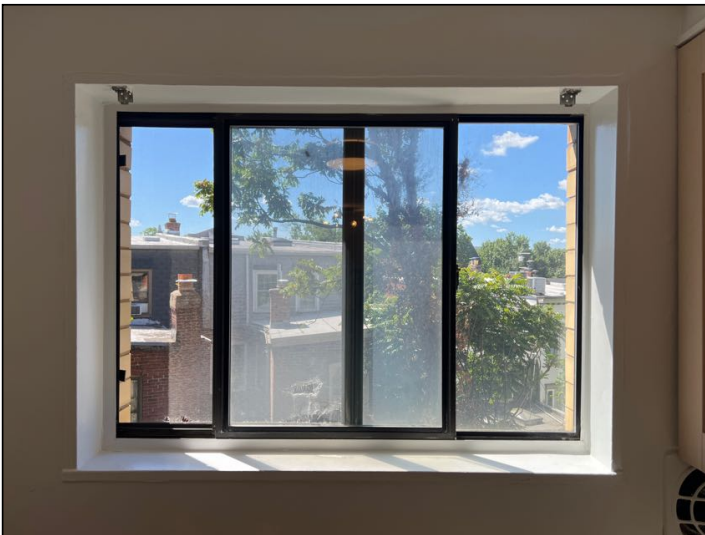
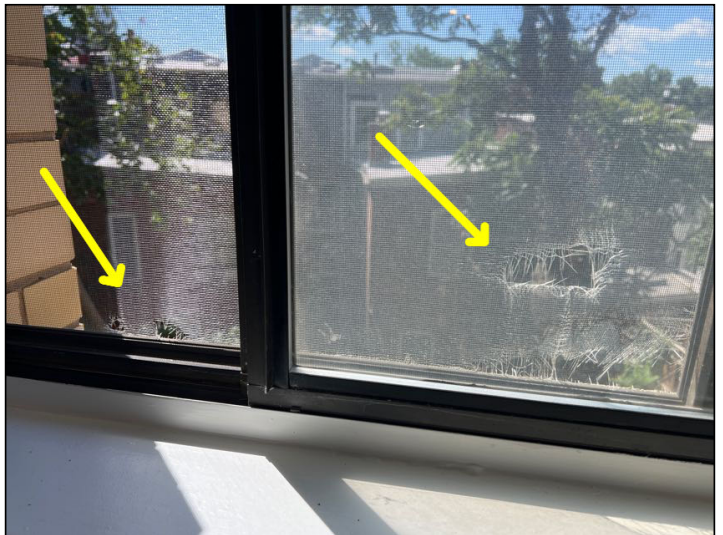
- All tested windows appeared functional at time of inspection.
- One or more damaged screens noted throughout property. Recommend installation/replacement to prevent pest intrusion.

Damaged screen

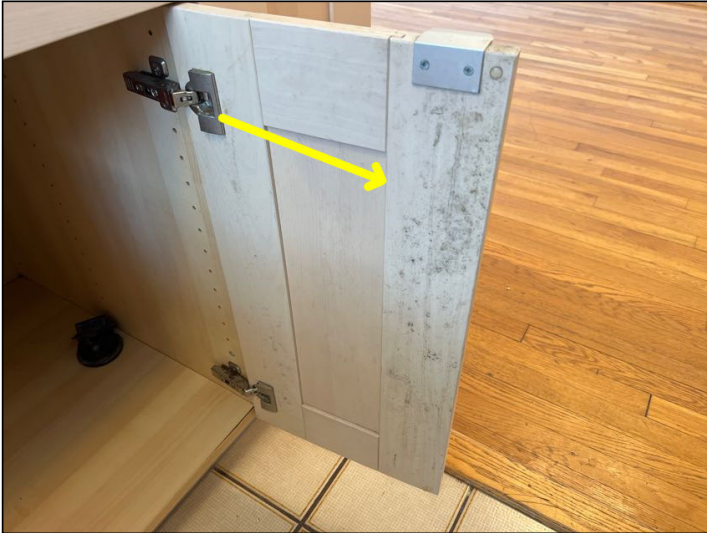
- Warping/buckling and moisture was detected at the cabinets structure and there was discoloration and odor noted, possible microbial growth
- Recommend testing for mold by a licensed specialist and further evaluation by a qualified contractor for moisture intrusion and repair/replacement as needed

Discoloration

| Page 21 Item: 8 | Cabinets | • Recommend testing for mold by a licensed specialist and further evaluation by a qualified contractor for moisture intrusion and repair/replacement as needed |

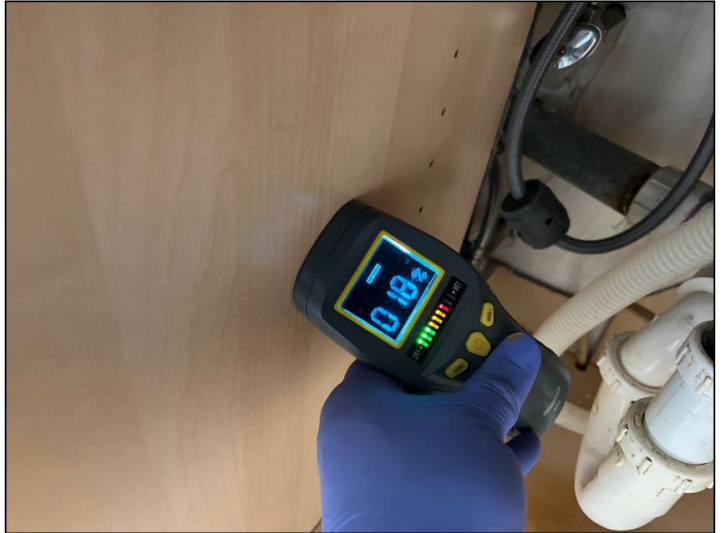
Moisture

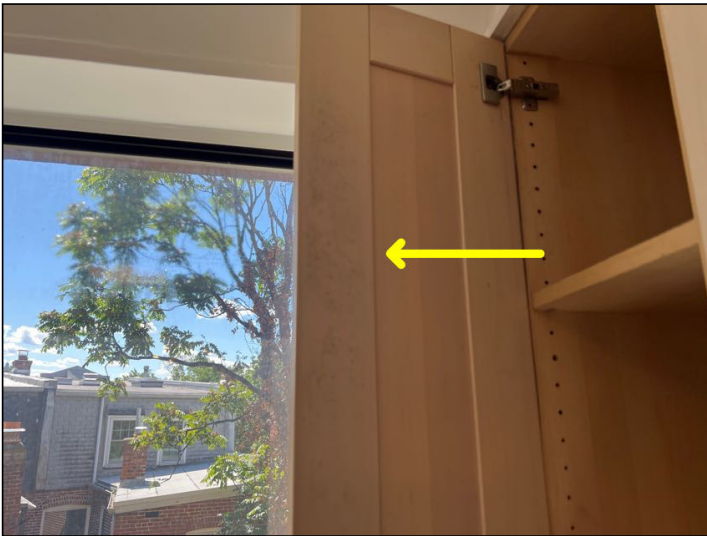
Discoloration

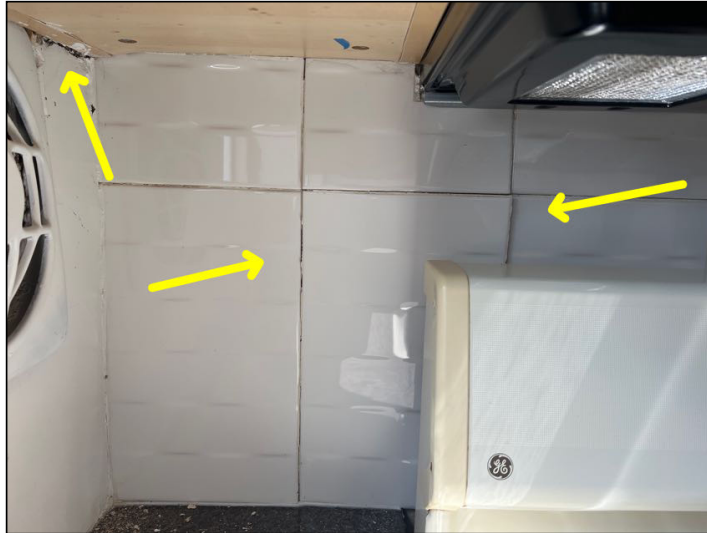
- Solid surface
- Loose/detached tiles and gaps noted at the backsplash. Recommend further evaluation by a qualified contractor for repair/replacement as needed

Gaps

| Page 21 Item: 9 | Counters | • Loose/detached tiles and gaps noted at the backsplash. Recommend further evaluation by a qualified contractor for repair/replacement as needed |

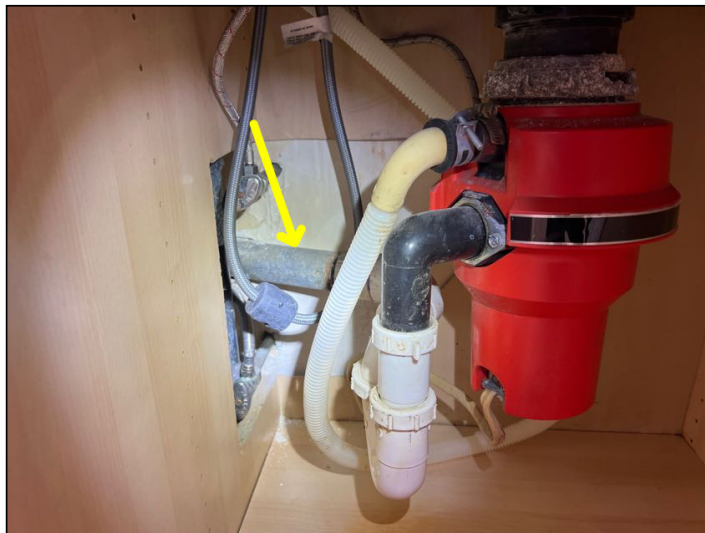
- Older metal drain piping noted. Buyer is cautioned that these pipes can leak at any time due to corrosion. Recommend replacing with **PVC/ABS**/plastic pipe by a licensed plumber

Metal

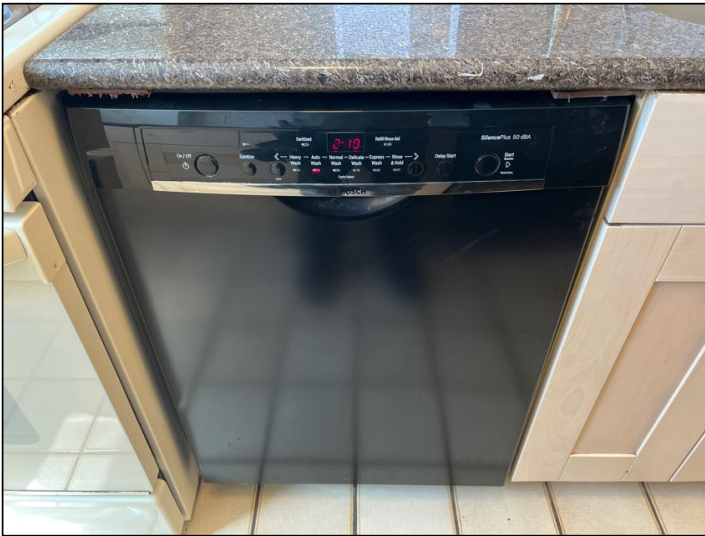
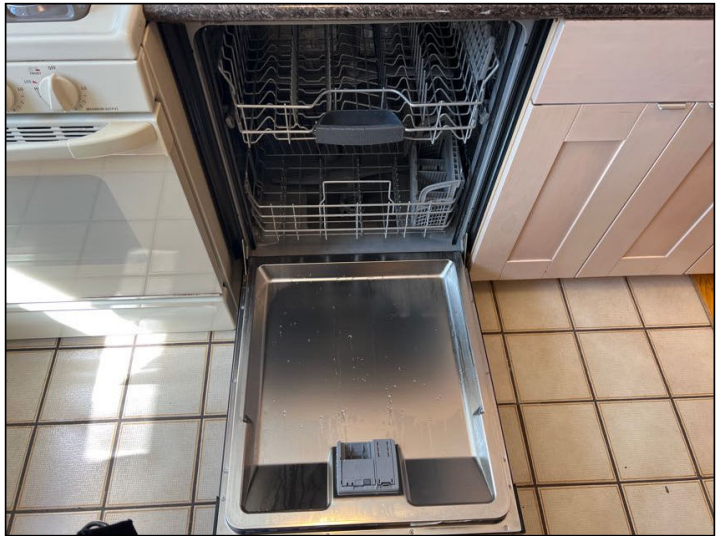
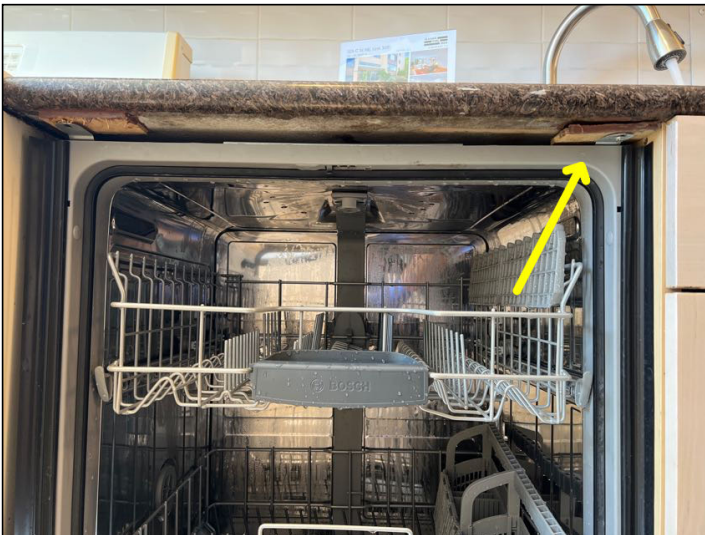
- Appeared functional using normal operating controls at time of inspection.
- Unit was not properly anchored to the counter top. Recommend properly securing unit by a qualified professional
- No high drain loop noted. Dishwasher high drain loop is to prevent back flow of water into the dishwasher. Recommend adding high loop for proper drainage

Not secured

| Page 24 Item: 13 | Dishwasher | • Unit was not properly anchored to the counter top. Recommend properly securing unit by a qualified professional |

| Page 24 Item: 13 | Dishwasher | • No high drain loop noted. Dishwasher high drain loop is to prevent back flow of water into the dishwasher. Recommend adding high loop for proper drainage |

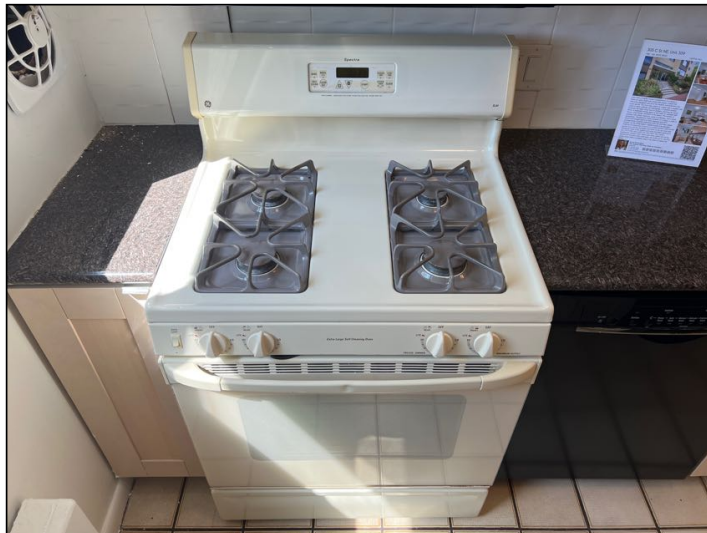
- Gas fired
- The gas service appeared to be off, unable to test the oven. Recommend client confirm proper function prior to closing
- Anti-tip bracket is missing from range installation. All freestanding ranges come with anti-tip bracket. Recommend installation by qualified appliance specialist.

| Page 26 Item: 16 | Oven/Range | • Anti-tip bracket is missing from range installation. All freestanding ranges come with anti-tip bracket. Recommend installation by qualified appliance specialist. |

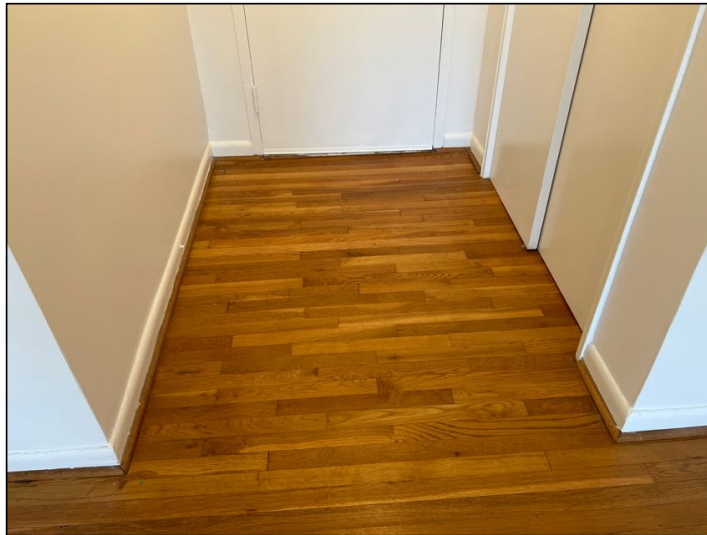
- Worn hardwood flooring noted throughout. Recommend refinish/replace as needed by a qualified contractor

Worn

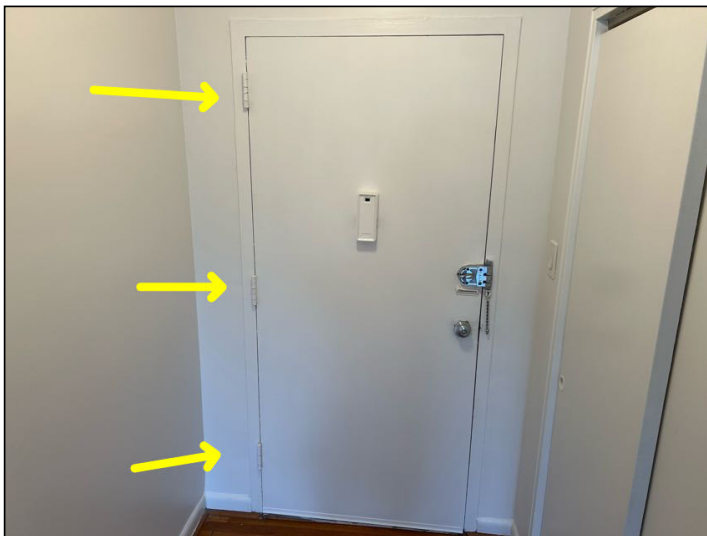
- Fire doors and auto closures are fundamental to the integrity of fire barriers which provide resistance to the spread of fire/smoke/carbon monoxide and provides security by reducing unauthorized entry. The door should close automatically when opened 12 inches or more and let go
- No auto closure present. Recommend installing an auto closure for safety and security.
- The entry door was worn at the time of inspection, loose hardware noted and the security latch was difficult to operate. Recommend upgrading door by a qualified contractor as needed

No auto closure

| Page 30 Item: 5 | Doors | • No auto closure present. Recommend installing an auto closure for safety and security. |

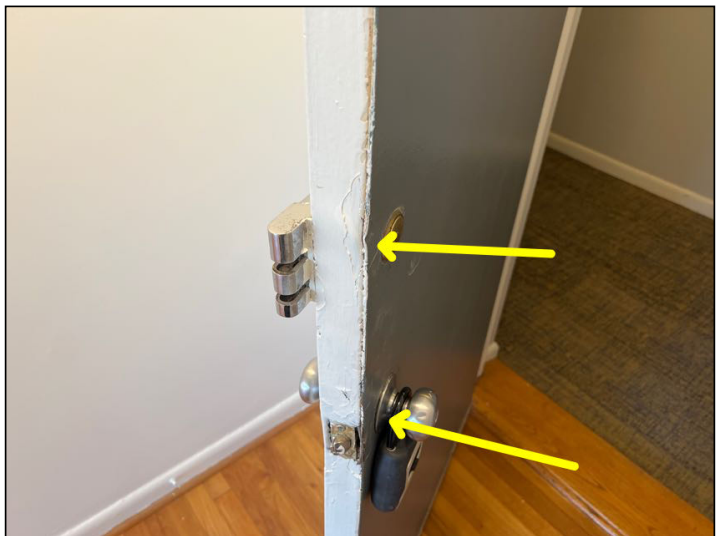
Worn door

| Page 30 Item: 5 | Doors | <ul style="list-style-type: none"> <li>The entry door was worn at the time of inspection, loose hardware noted and the security latch was difficult to operate. Recommend upgrading door by a qualified contractor as needed</li> </ul> |

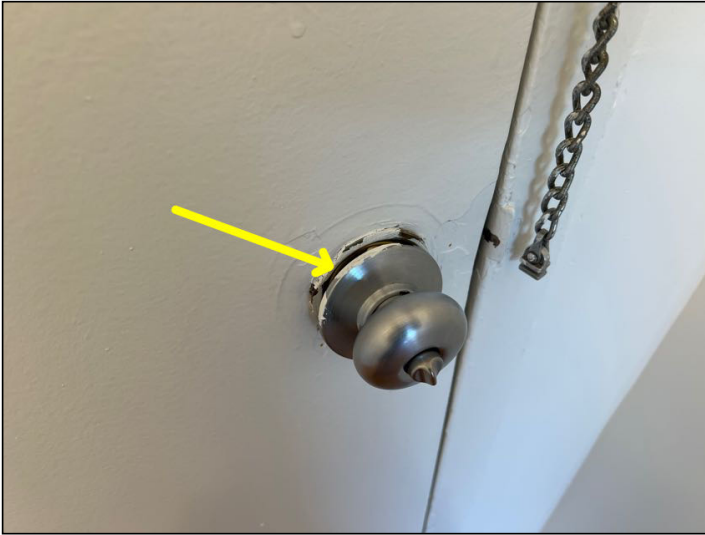
Loose hardware

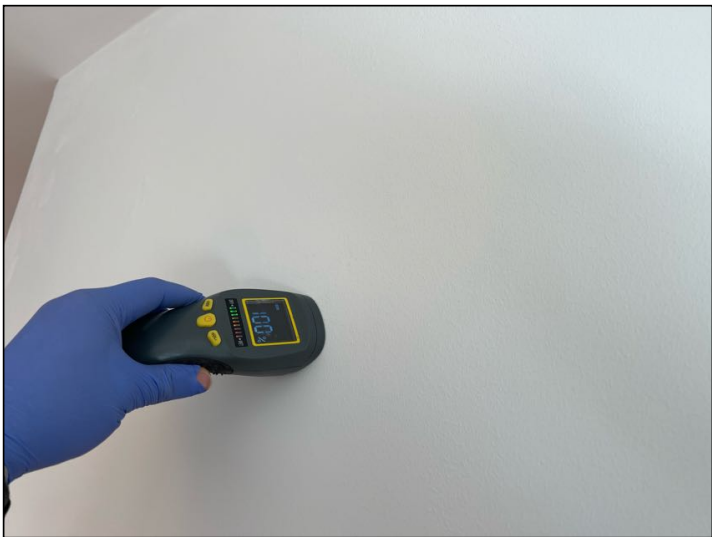
Materials: Drywall  
Observations:  
• Moisture detected at the wall behind the kitchen cabinetry. Recommend further evaluation by a licensed contractor for repair/replacement as needed

Moisture detected

| Page 33 Item: 2 | Wall Condition | <ul style="list-style-type: none"> <li>Moisture detected at the wall behind the kitchen cabinetry. Recommend further evaluation by a licensed contractor for repair/replacement as needed</li> </ul> |

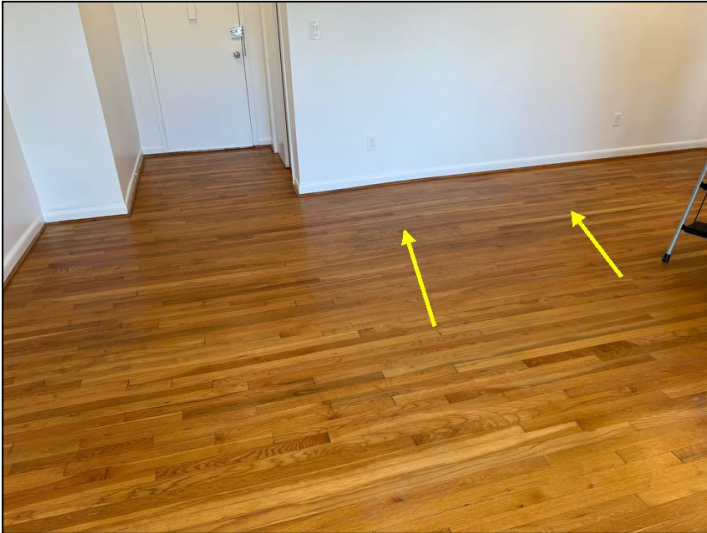
Materials: Hardwood  
Observations:  
• The flooring was not leveled throughout and there was moisture detected near the area by the kitchen wall. Recommend further evaluation by a qualified contractor for repair/replacement

Uneven

| Page 34 Item: 4 | Floor Condition | <ul style="list-style-type: none"> <li>The flooring was not leveled throughout and there was moisture detected near the area by the kitchen wall. Recommend further evaluation by a qualified contractor for repair/replacement</li> </ul> |

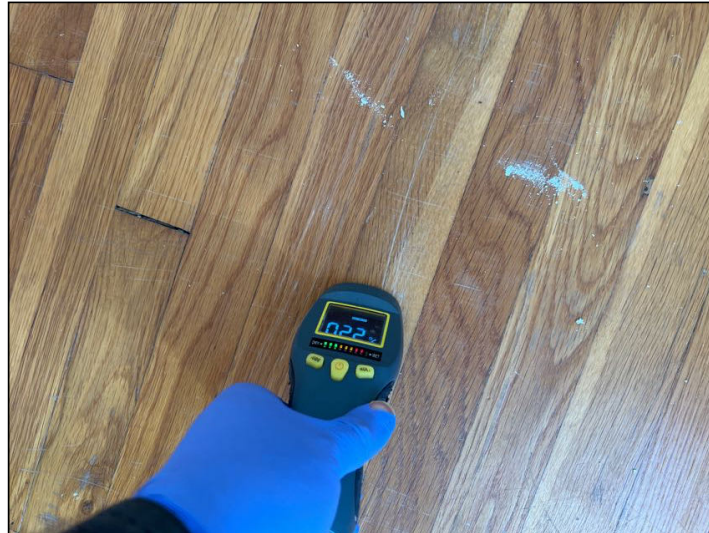
Moisture detected

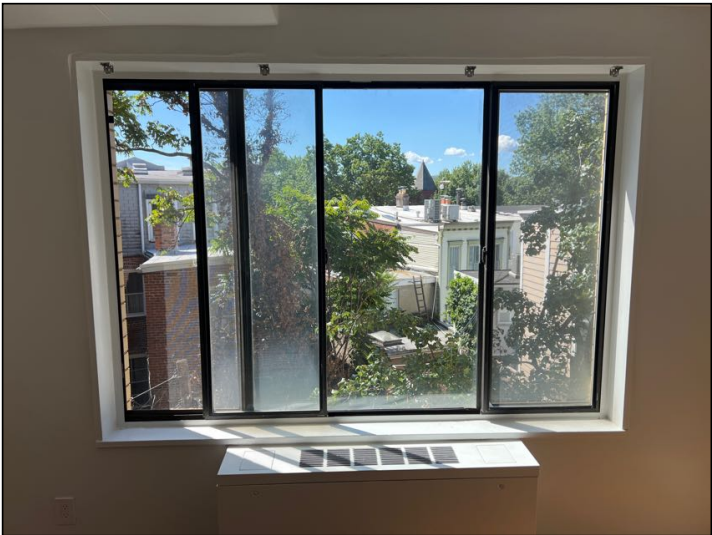
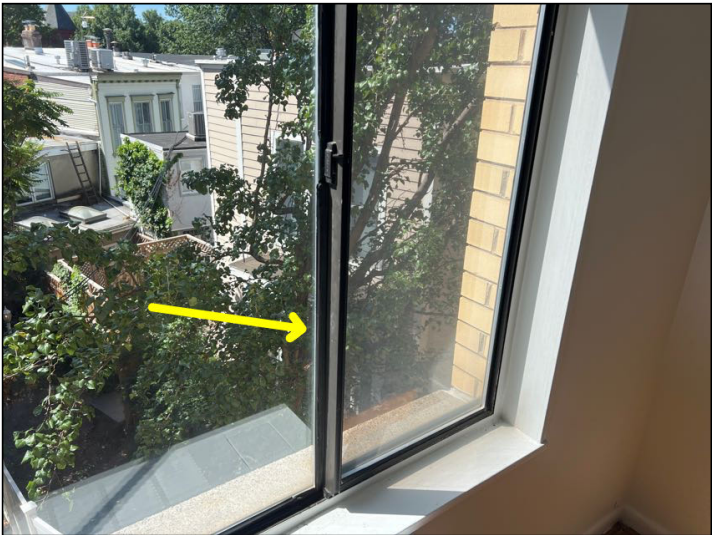
- One or more sliding windows was difficult to open and damaged screens noted. Recommend repair/replacement as needed by a licensed window contractor

Difficult to open

| Page 35 Item: 5 | Window Condition | <ul style="list-style-type: none"> <li>One or more sliding windows was difficult to open and damaged screens noted. Recommend repair/replacement as needed by a licensed window contractor</li> </ul> |

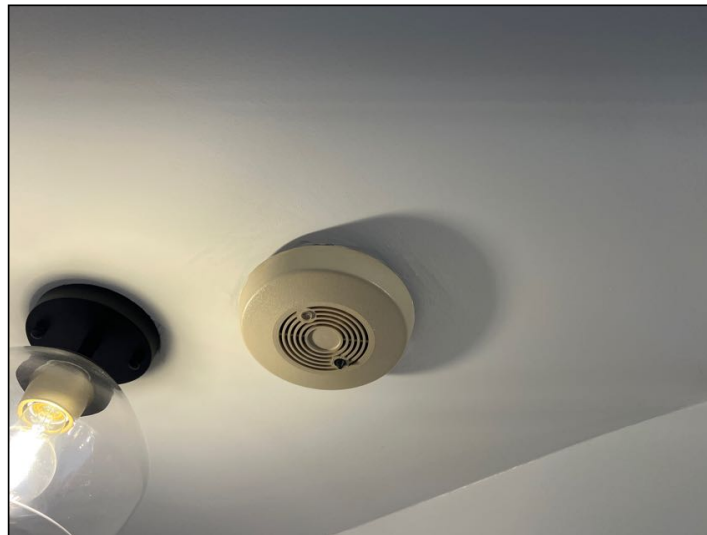
- **MAINTENANCE:** Periodic testing and changing batteries yearly to ensure proper Smoke Alarm operation is required for hardwired detectors. And replacement required after 10 yrs for hardwired and sealed battery detectors.
- **Smoke detectors** appeared old, smoke detectors last 6-10 years. Recommend replacement and installing CO (carbon monoxide) detector when gas systems are installed

Old

| Page 37 Item: 7 | Smoke Detectors | • Smoke detectors appeared old, smoke detectors last 6-10 years. Recommend replacement and installing CO (carbon monoxide) detector when gas systems are installed |

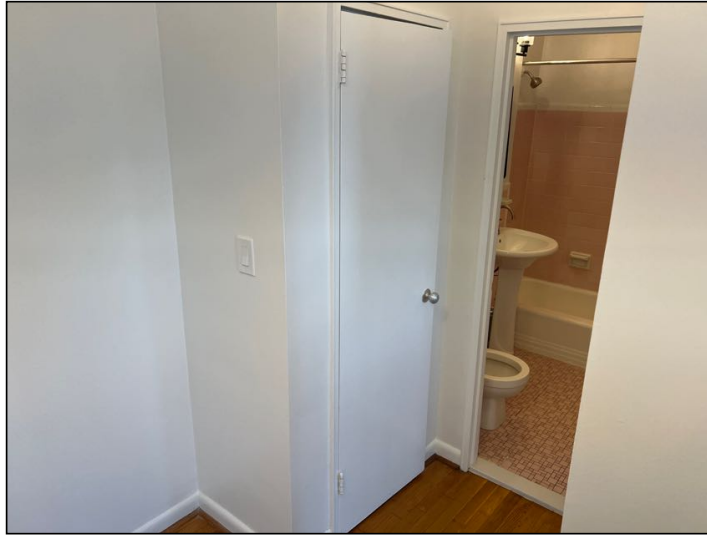
- Appeared functional at time of inspection.
- One or more door stops missing/ineffective. Recommend repair/replacement as needed.

No doorstop

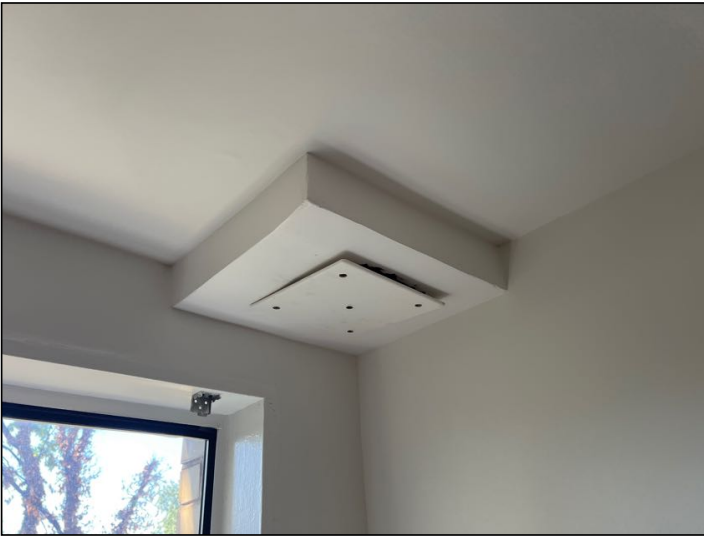
- Loose access hatch noted at the ceiling. Recommend replacing as needed

Loose access hatch

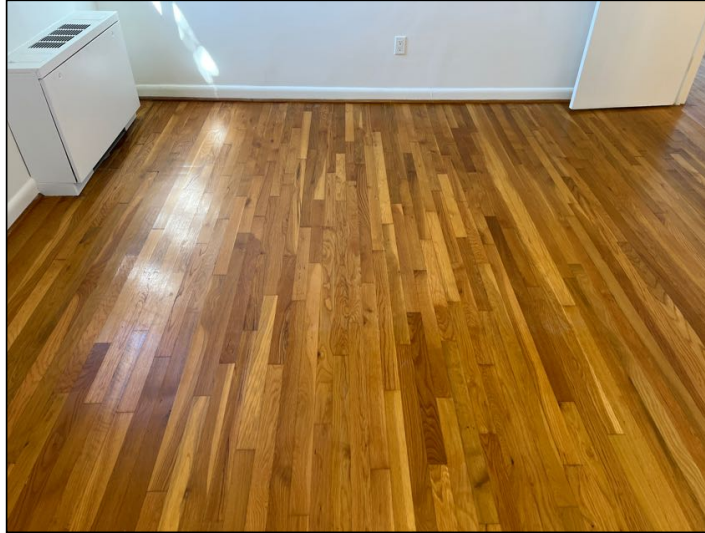
- Worn hardwood flooring noted, some stains observed. Recommend refinish/replace as needed by a qualified contractor

Worn/stains

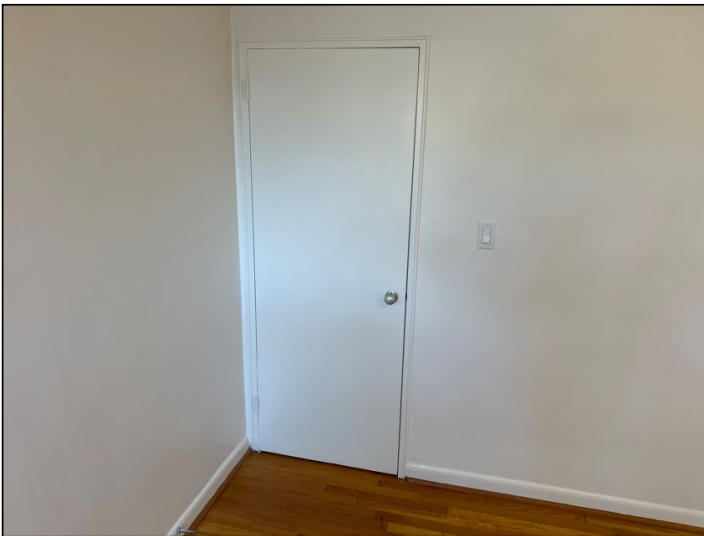
- The door strike plate was insufficient, the latch hangs up when tested. Recommend repair/adjust as needed

Insufficient strike plate

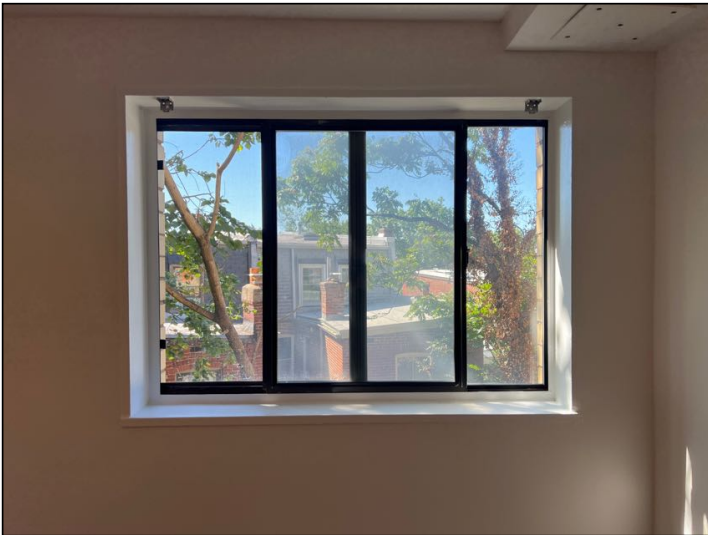
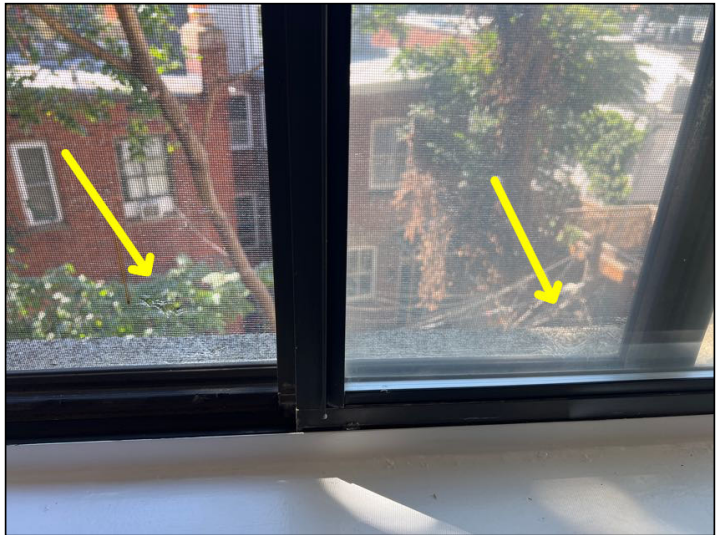
- One or more window(s) shows sign of loss of seal/condensation and damage. Recommend repair/replacement to provide energy savings and prevent pest intrusion.

Damaged screen

| Page 40 Item: 6 | Window Condition | <ul style="list-style-type: none"> <li>One or more window(s) shows sign of loss of seal/condensation and damage. Recommend repair/replacement to provide energy savings and prevent pest intrusion.</li> </ul> |

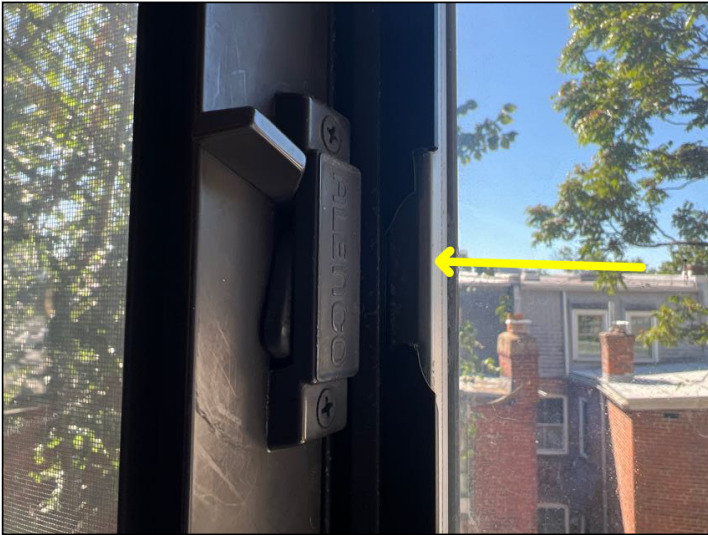
Damaged trim

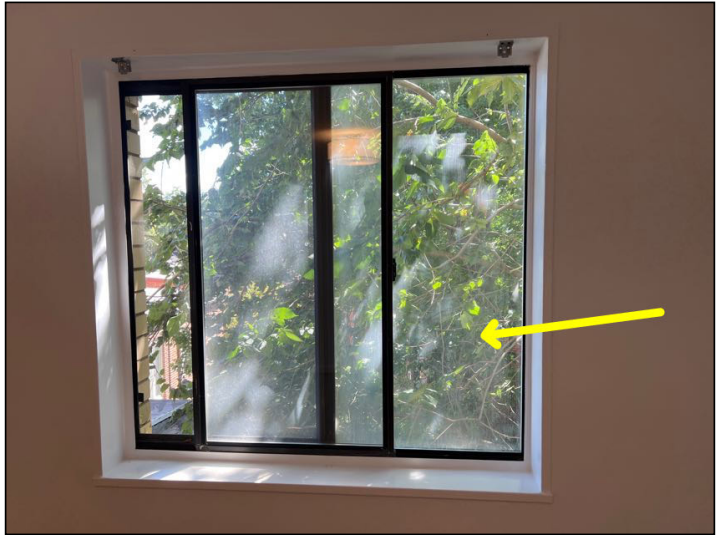
Loss seal

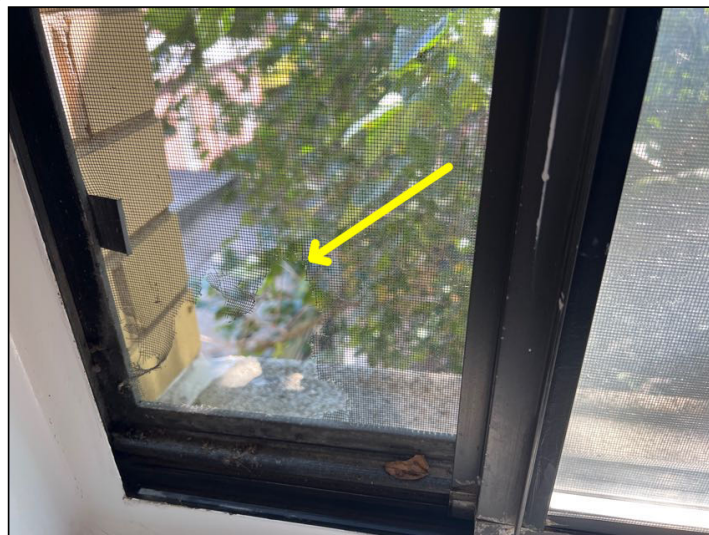
Damaged screen

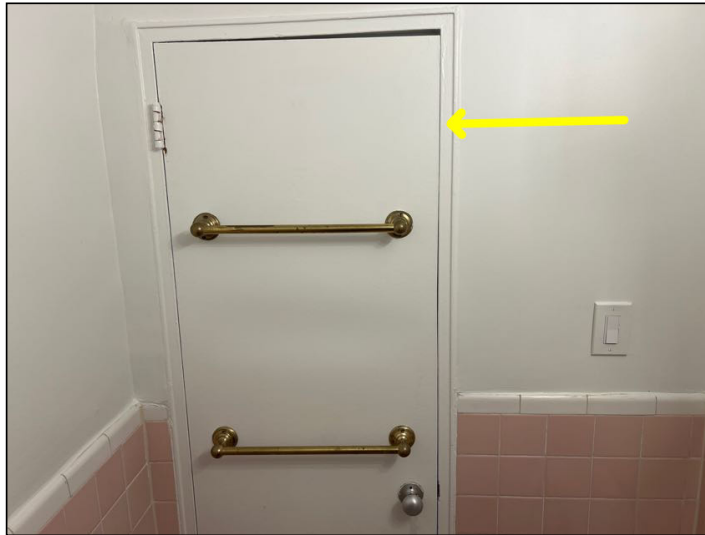
- Misaligned door noted, rubs frame. Recommend repair/replacement by a qualified contractor.

Rubs frame

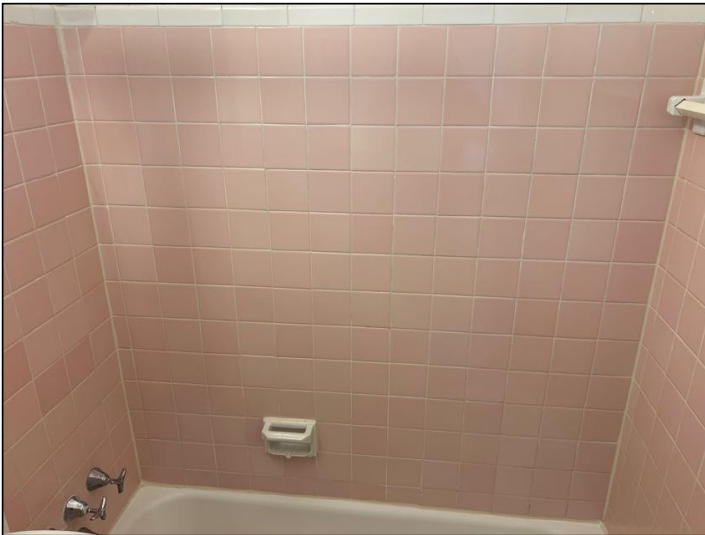
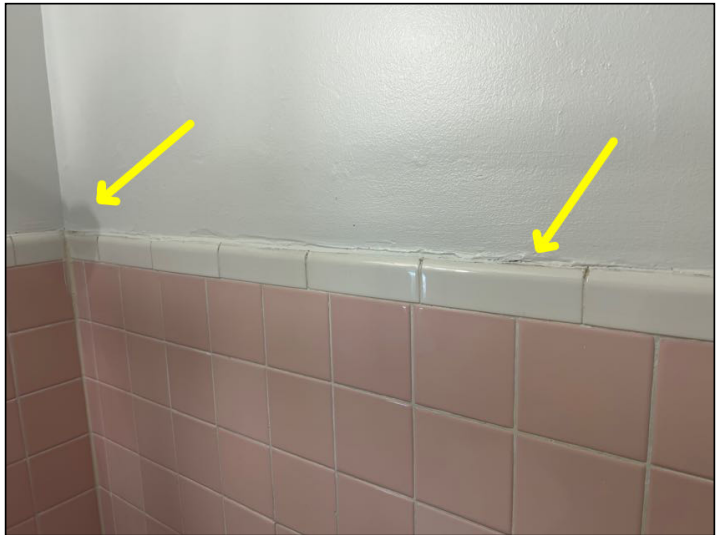
- Gaps/cracks noted in grout/seal in one or more locations. Recommend scrape/caulk/reseal as needed.

Gaps

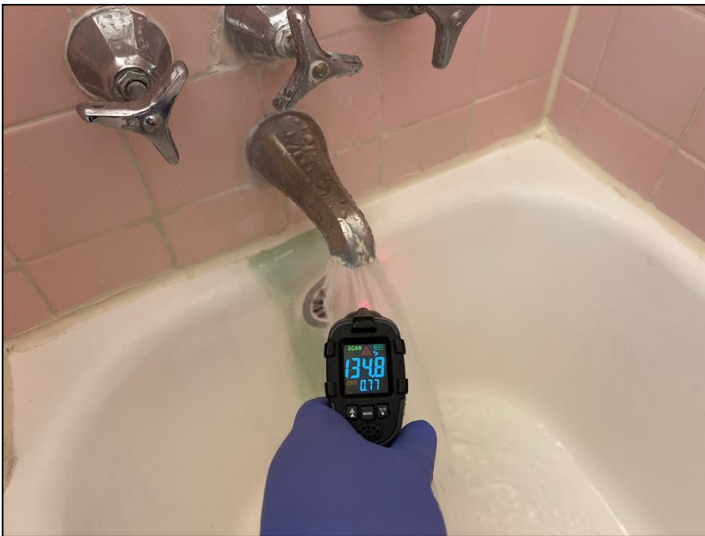
- Water was too hot at some faucets throughout. Hot water should not exceed 120-125 degrees to prevent scalding. Recommend lowering the water heater setting as needed for safety
- Inoperable/missing drain stopper noted. Recommend replace as needed
- Discoloration and corrosion noted at the tub finish. Recommend repair/replace by a qualified contractor

Too hot

| Page 48 Item: 13 | Bath Tubs | • Water was too hot at some faucets throughout. Hot water should not exceed 120-125 degrees to prevent scalding. Recommend lowering the water heater setting as needed for safety |

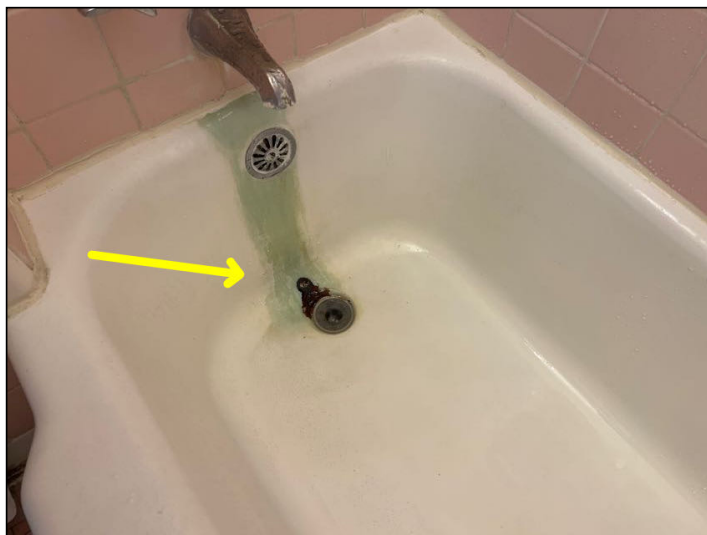
Discoloration/corrosion

| Page 48 Item: 13 | Bath Tubs | • Discoloration and corrosion noted at the tub finish. Recommend repair/replace by a qualified contractor |

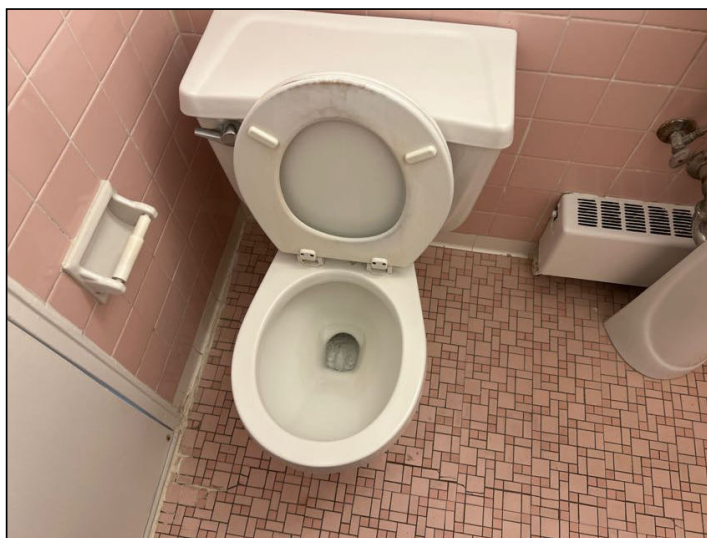
- Slow flush noted when the toilet was tested. Recommend further review by a licensed plumber for improvement as needed

Slow flush
