# INSPECTION REPORT

10000 Sample Street, Sample MD 10000  
Inspection prepared for: Sample Client  
Real Estate Agent: Sample Agent

Date of Inspection: 12/20/2021 Time: 9:00 AM  
Year Built: 2021 Size (sqft): 2800  
Weather: Clear 25 to 30 degrees F  
Order ID: 9086

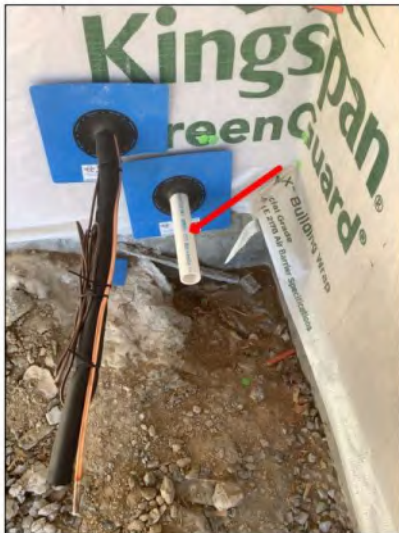
Sump pump discharge pipe

Observations:  
• New Construction - Some, if not many components have not been built/installed or completed/finished yet.
