Next Day Inspect Commercial Inspection Report

111 SAMPLE AVE, SAMPLE, MD 00001 Inspection prepared for: SAMPLE SAMPLE Date of Inspection: 2/5/2025 Time: 9:30 AM Year Built: 1994 Size (Sqft): 3240 Weather: Cloudy 47 degrees F

Inspector: Paulo Narduche 707 Godfrey Court SE, Leesburg, VA 20175

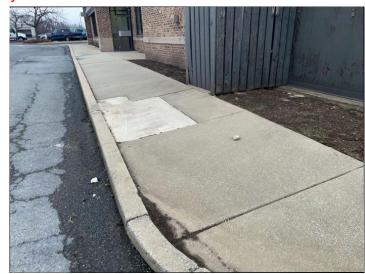
- Concrete sidewalk noted.
- Walkway at the drive-thru was cracked and displaced. Tripping hazard. Recommend repair for safety.

Displacement

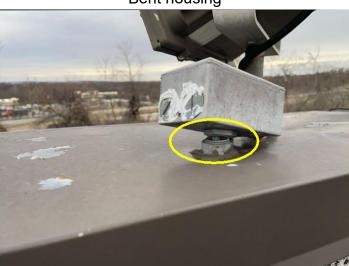
- Pole sign was not operational at the time of inspection. Recommend further review and repair as needed by a licensed electrician.
- Drive-thru pole light made a buzzing noise at the time of inspection. Power was not on. Recommend further review and repair as needed.
- Loose electrical box noted on the drive-thru side of building. Recommend repair by a licensed electrician.
- Covers were missing or broken on one or more exterior lights. Recommend repair.
- Open or disconnected **PVO** conduit noted at the drive-thru and at the roof top lights. Recommend repair.

Bent housing

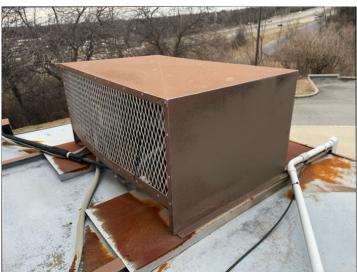
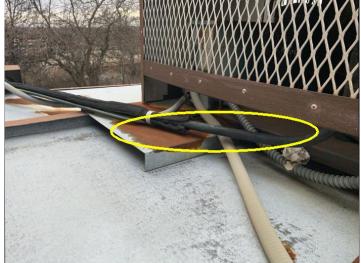
- Corrosion noted on the exterior cooler roofs. Recommend review and repair as needed by a qualified contractor.
- Corrosion and deterioration noted on the exterior cooler walls. Recommend review and repair as needed by a qualified contractor.

Corrosion

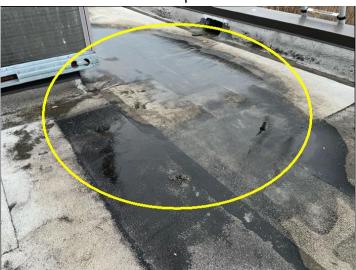
Gap

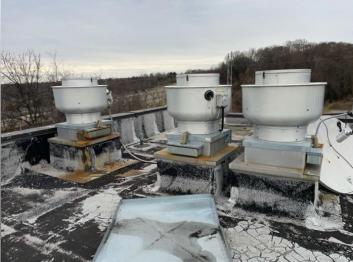
Detached top

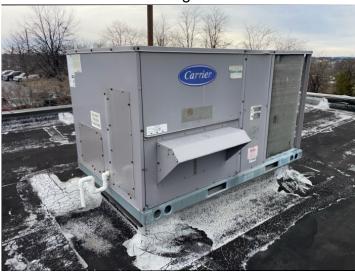
- Date of manufacture was 2014. Life expectancy around 20 years.
- Unable to operate unit. The thermostat was inoperable and there was no gas supply.
- Cooling cycle was not tested due to the outside temperature below 65 degrees F.

MFD: 2014

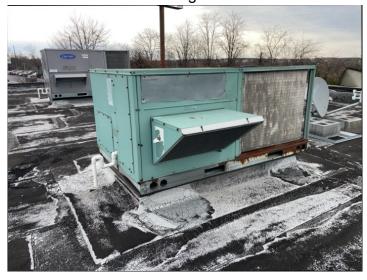
- Date of manufacture was 1994. Life expectancy around 20 years.
- Unable to operate unit. The thermostat was inoperable and there was no gas supply.
- Cooling cycle was not tested due to the outside temperature below 65 degrees F.

MFD: 1994

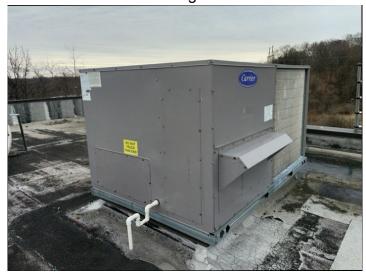
- Date of manufacture was 2016. Life expectancy around 20 years.
- Unable to operate unit. There was no gas supply.
- Cooling cycle was not tested due to the outside temperature below 65 degrees F.

MFD: 2016

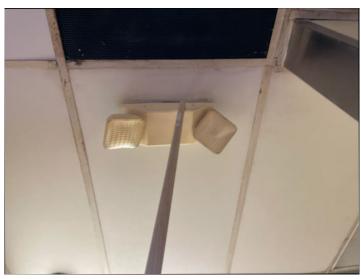
Did not work
