# INSPECTION REPORT

1001 Sample Ave, Sample, MD 10101

Date of Inspection: 4/17/2026 Time: 9:00 AM

Age of Home: 2006 Size: 3219 sq feet

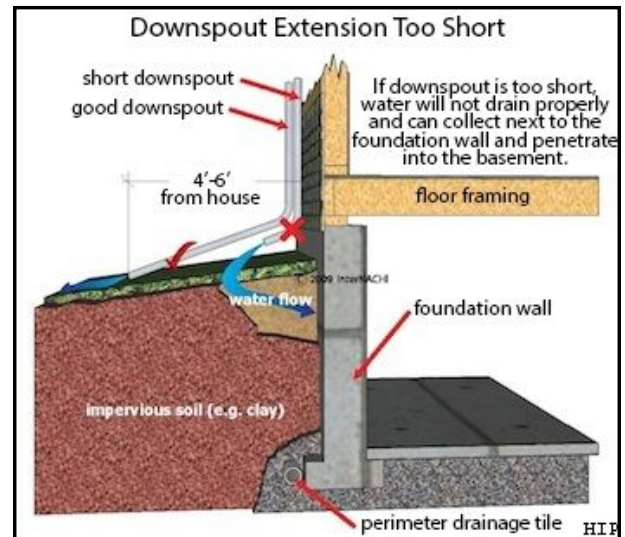
Terminates on roof, causing staining

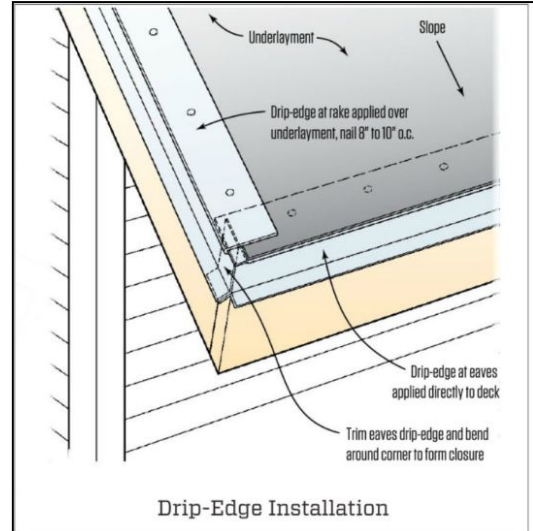
Missing drip edge

- Evidence of past leaks, mainly near the edges of the roof/attic. Roof is likely missing drip edge flashing. Recommend evaluation of roof areas for repair/replacement as needed by roofing professional.

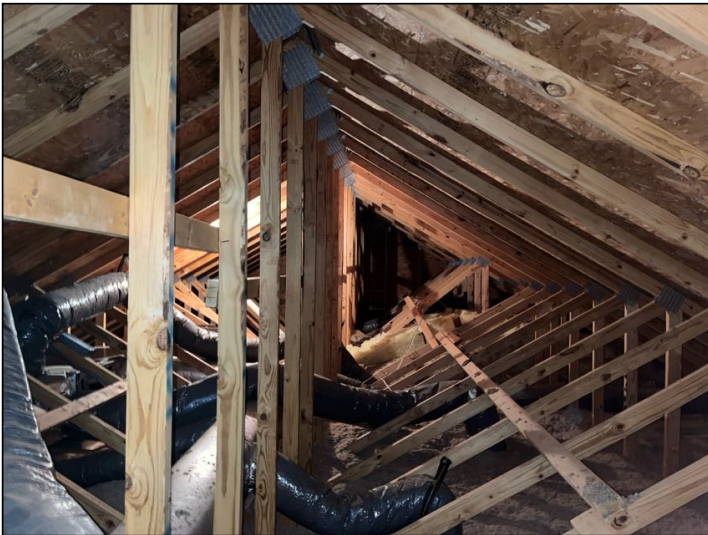
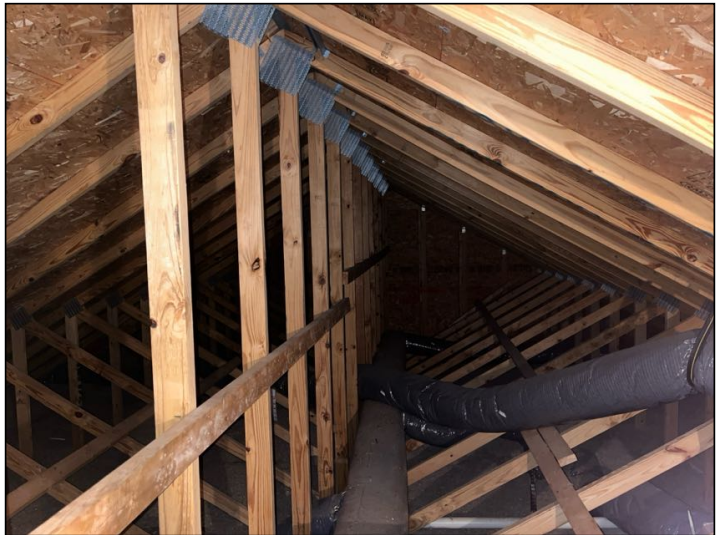
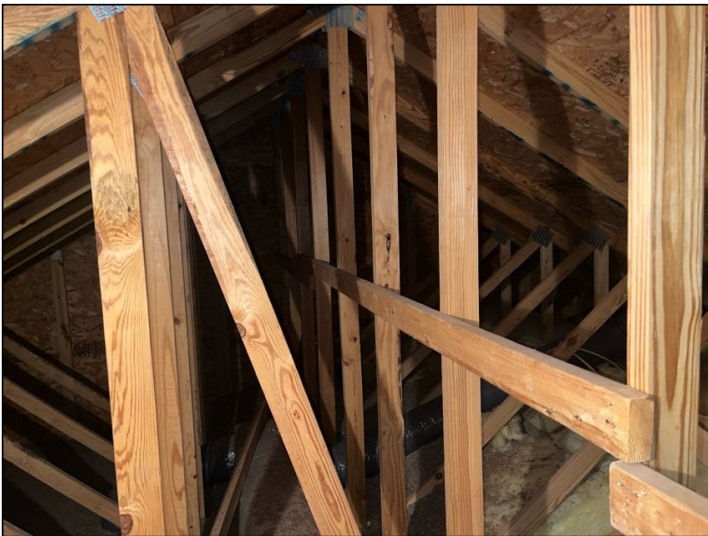
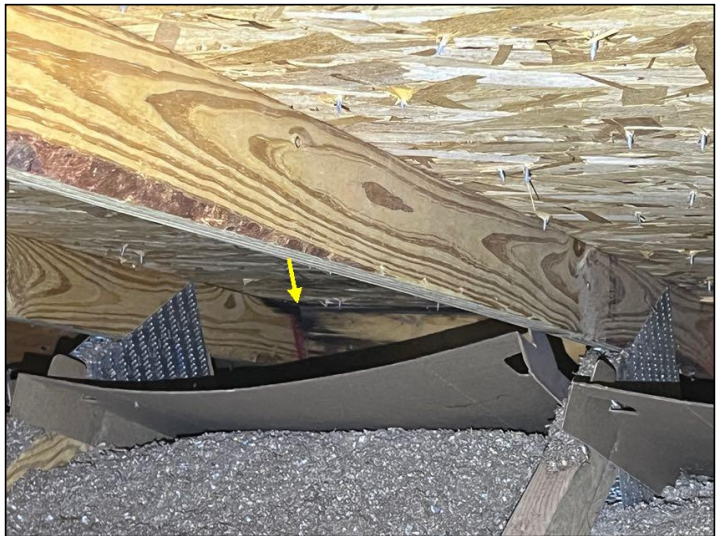
- Loose horizontal wood bracing was observed in the attic that does not appear to be securely fastened, and several nails were noted protruding outward from the boards. These conditions present a potential safety hazard for anyone accessing the attic and could damage nearby wiring or insulation. A licensed general contractor should further evaluate the attic framing and correct or remove the loose bracing and address the exposed nails as needed.

Signs of moisture intrusion
