# INSPECTION REPORT

10000 Sample Street, Sample MD 10000  
Inspection prepared for: Sample Client  
Real Estate Agent: Sample Agent

Date of Inspection: 12/20/2021 Time: 9:00 AM  
Year Built: 2021 Size (sqft): 2800  
Weather: Clear 25 to 30 degrees F  
Order ID: 9086

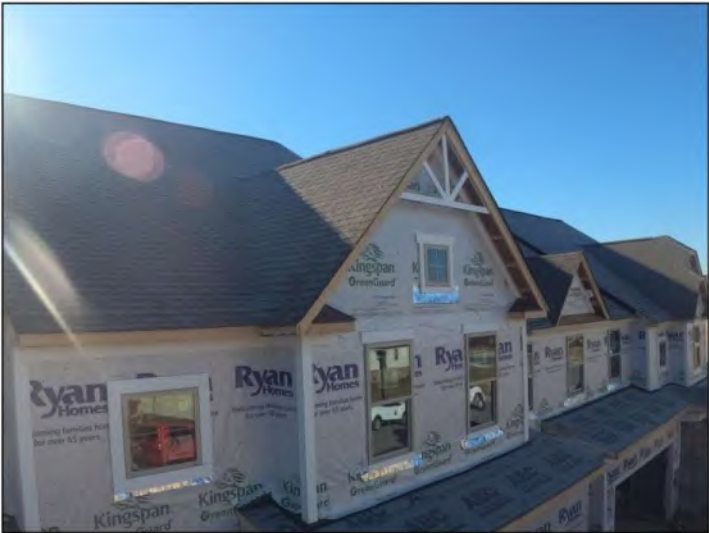
1. Roof Condition

Materials: Inspected from ground level with extended "Eyestick" and camera. Some areas of the roof may be visually restricted from inspection.  
Materials: Asphalt shingles.  
Observations:  
• No major system safety or function concerns noted at the time of inspection.

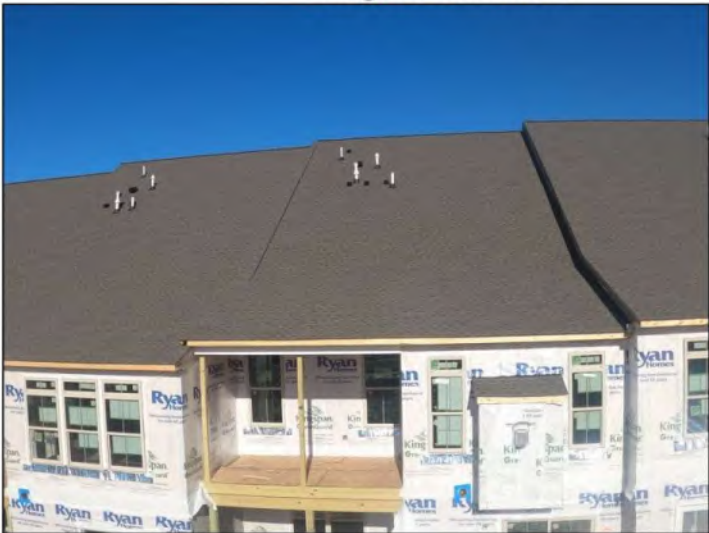
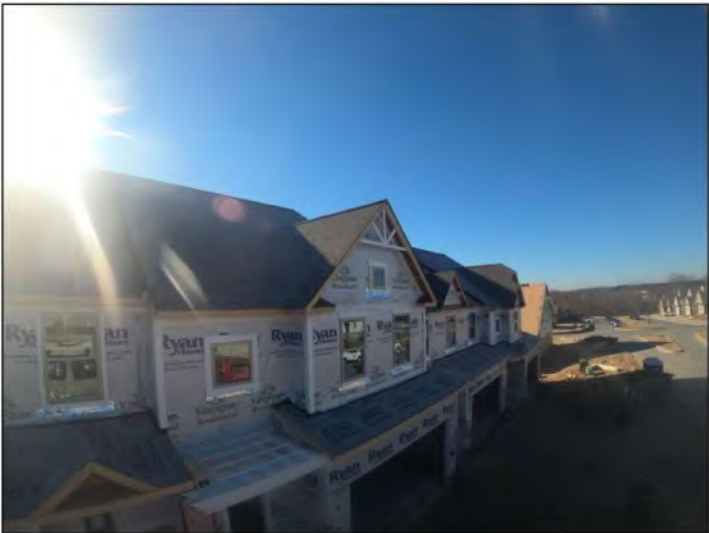
2. Eave and rake

Materials: Wood  
Observations:  
• The rough framing for the fascia boards were in place and appeared to be in good condition.

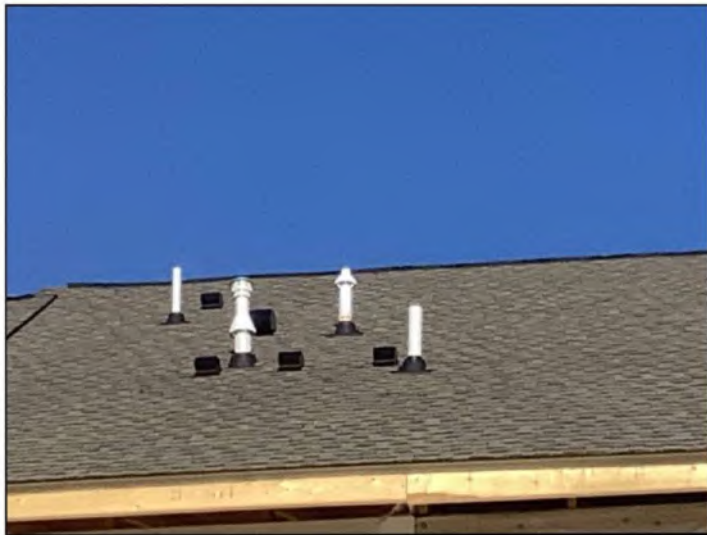
3. Vent Stack

Observations:  
• Appeared to be in good condition at the time of inspection.

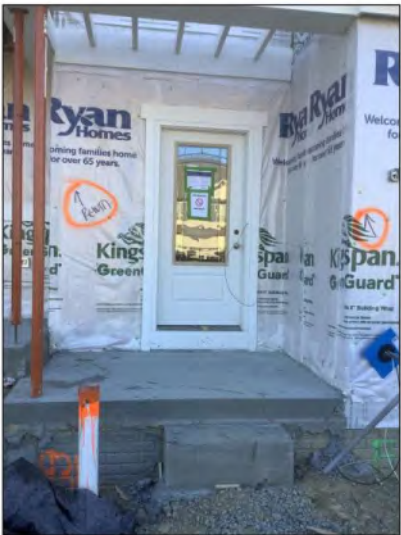
Observations:  
• New construction hardware and other components are not installed yet

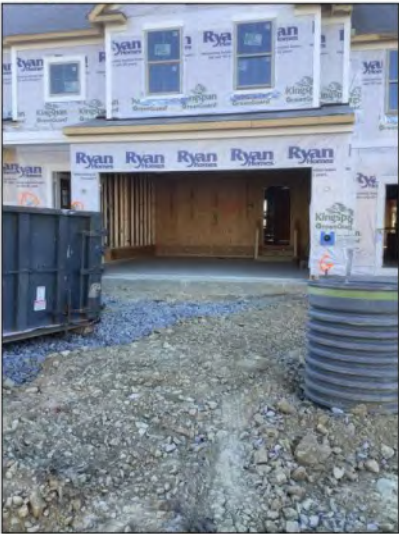
1. Driveway and Walkway Condition

- New construction, the driveway is not finished. It appears acceptable for this stage of construction. No major system safety or function concerns noted at the time of inspection.

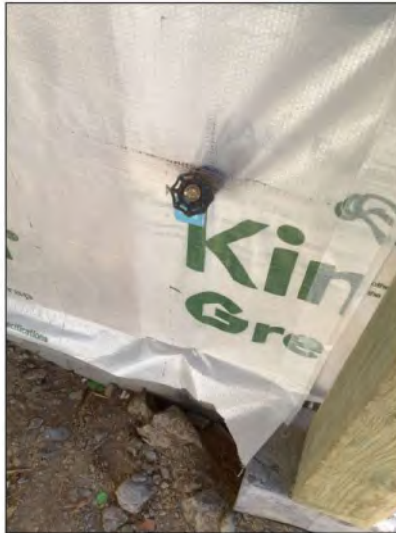
**5. Exterior Faucet Condition**

- The water is off to structure, all water areas not tested.

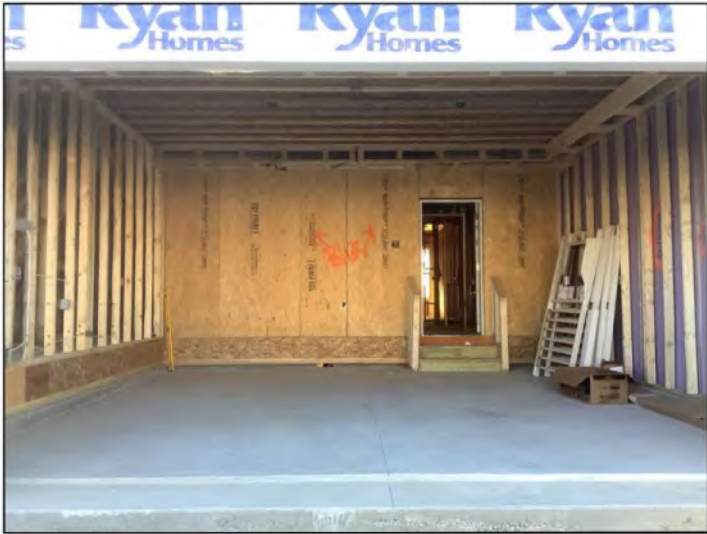
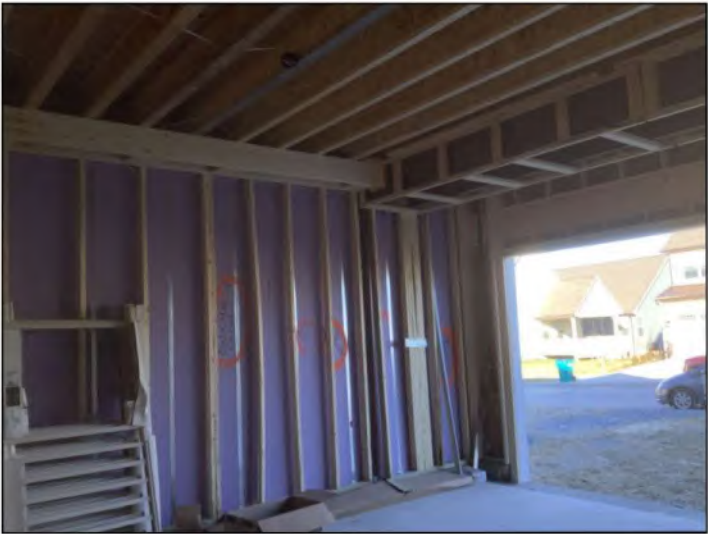
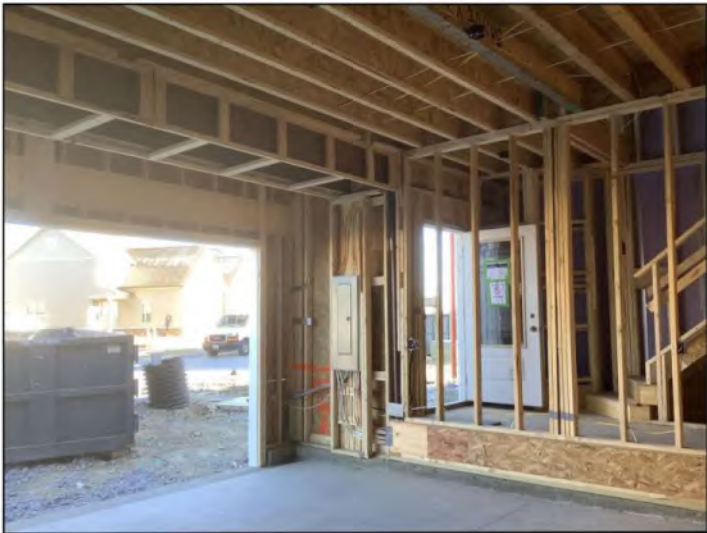
1. General Condition

- New Construction - Some, if not many components have not been built/installed or completed/finished yet.
- acceptable

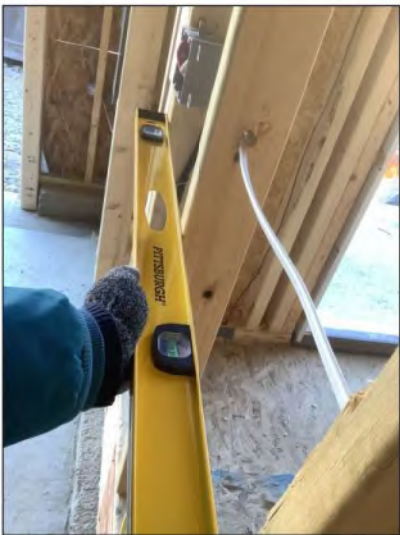
2. Walls & Sill Plate

- Walls framing appear to be satisfactory

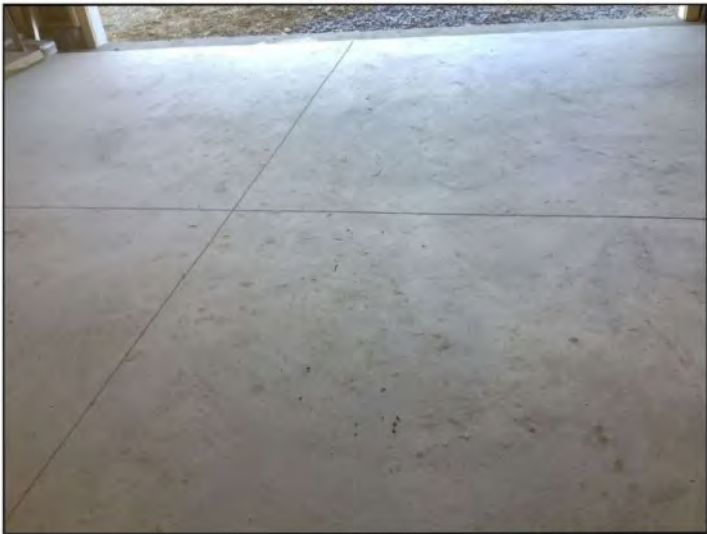
4. Floor Condition

- The visible part of the garage floor, appear to be in good condition

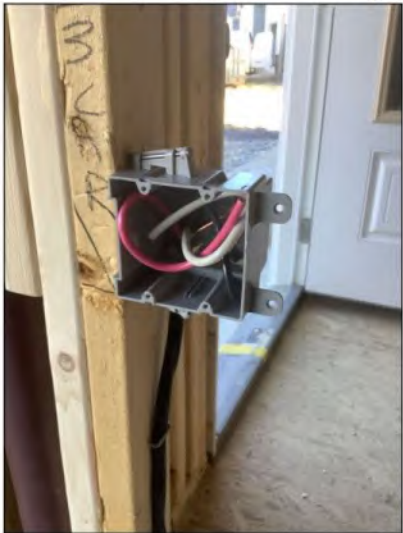
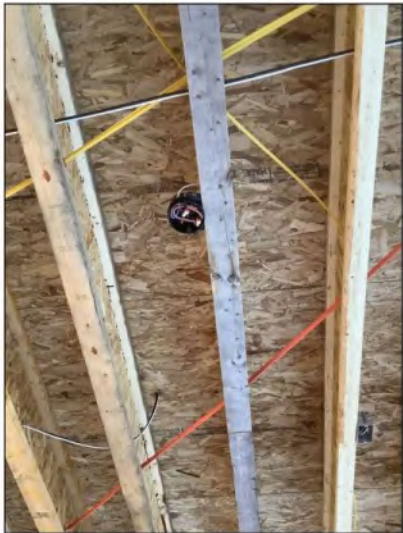
- All wiring and rough in appeared functional and in satisfactory condition at the time of inspection.

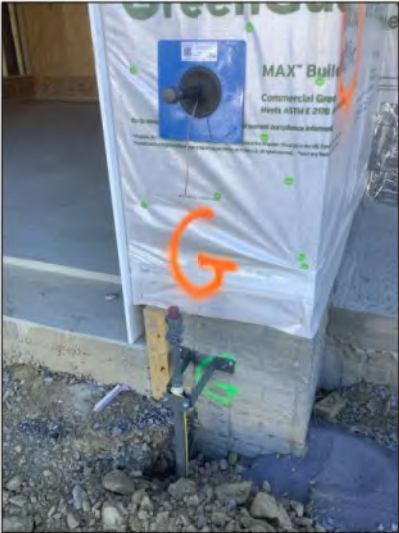
## 1. Main Gas Valve Condition

Observations:  
• Not present at the time of inspection.

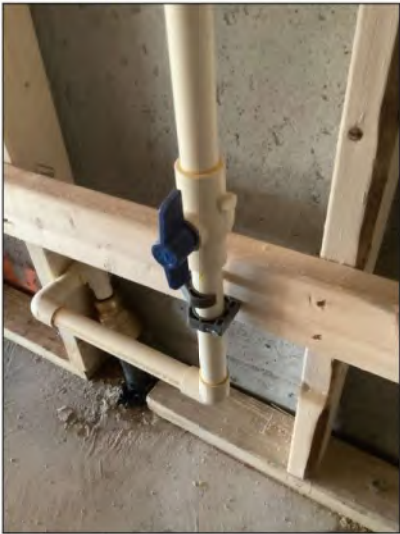
## 1. Water Main

- 1 inch
- CPVC
- No deficiencies noted.
- Location: Basement

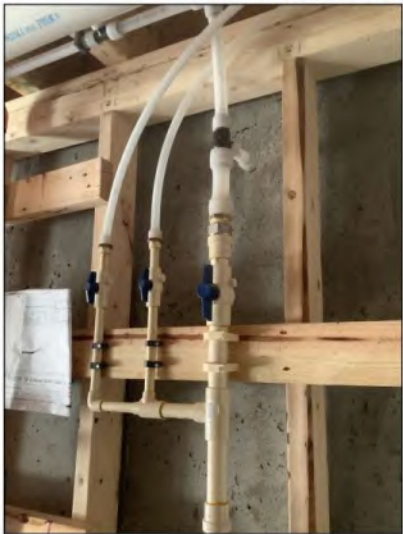
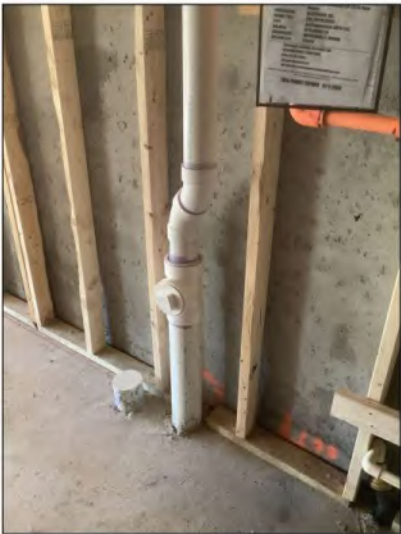
## 2. Plumbing

Materials: Aquapex piping noted. • CPVC piping noted. • **PVC** waste pipe noted.

- No deficiencies noted.

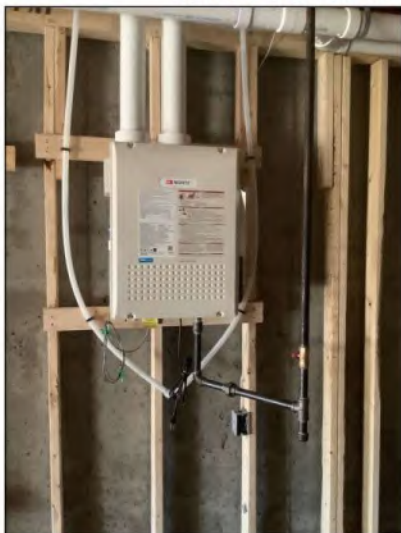
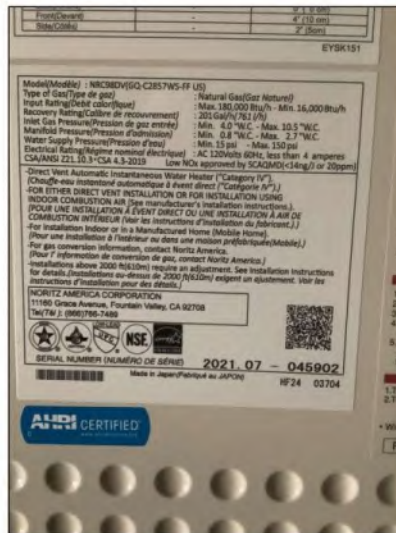
## 1. Heater Enclosure

- New Construction - Some, if not many components have not been built/installed or completed/finished yet.

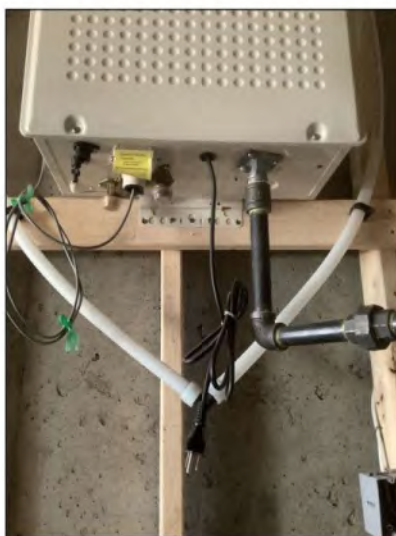
MFD 2021

- No major system safety or function concerns noted at the time of inspection.
- Manufacture date:( 2021). Life expectancy around 12 years.

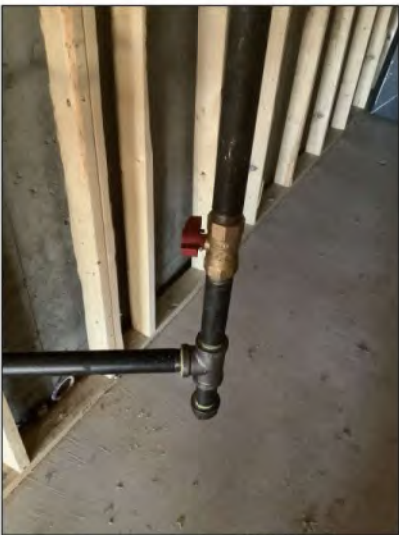
- Gas valve present and appeared in good condition.

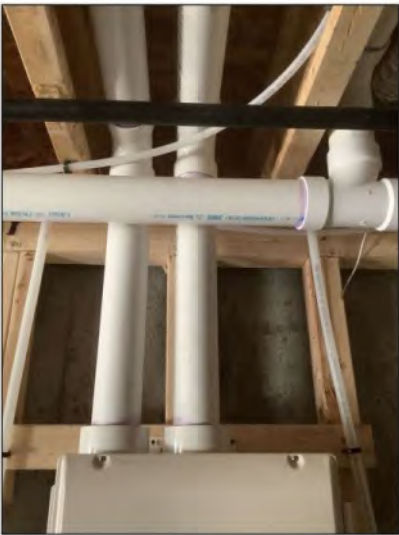
4. Venting

Observations:  
• Appeared in good condition at the time of inspection.

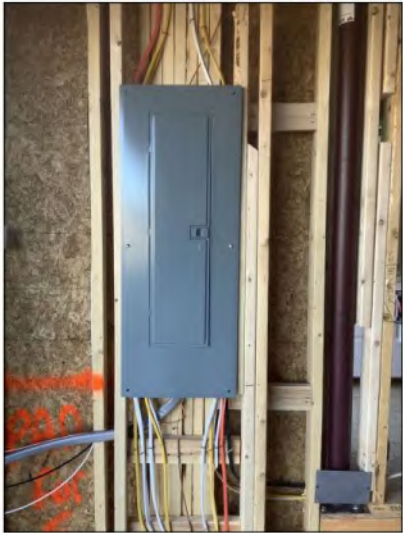
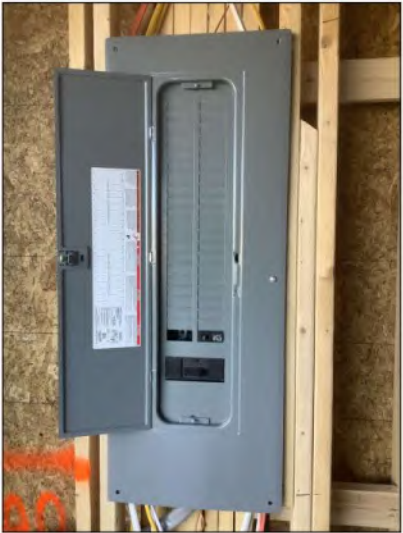
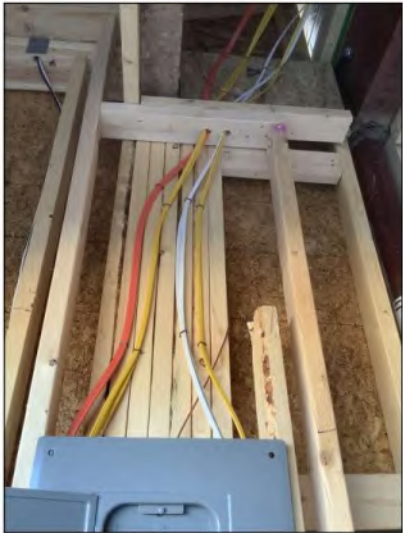
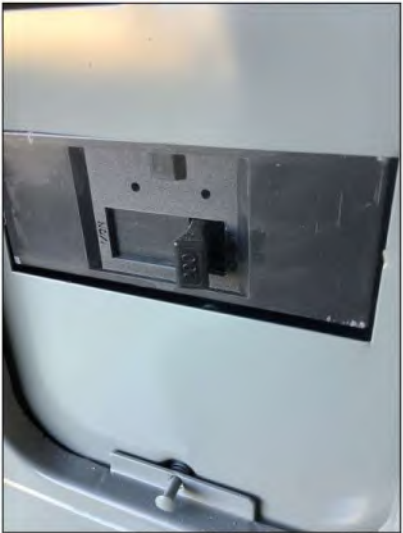
1. Electrical Panel

- New Construction - Some, if not many components have not been built/installed or completed/finished yet.

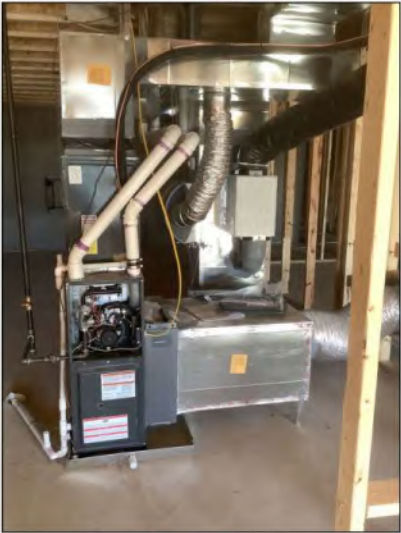
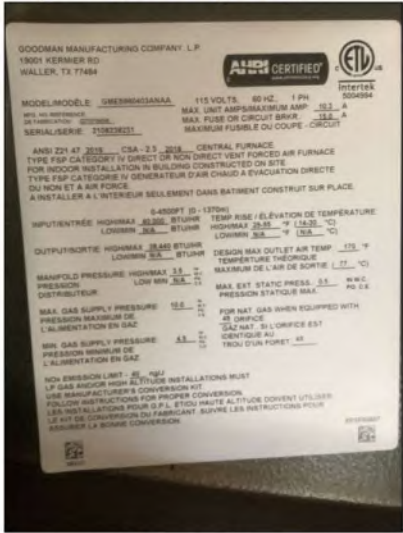
2. Heater Condition

Location: The furnace is located in the basement.  
Type: Gas fired forced hot air.  
Observations:  
• New Construction - Some, if not many components have not been built/installed or completed/finished yet.  
• Manufacture date (2021), life expectancy around 20 years.

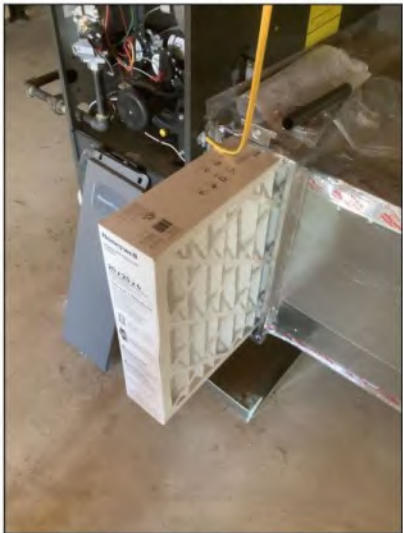
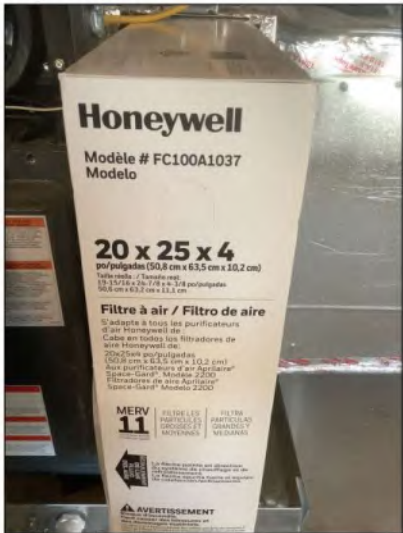
3. Filters

Location: Located on the right side of the cabinet.

- Observations:
- **MAINTENANCE:** The air filter(s) should be inspected at least monthly and cleaned or replaced as required. Remember that dirty filters are the most common cause of inadequate heating or cooling performance.
  - Filters appeared clean at the time of inspection.

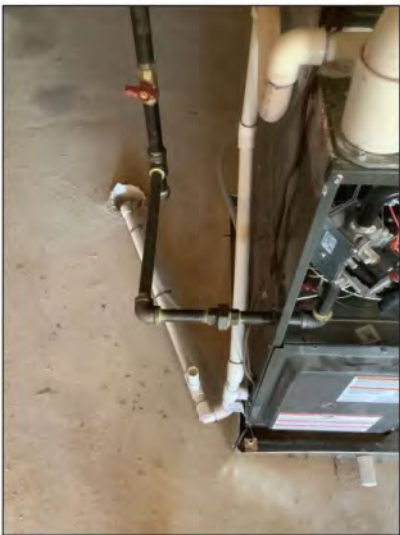
- Observations:
- Gas shut off valves were present and functional.

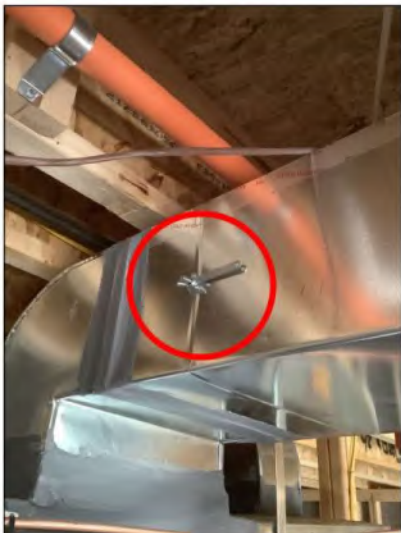
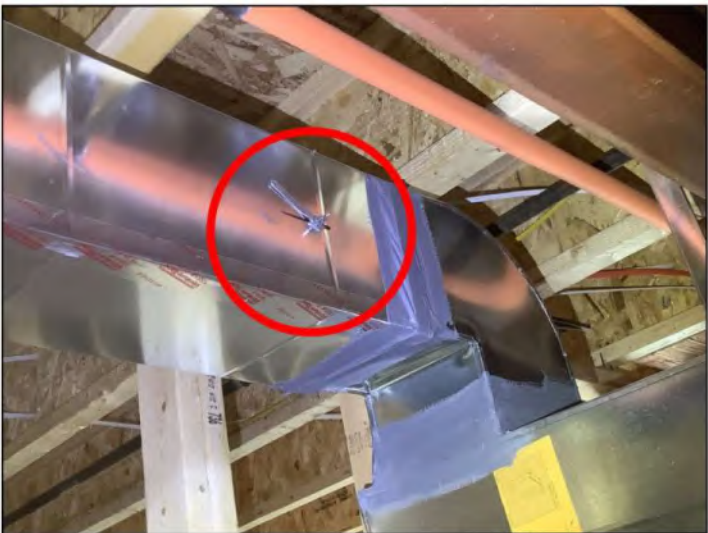
- The air supply system appeared to be functional. Manual dampers noted.

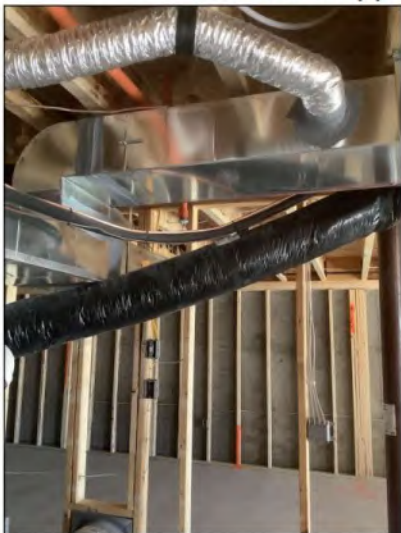
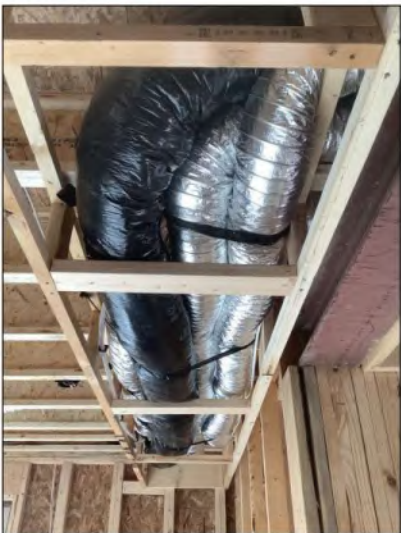
- Ductwork Appears to be in good condition.

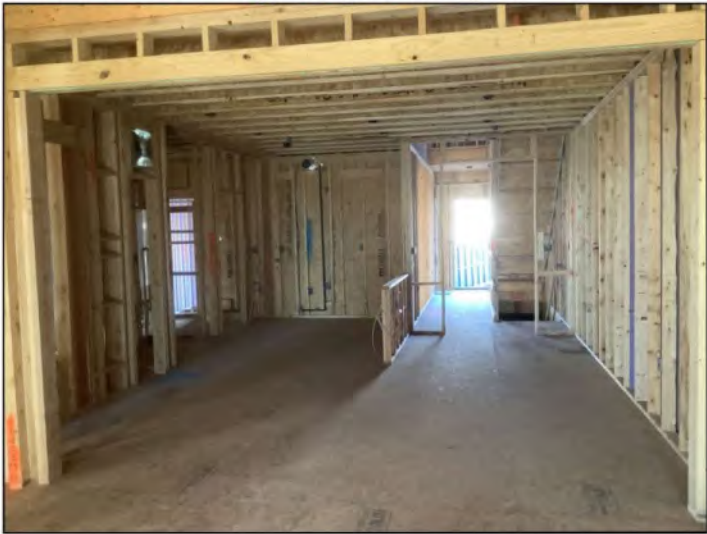
Materials: Main floor  
Observations:  
• Acceptable  
• New Construction - Some, if not many components have not been built/installed or completed/finished yet.

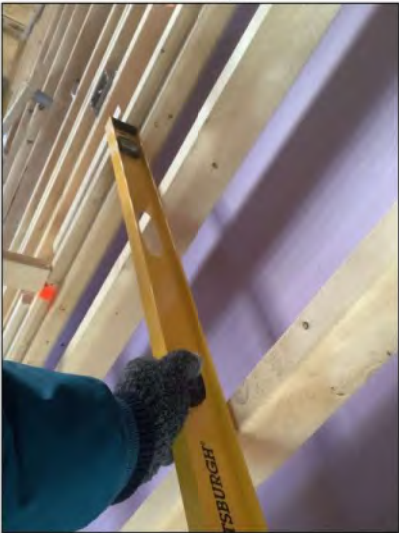
Materials: Wood studs  
Observations:  
• Framing appears satisfactory.

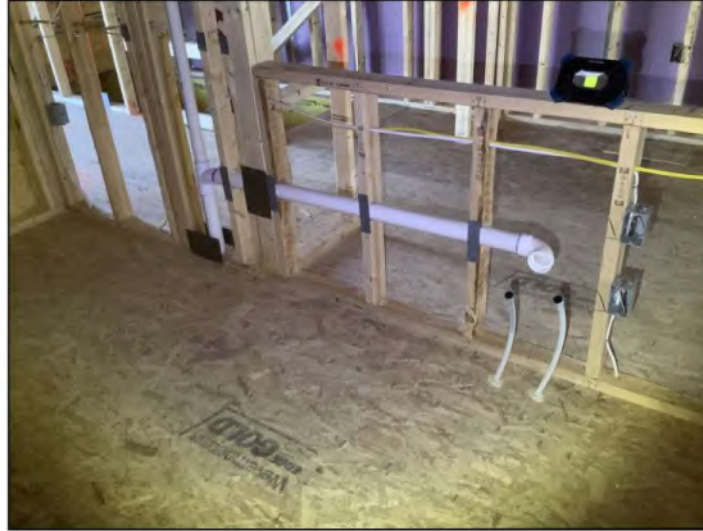
- Plumbing rough-in appears to be acceptable.

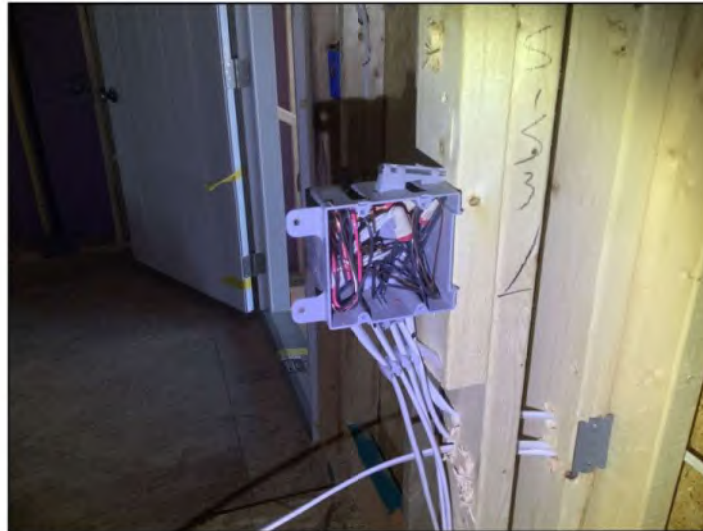
- Electrical wiring and rough-in appear to be acceptable.

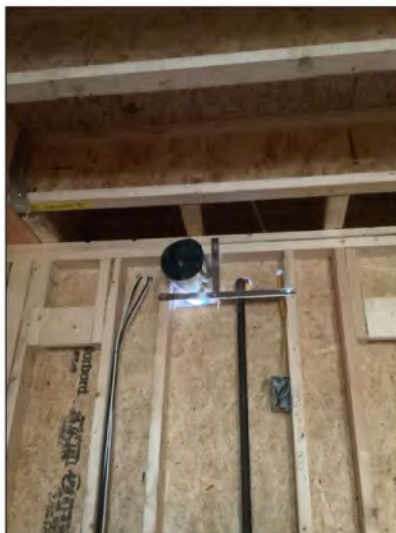
- New construction; rough-in ductwork only observed

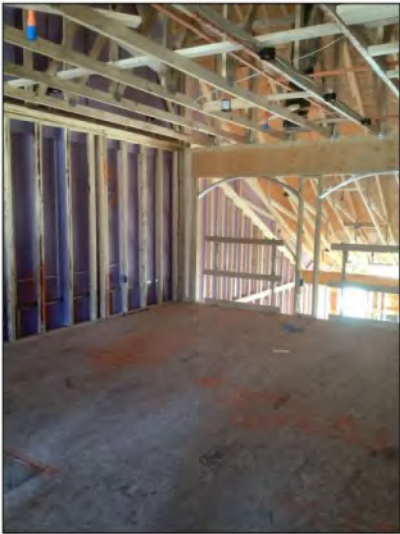
Materials: Second floor  
Observations:  
• Acceptable  
• New Construction - Some, if not many components have not been built/installed or completed/finished yet.

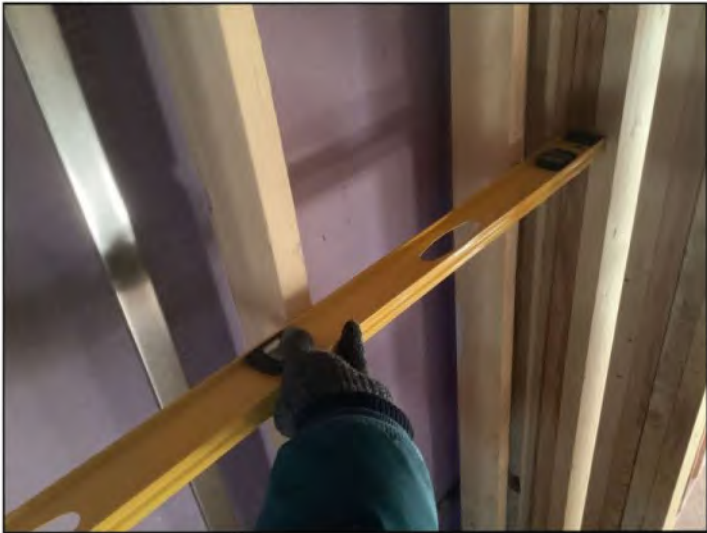
Materials: Wood studs  
Observations:  
• No deficiencies noted.

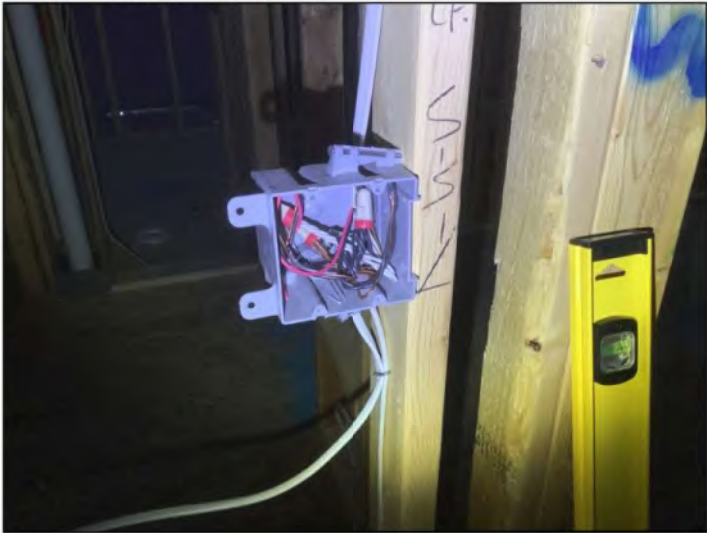
Observations:  
• All wiring and rough in appeared functional and in satisfactory condition at the time of inspection.

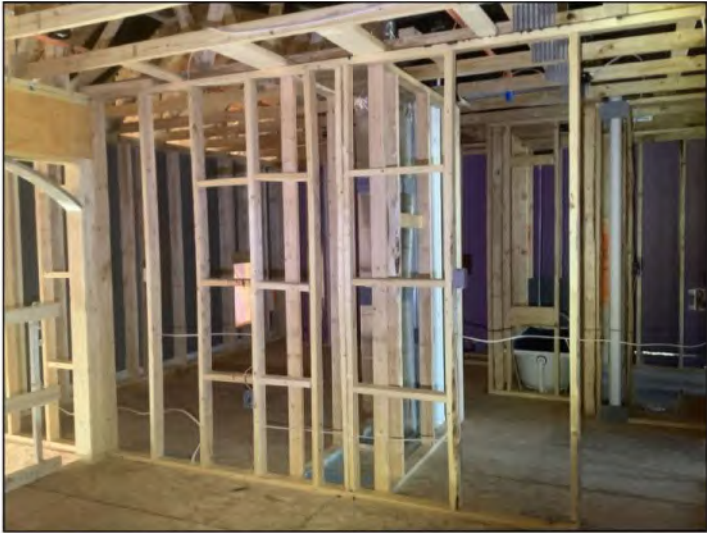
Observations:  
• The closets were in good condition at the time of inspection.

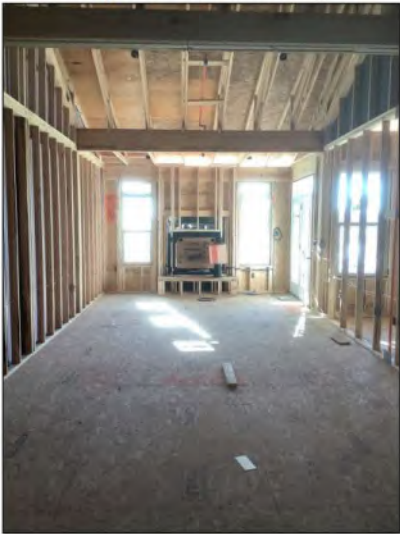
Materials: First floor  
Observations:  
• Acceptable  
• New Construction - Some, if not many components have not been built/installed or completed/finished yet.

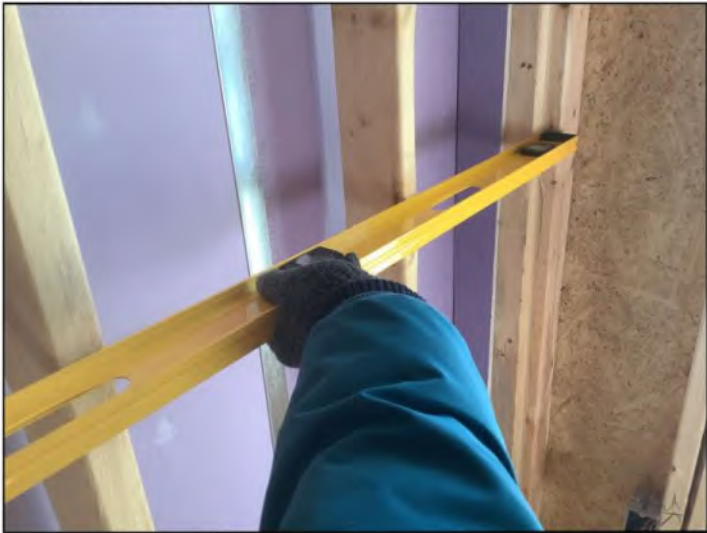
Materials: Wood studs  
Observations:  
• No deficiencies noted.

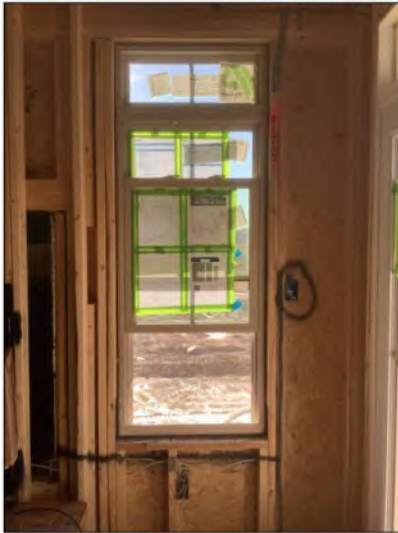
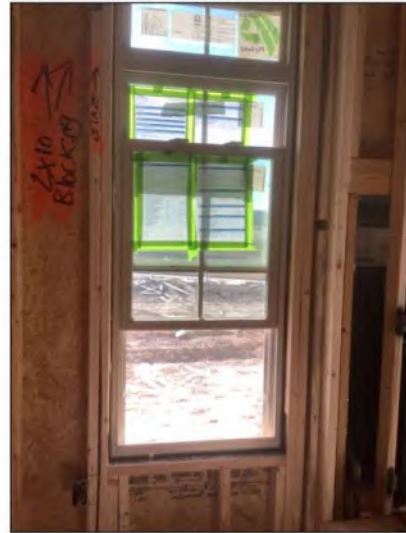
- Windows appeared functional at the time of inspection.

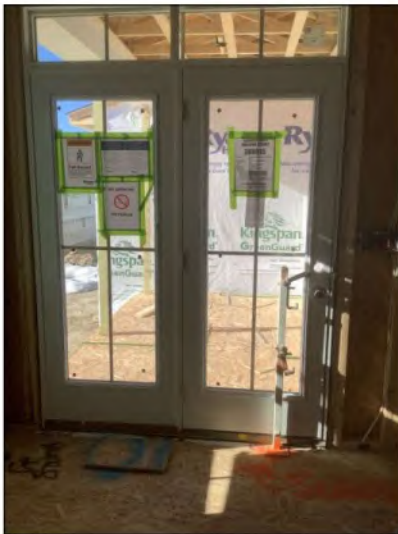
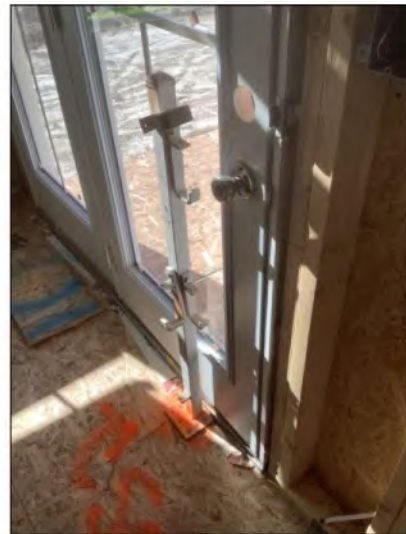
- New construction hardware and other components are not installed yet

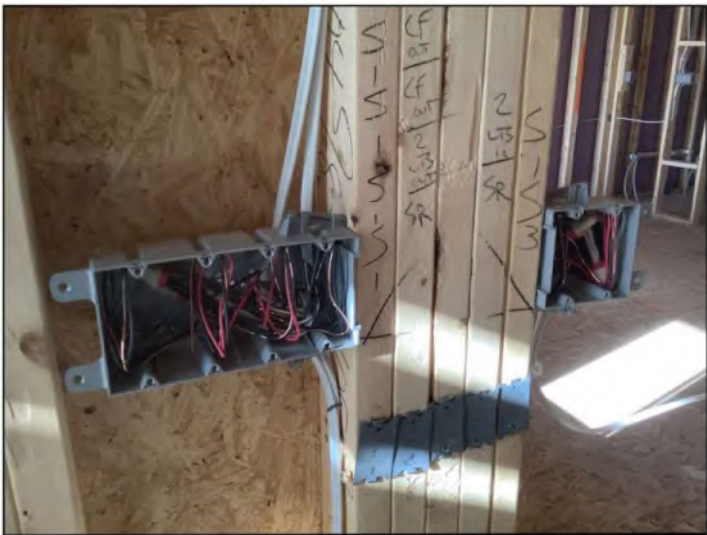
- All wiring and rough in appeared functional and in satisfactory condition at the time of inspection.

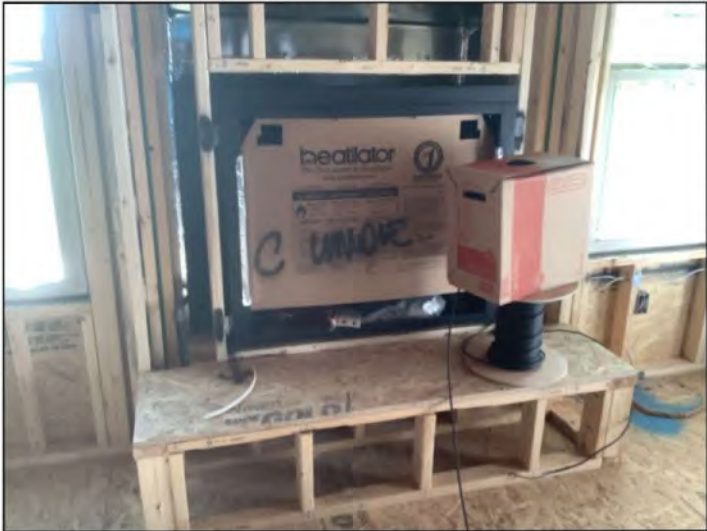
- Observations:
- New Construction - Some, if not many components have not been built/installed or completed/finished yet.
  - The fireplace appears to be in fair visual condition.

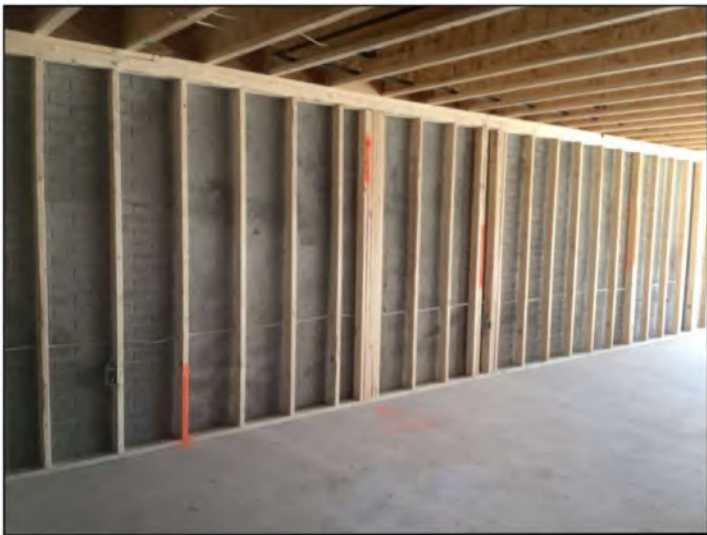
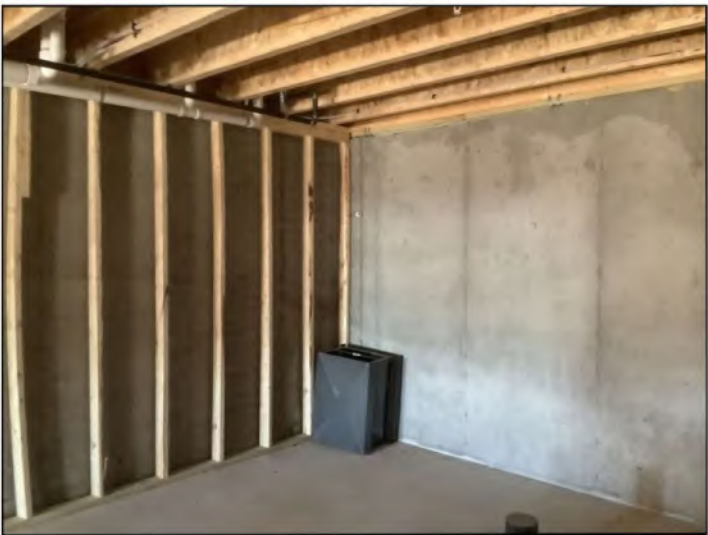
- Appeared to be in good condition at the time of inspection.

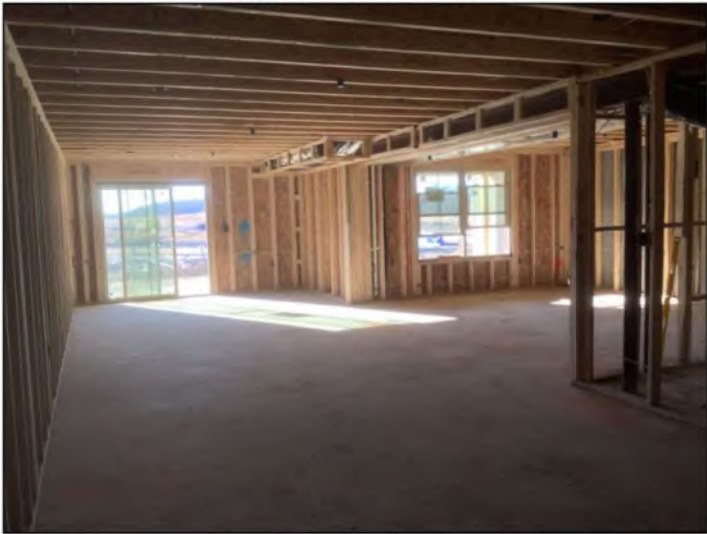
Materials: Basement  
Observations:  
• Acceptable  
• New Construction - Some, if not many components have not been built/installed or completed/finished yet.

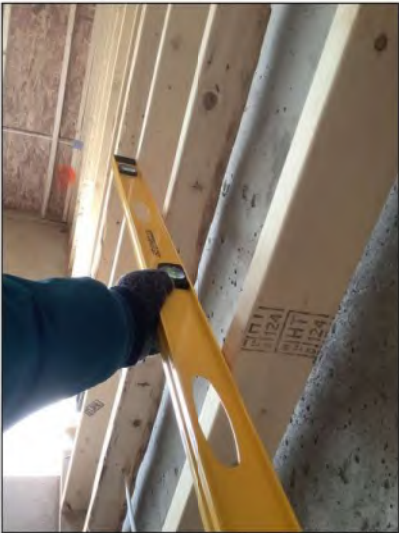
Materials: Wood studs  
Observations:  
• No deficiencies noted.

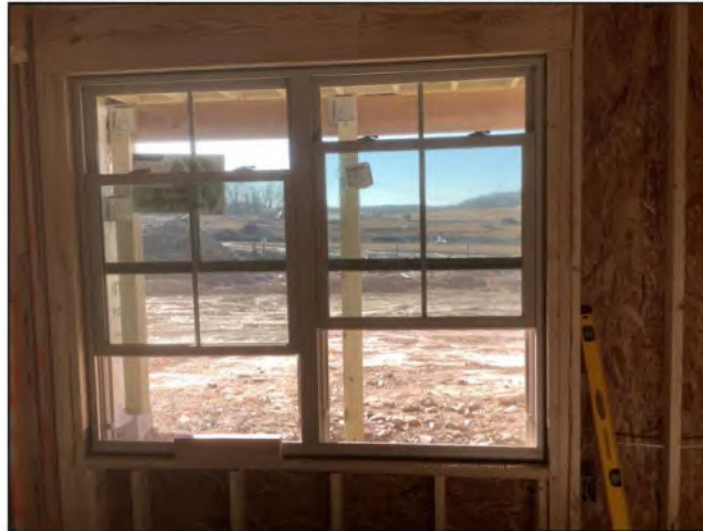
- Windows appeared functional at the time of inspection.

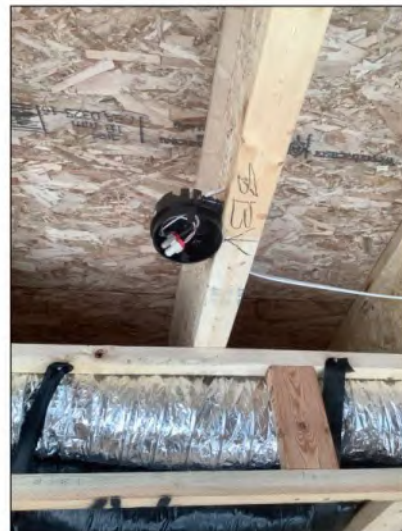
- All wiring and rough in appeared functional and in satisfactory condition at the time of inspection.

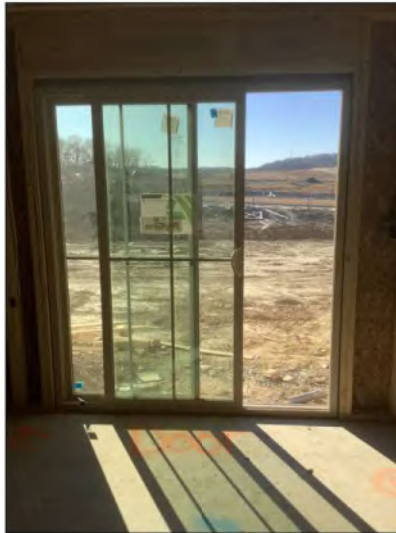
- The patio door was functional during the inspection.

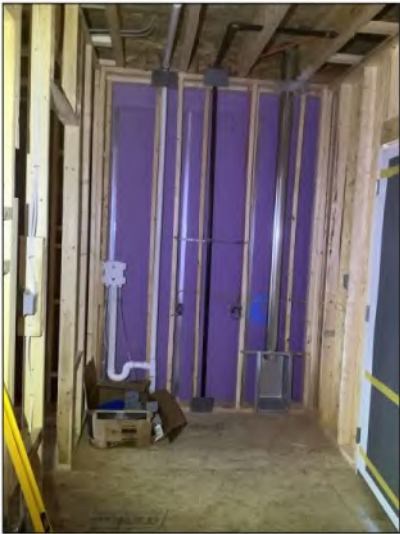
- New Construction - Some, if not many components have not been built/installed or completed/finished yet.
- Acceptable

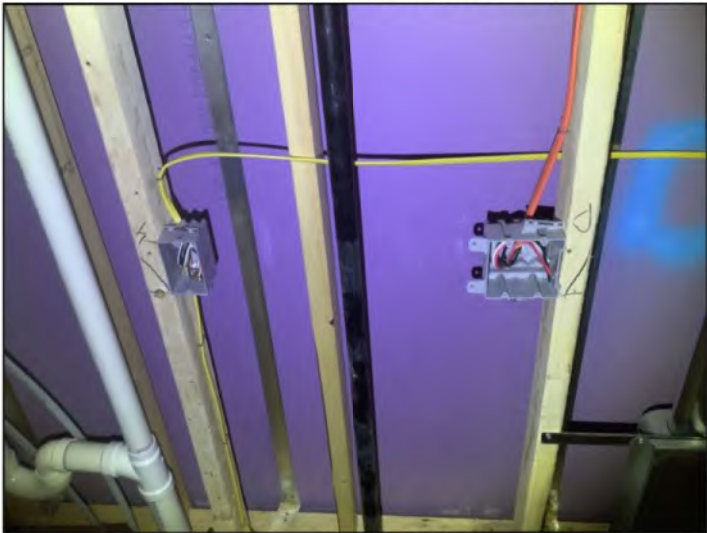
Observations:  
• Rough-in only. New Construction - Some, if not many components have not been built/installed or completed/finished yet.

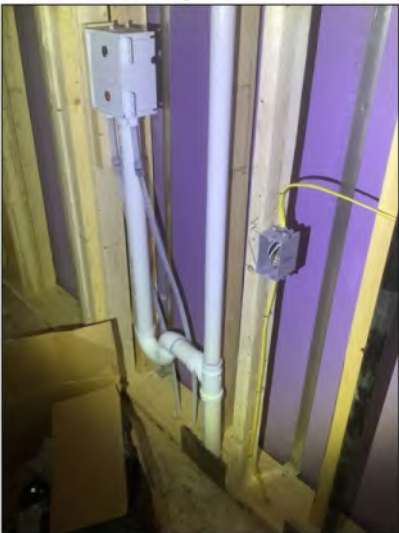
Observations:  
• Rough-in only. New Construction - Some, if not many components have not been built/installed or completed/finished yet.

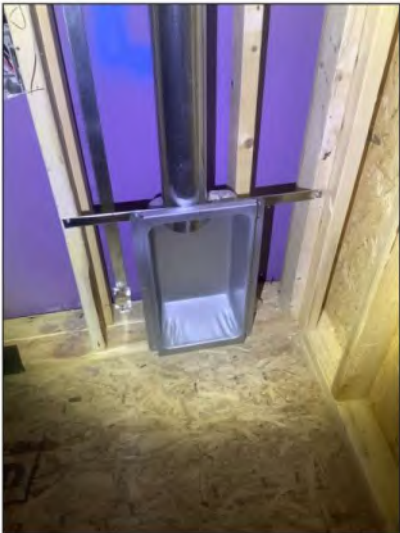
Observations:  
• No deficiencies noted.

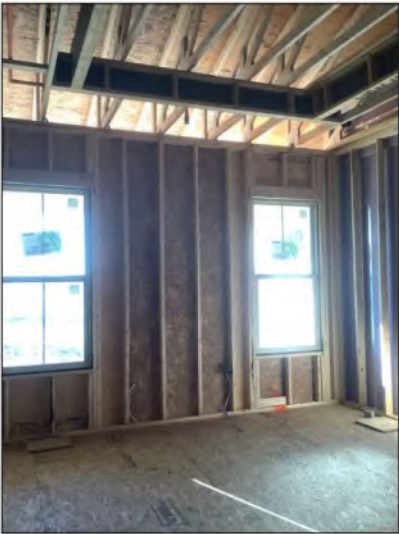
- New Construction - Some, if not many components have not been built/installed or completed/finished yet.
- Acceptable

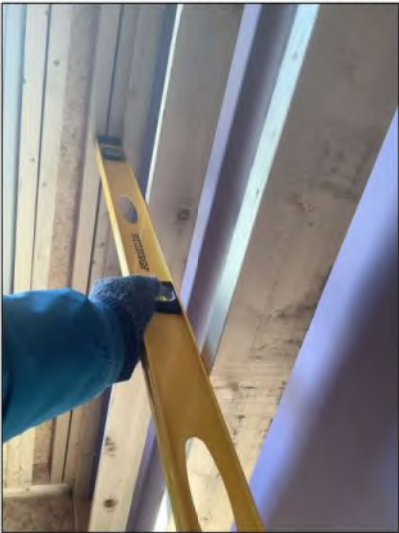
- Walls framing appear to be satisfactory

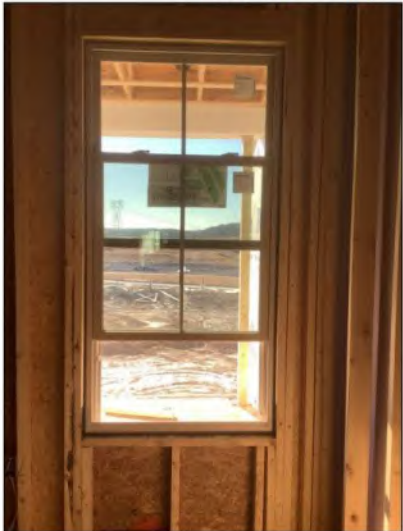
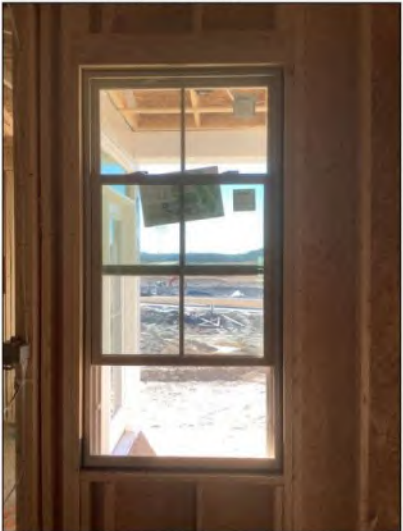
5. Window Condition

Type: Vinyl framed • Single hung window • double pane  
Observations:  
• Windows appeared functional at the time of inspection.

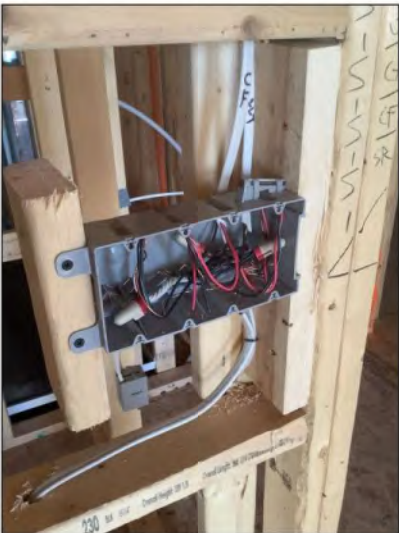
Observations:  
• Electrical wiring and rough-in appear to be acceptable.

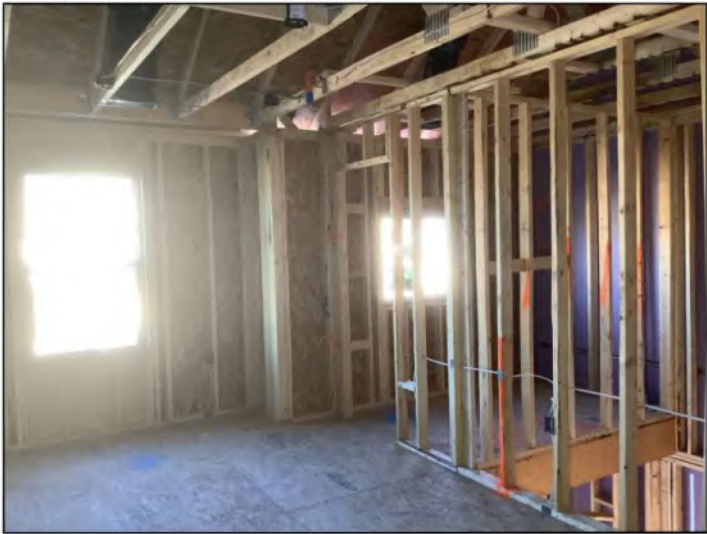
1. General Condition

Materials: 2nd floor  
Observations:  
• New Construction - Some, if not many components have not been built/installed or completed/finished yet.  
• Acceptable

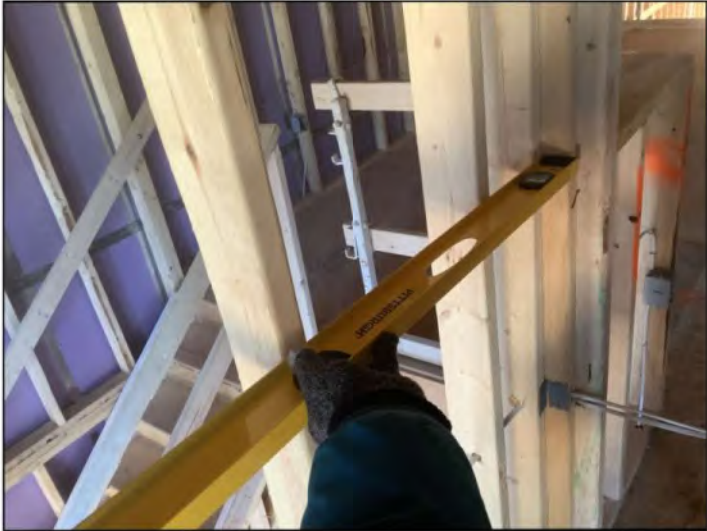
3. Wall Condition

Materials: Wood studs 2x4.  
Observations:  
• Walls framing appear to be satisfactory

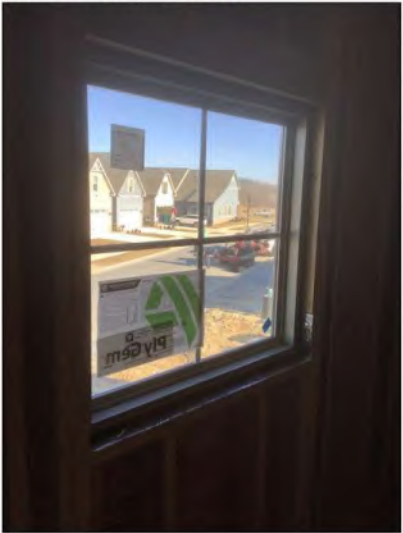
5. Window Condition

Type: Vinyl framed • Single hung window • Fixed window • double pane  
Observations:  
• Windows appeared functional at the time of inspection.

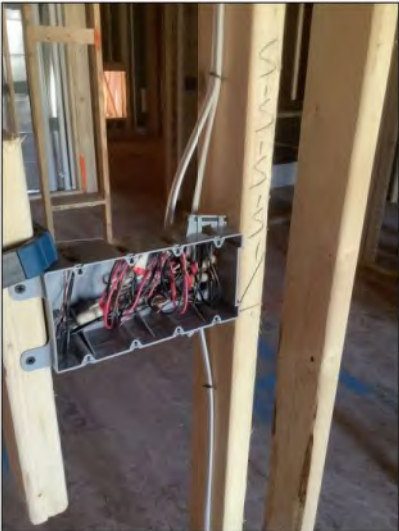
Observations:  
• Electrical wiring and rough-in appear to be acceptable.

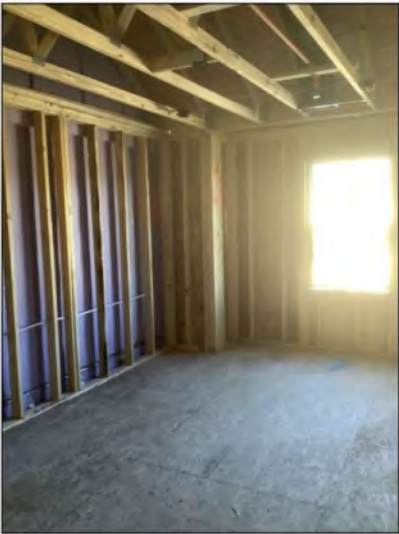
1. General Condition

- New Construction - Some, if not many components have not been built/installed or completed/finished yet.
- Acceptable

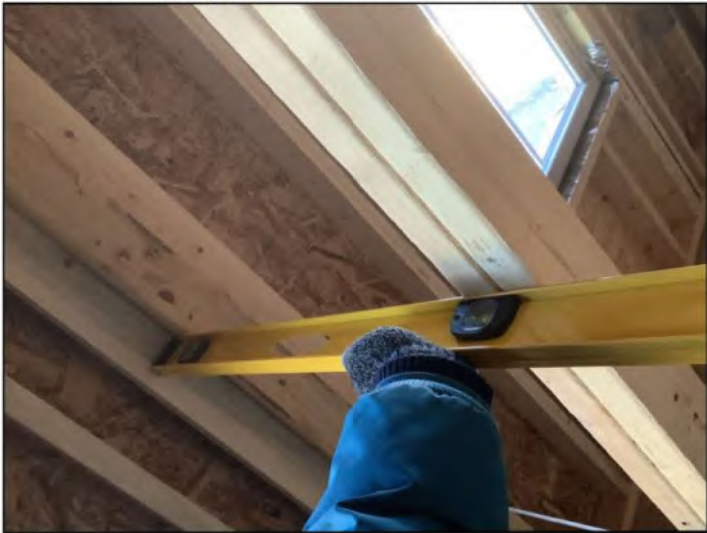
3. Wall Condition

- Walls framing appear to be satisfactory

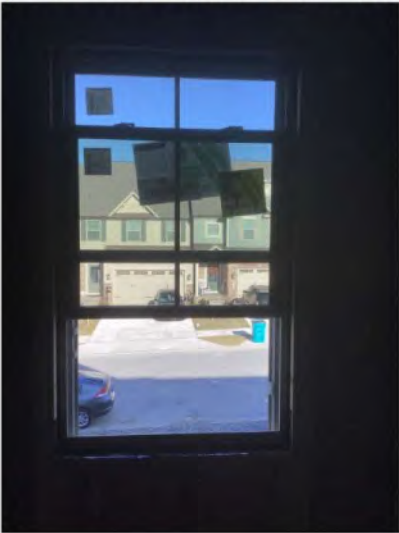
5. Window Condition

Type: Vinyl framed • Single hung window • double pane  
Observations:  
• Windows appeared functional at the time of inspection.

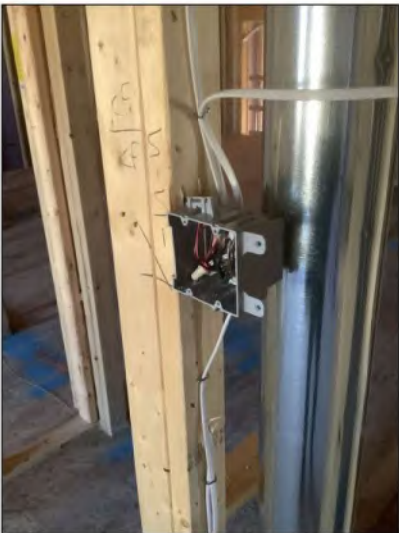
Observations:  
• Electrical wiring and rough-in appear to be acceptable.

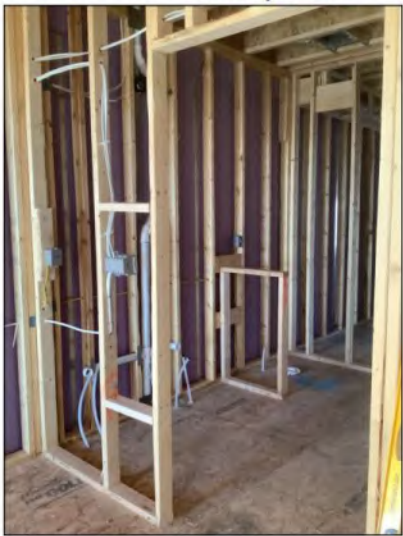
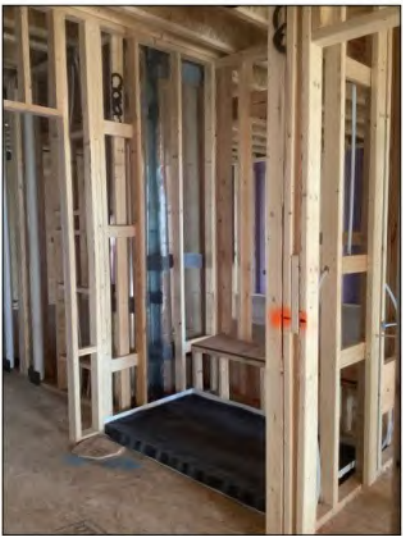
1. General Condition

Materials: Main Floor, Master bathroom.  
Observations:  
• New Construction - Some, if not many components have not been built/installed or completed/finished yet.  
• Acceptable
