# INSPECTION REPORT

10000 Sample Street, Sample MD 10000  
Inspection prepared for: Sample Client  
Real Estate Agent: Sample Agent

Date of Inspection: 12/20/2021 Time: 9:00 AM  
Year Built: 2021 Size (sqft): 2800  
Weather: Clear 25 to 30 degrees F  
Order ID: 9086

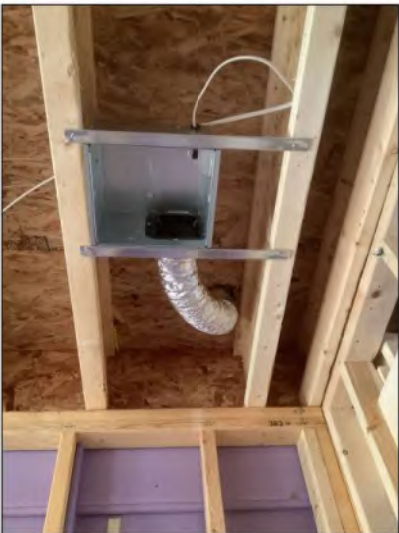
2. Exhaust Fan

Observations:  
• Exhaust fan rough-in is acceptable

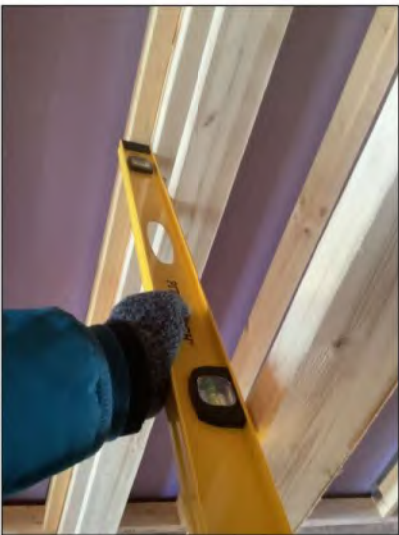
4. Bath Wall Condition

Materials: Wood studs  
Observations:  
• Walls framing appear to be satisfactory

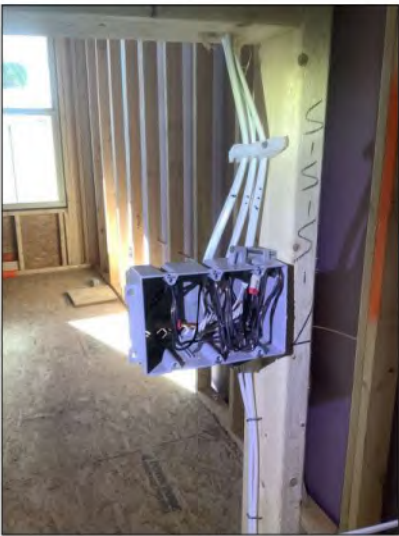
Observations:  
• Electrical wiring and rough-in appear to be acceptable.

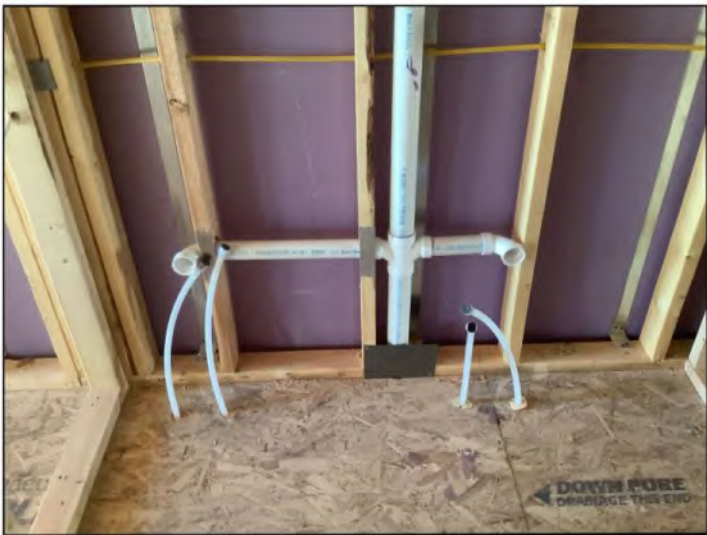
8. Plumbing

Observations:  
• Rough-in; New Construction - Some, if not many components have not been built/installed or completed/finished yet.

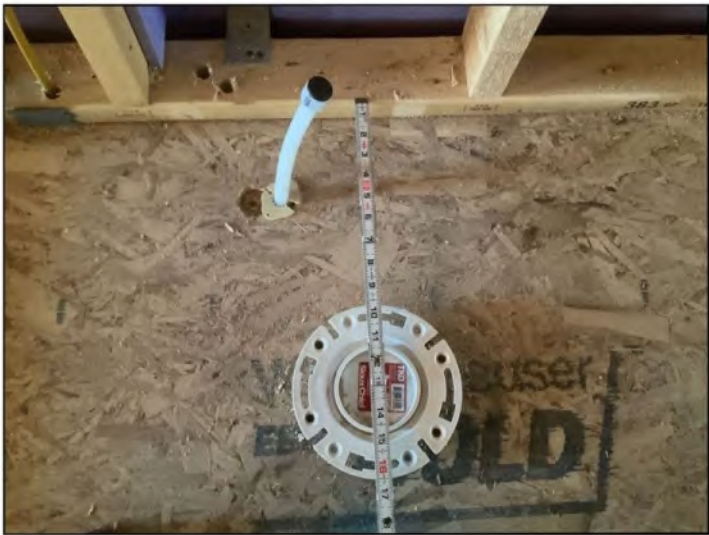
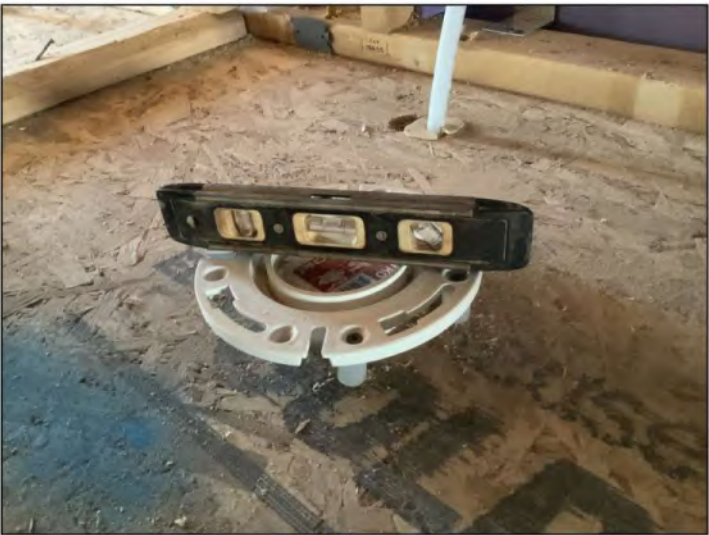
9. Toilets

Observations:  
• Toilet rough-in is acceptable

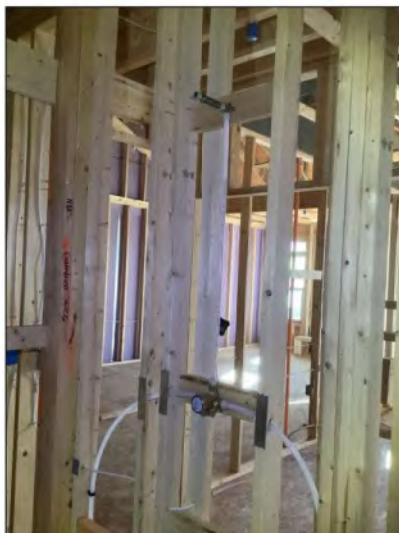
10. Showers

Observations:  
• Shower plumbing and rough-in is acceptable

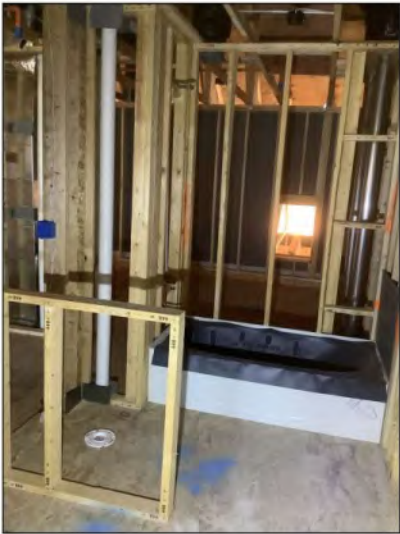
1. General Condition

- New Construction - Some, if not many components have not been built/installed or completed/finished yet.
- Acceptable

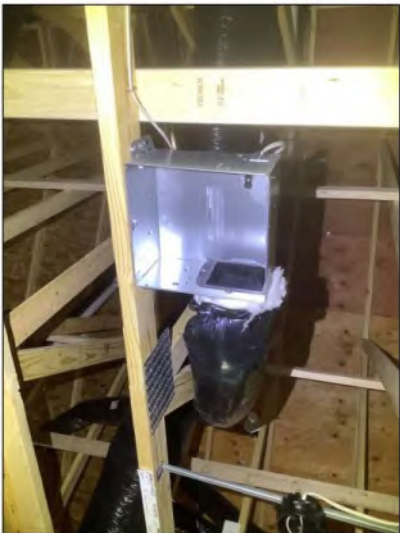
2. Exhaust Fan

- Exhaust fan rough-in is acceptable

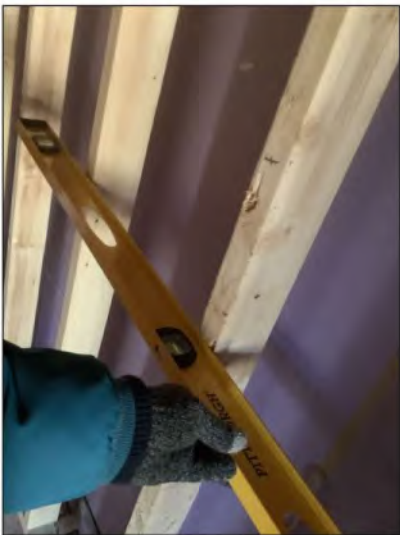
4. Bath Wall Condition

- Walls framing appear to be satisfactory

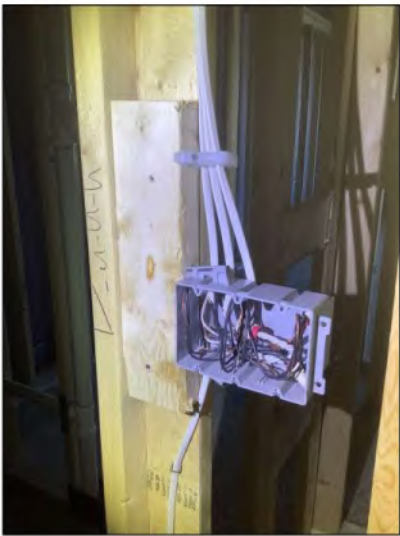
Observations:  
• Electrical wiring and rough-in appear to be acceptable.

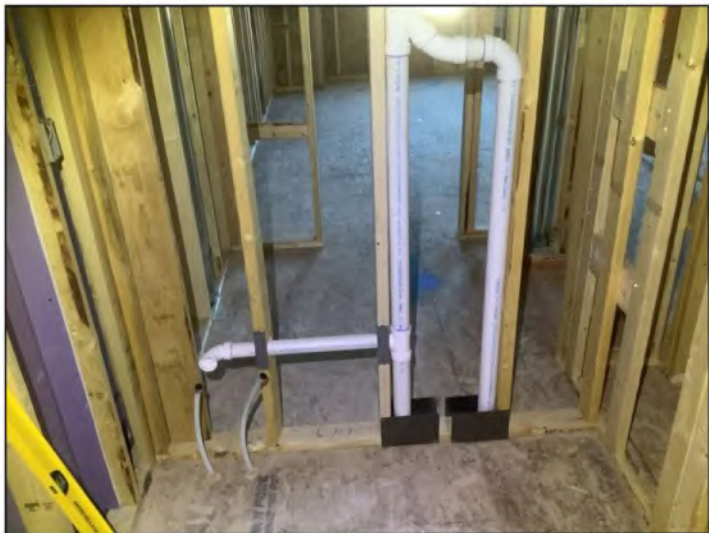
8. Plumbing

Observations:  
• Rough-in; New Construction - Some, if not many components have not been built/installed or completed/finished yet.

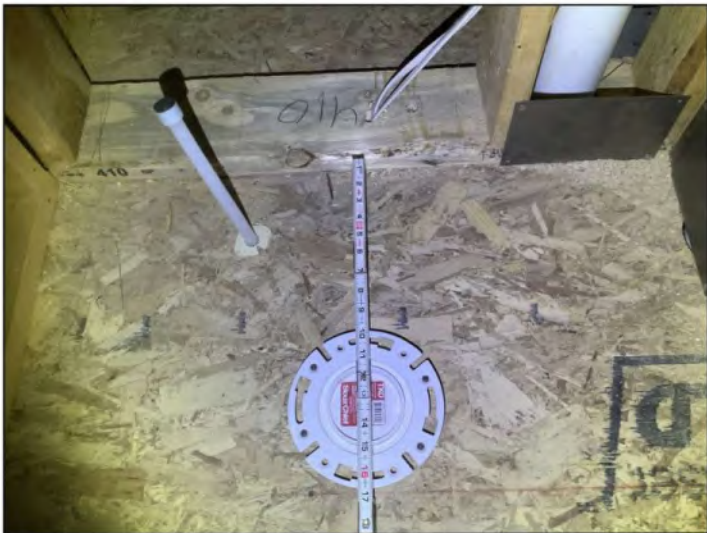
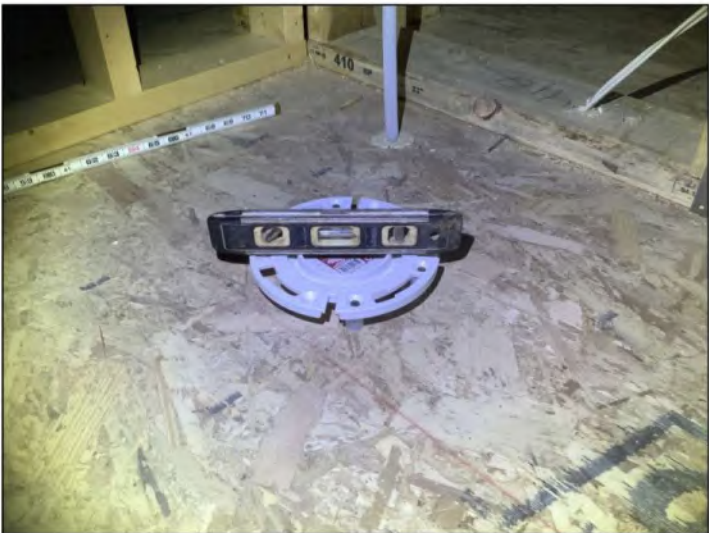
9. Toilets

Observations:  
• Toilet rough-in is acceptable

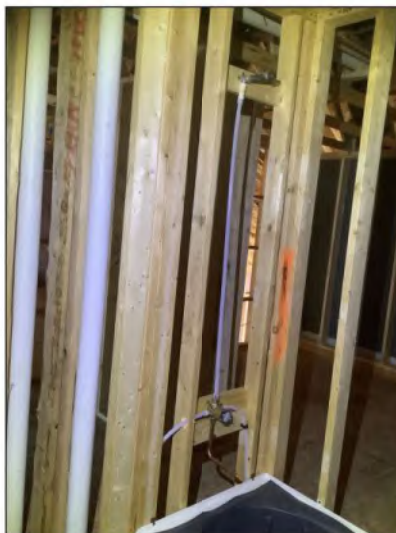
10. Showers

Observations:  
• Shower plumbing and rough-in is acceptable

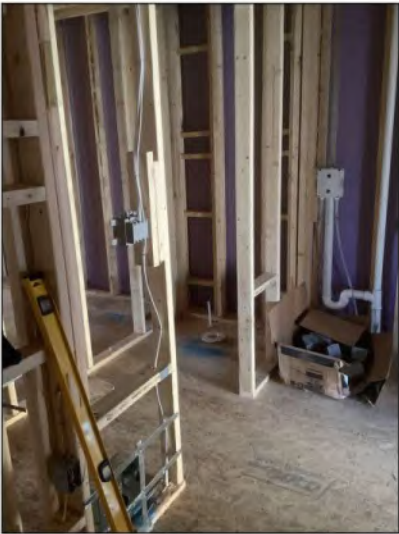
1. General Condition

Materials: First floor  
Observations:  
• New Construction - Some, if not many components have not been built/installed or completed/finished yet.  
• Acceptable

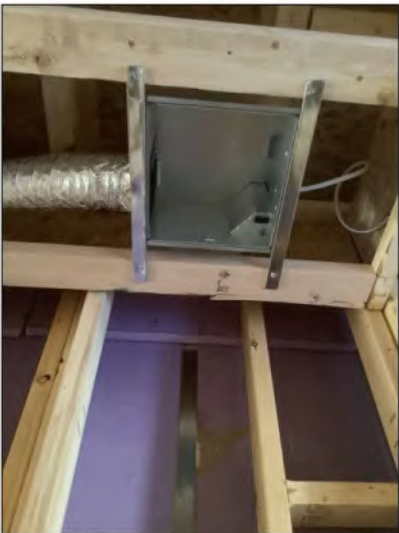
2. Exhaust Fan

Observations:  
• Exhaust fan rough-in is acceptable

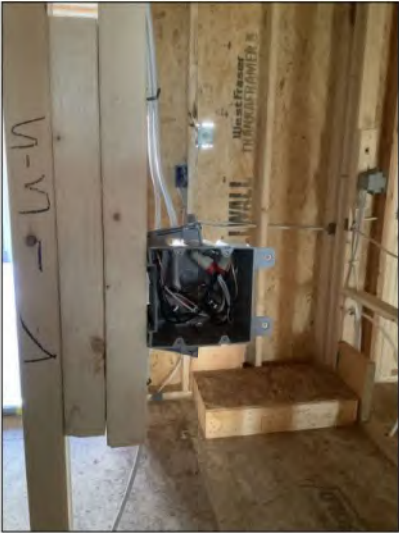
Observations:  
• Electrical wiring and rough-in appear to be acceptable.

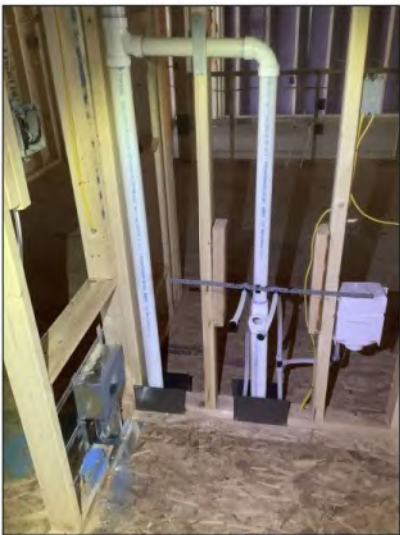
8. Plumbing

Observations:  
• Rough-in; New Construction - Some, if not many components have not been built/installed or completed/finished yet.

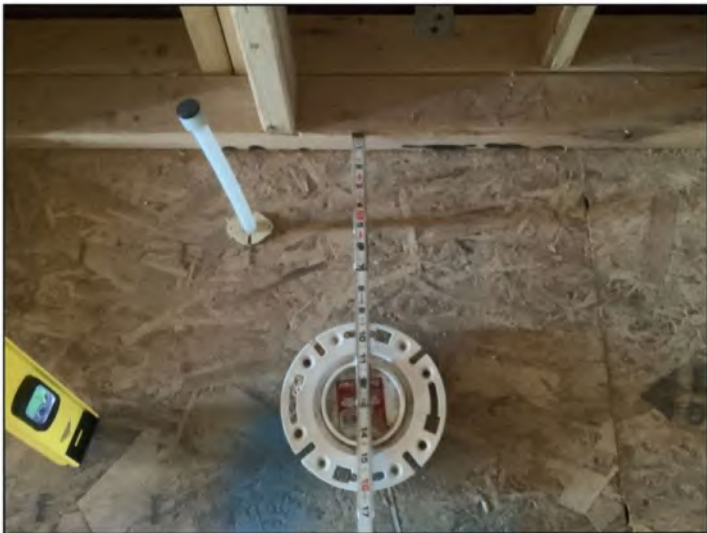
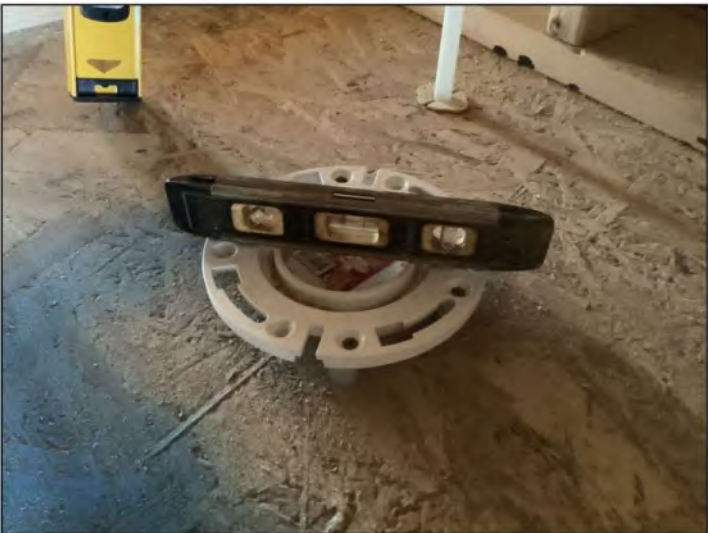
9. Toilets

Observations:  
• Toilet rough-in is acceptable
