# INSPECTION REPORT

111 SAMPLE AVE, SAMPLE, VA

Date of Inspection: 2/19/2025 Time: 12:00 PM

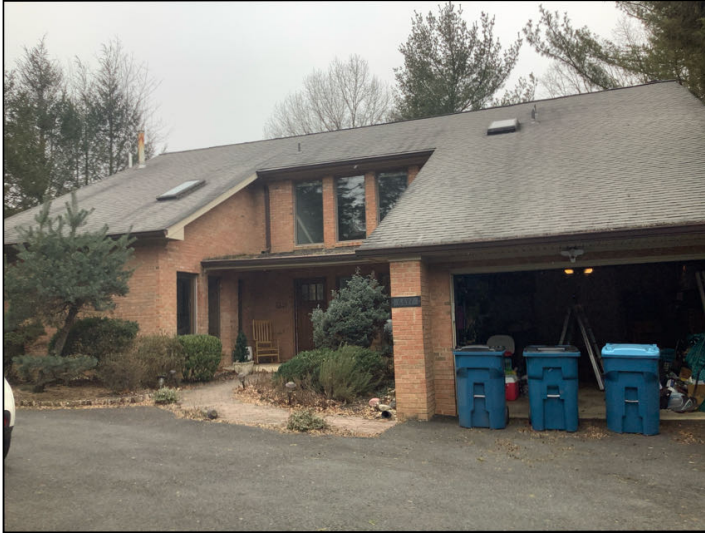
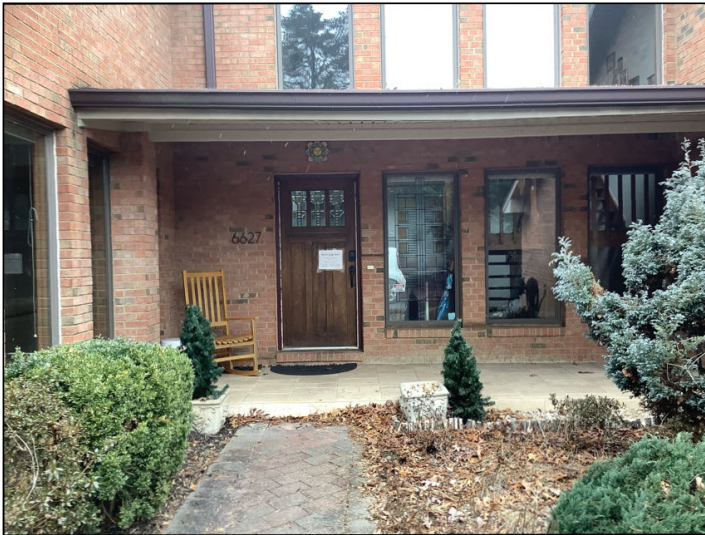
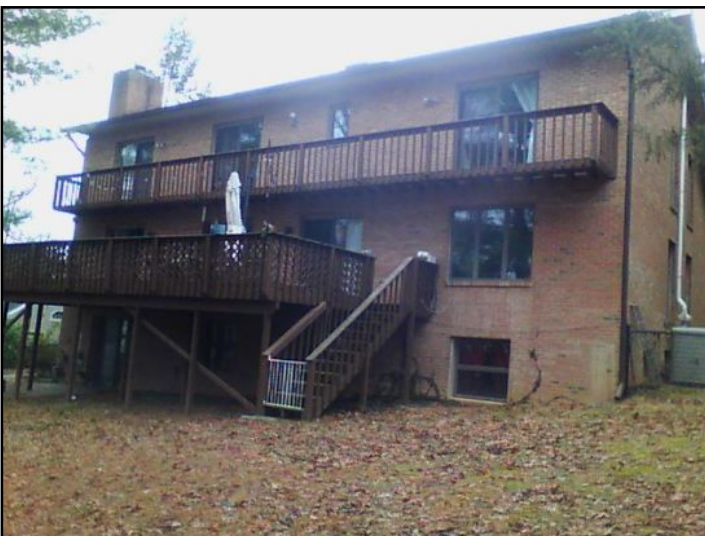
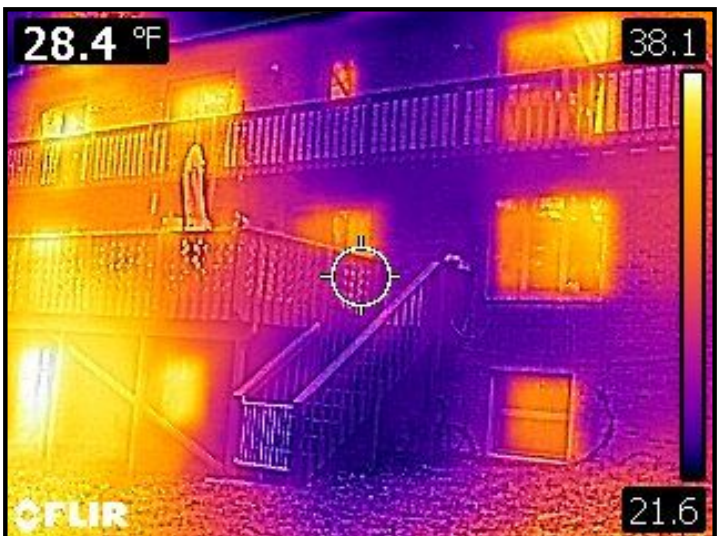
- No major system or safety concerns noted.

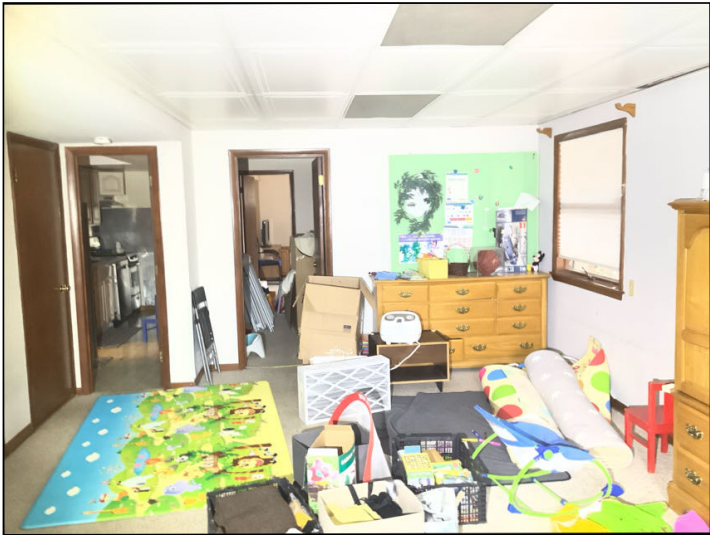
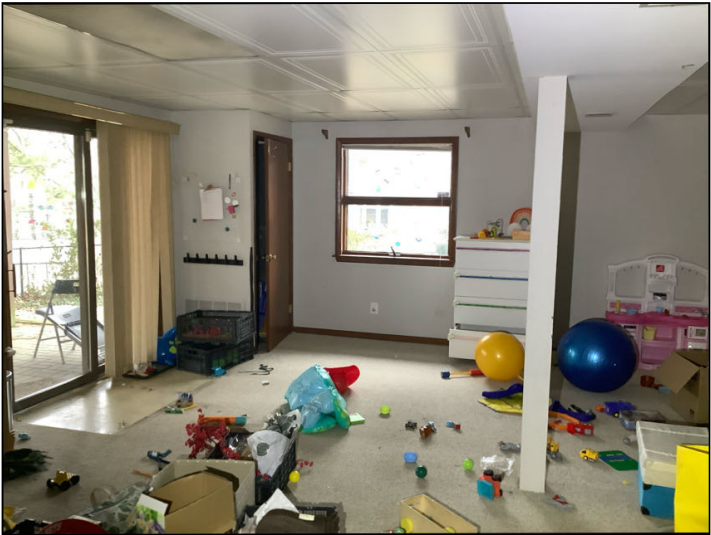
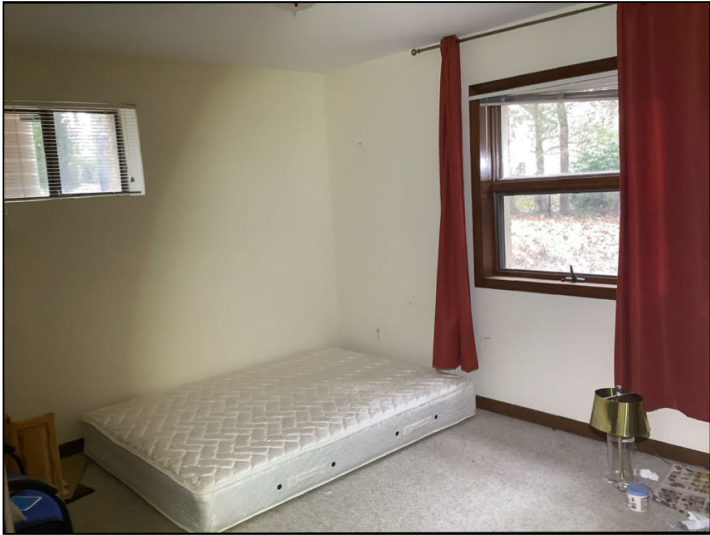
Basement bedroom

Observations:  
• Acceptable

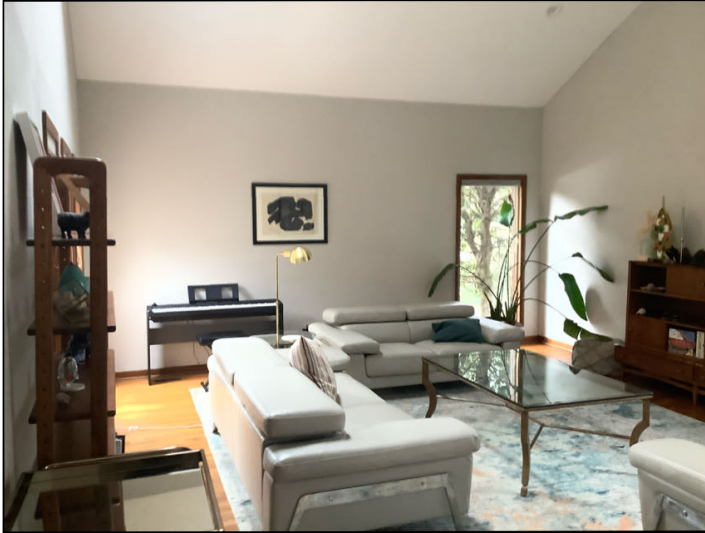
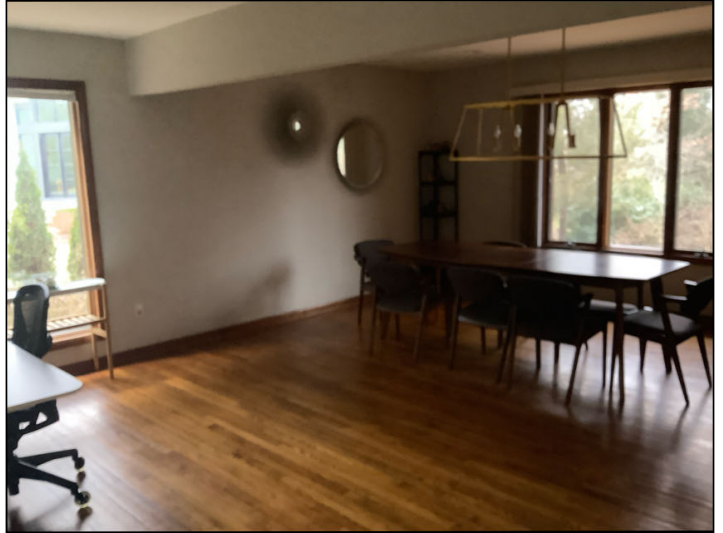
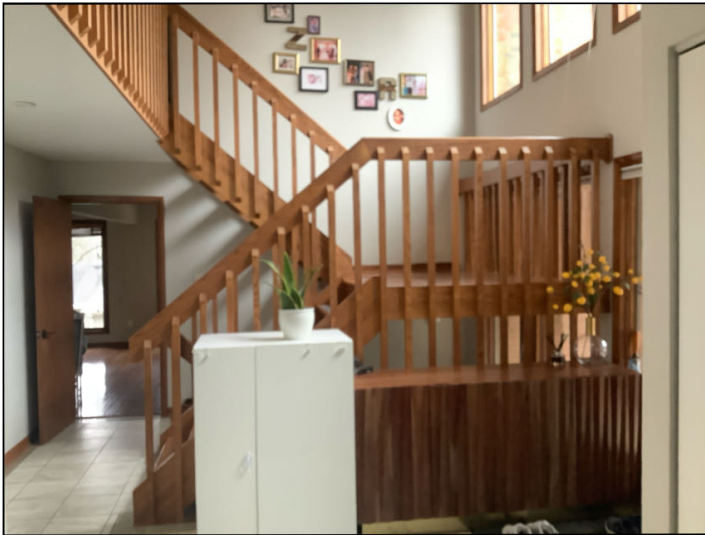
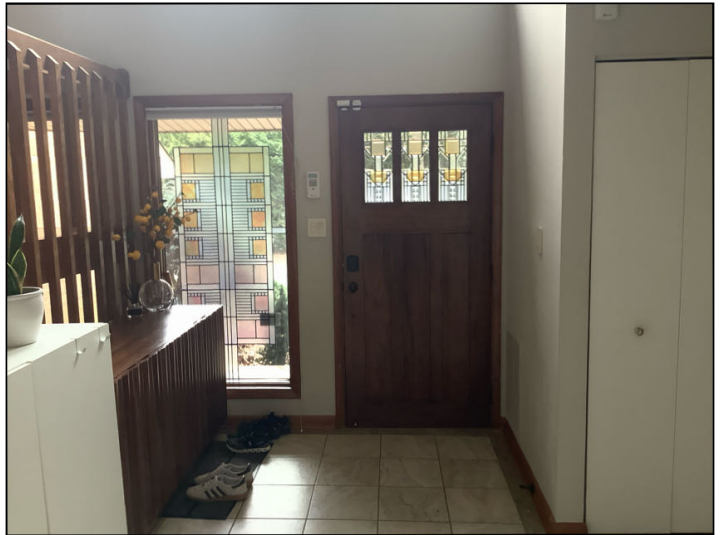
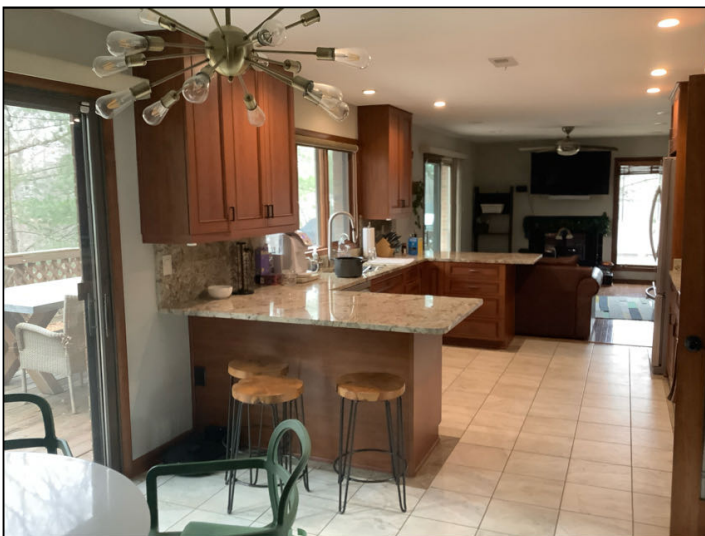
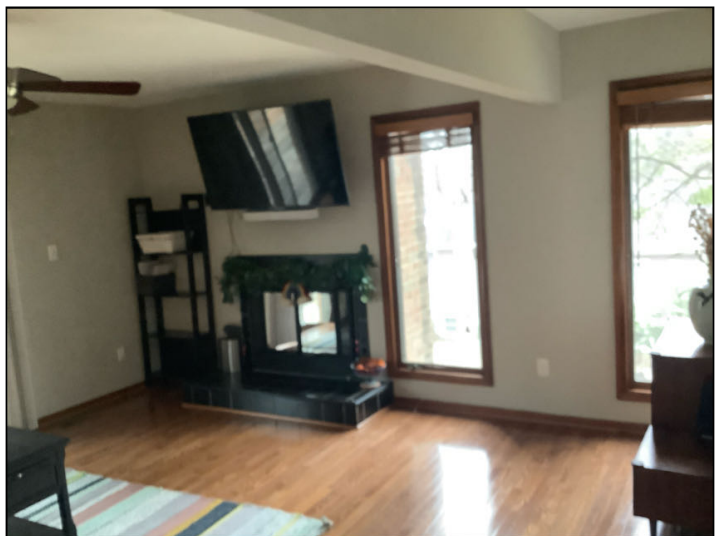
- Acceptable
